MEMORANDUM

RE: *[Handwritten signature]*
Intersection Evaluation
Parmenter Road/Pine Hill Road Intersection
Southborough, Massachusetts

MDM Transportation Consultants, Inc. (MDM) has prepared a safety and operations evaluation for the intersection of Parmenter Road and Pine Hill Road in Southborough, Massachusetts. The study location relative to area roadways is shown in **Figure 1**. This evaluation summarizes baseline traffic and safety conditions at the intersection including survey of daily and peak hour traffic volumes, travel speed data, intersection sight lines, and crash data. The purpose of the study will be to identify potential roadway and intersection improvements that are necessary to address existing traffic operations and safety.

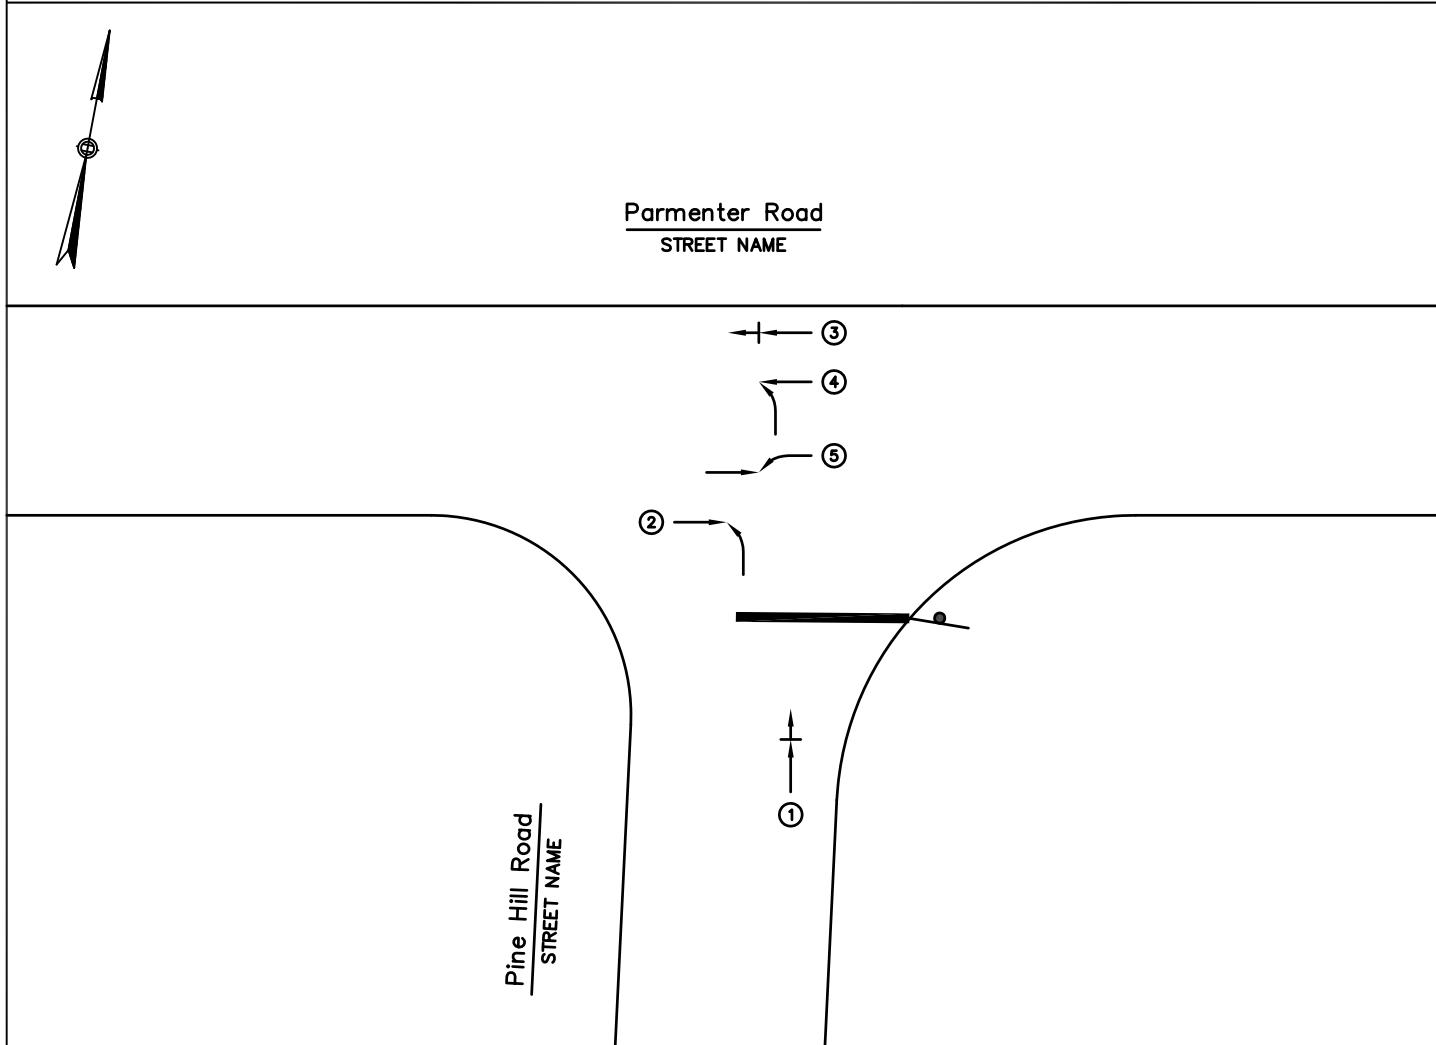
COLLISION DIAGRAM

MDM had also obtained crash record data for the Parmenter Road at Pine Hill Road intersection for the period 2011 through August 2015 from the Southborough Police Department to develop a collision diagram to facilitate an understanding of potential causal factors for crashes. The collision diagram for the study intersection is shown in **Figure 3**.

In summary, Parmenter Road at Pine Hill Road experienced a crash rate slightly above the District-wide average, therefore safety countermeasures may be warranted at or near the intersection. A review of the MassDOT crash data indicates and roadway characteristics indicate that roadside obstructions, lack of clear zones, and limited sight distance are likely contributing factors in the reported crashes. A discussion of potential countermeasures is presented under Recommendations.

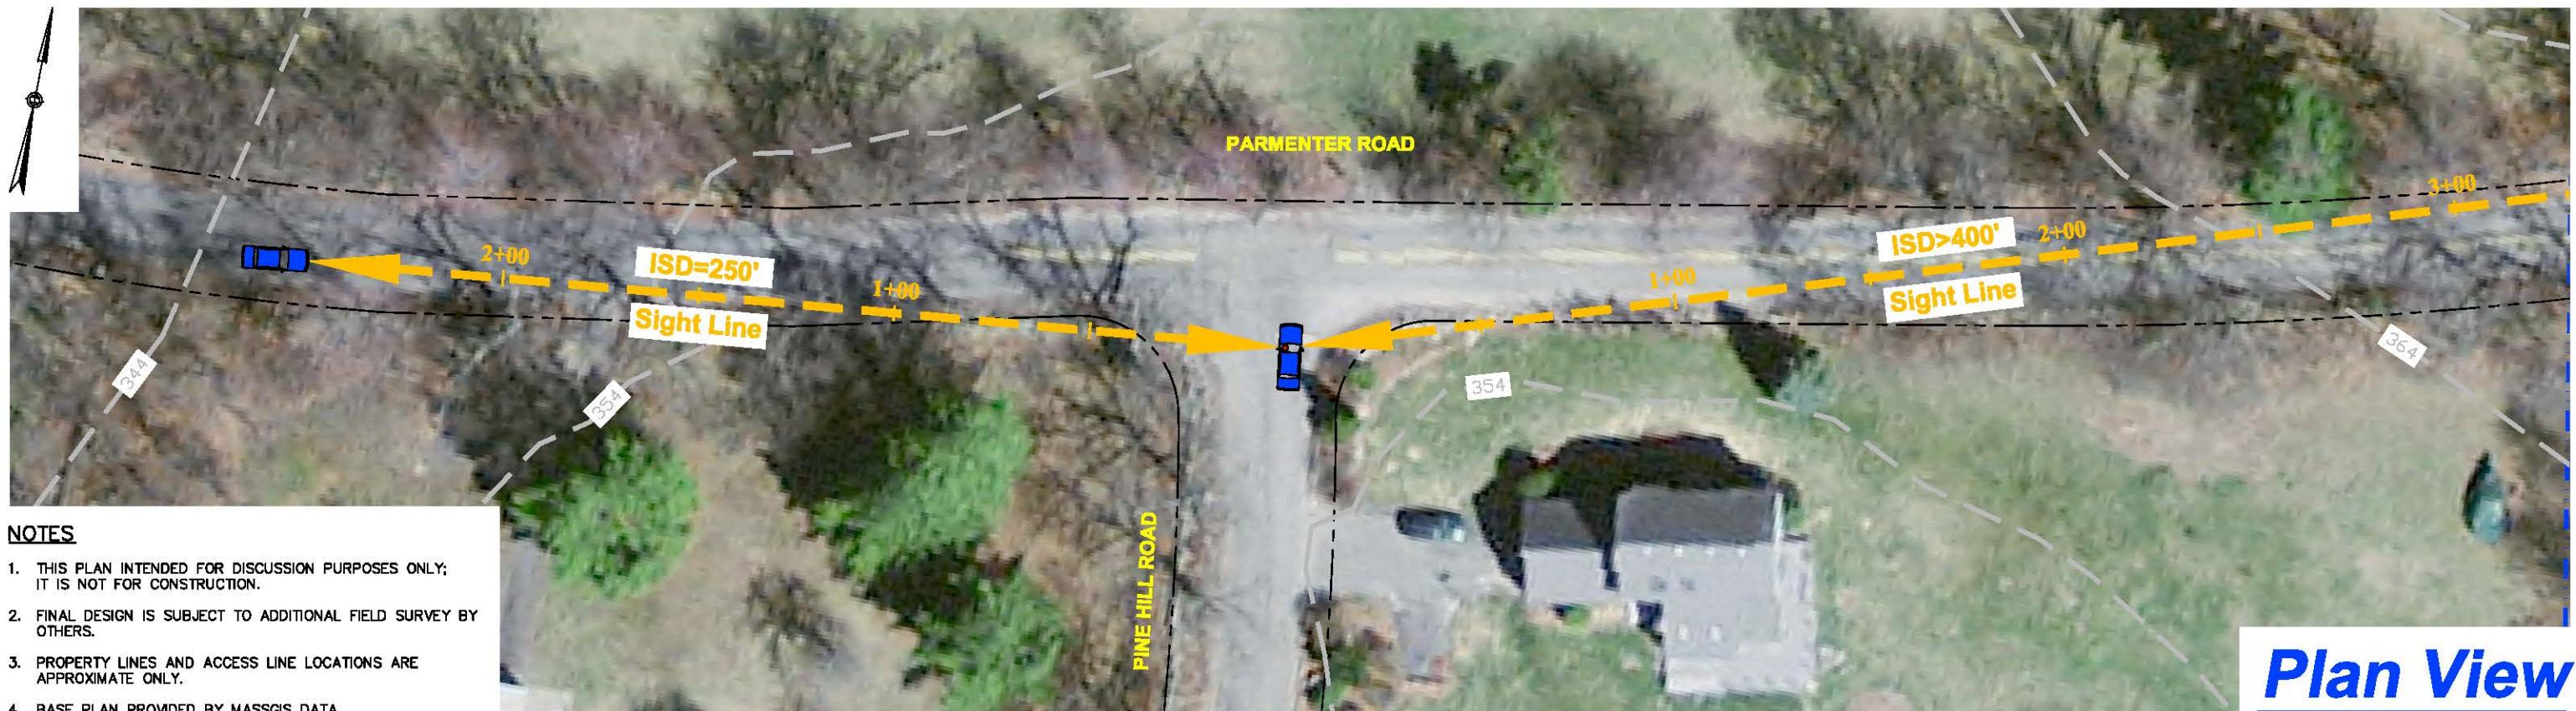
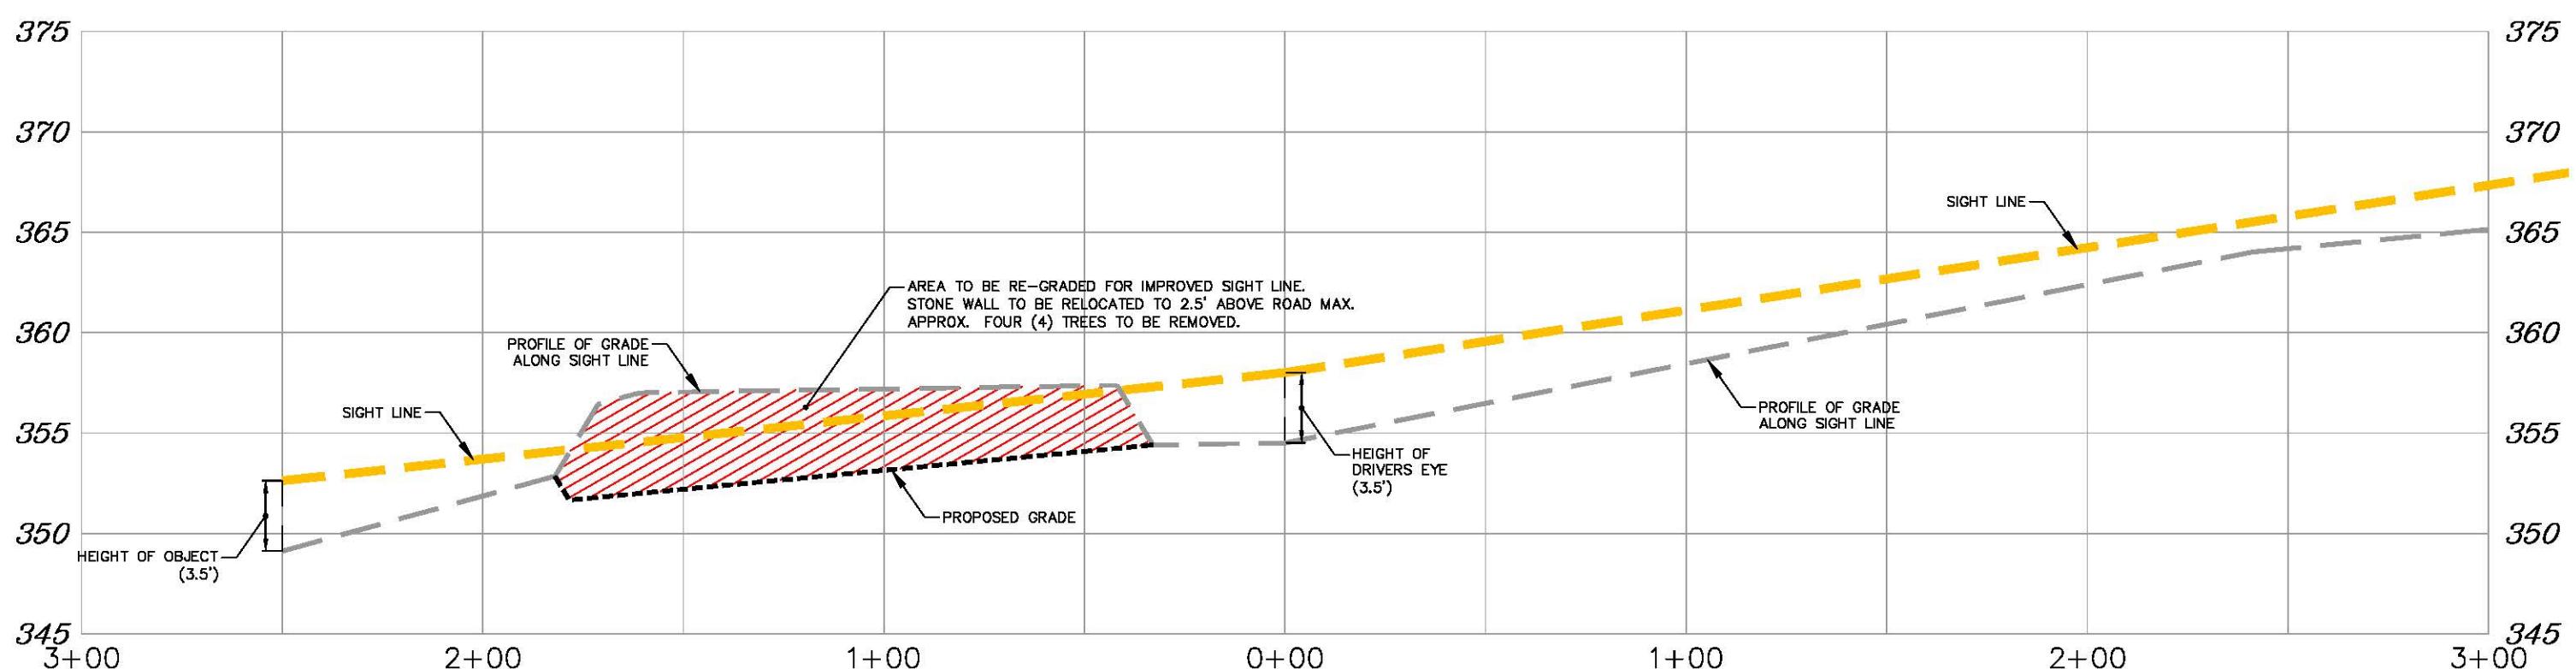
Figure 4
Intersection Sight Distance

The results of the ISD analysis presented in **Table 5** indicate that the available sight line looking east from Pine Hill Road onto Parmenter Road exceed both the minimum and ideal sight line recommendations from AASHTO based on the regulatory speed and 85th percentile speed. The available sight line looking to the west from Pine Hill Road onto Parmenter Road currently do not satisfy even the minimum recommended sight line requirement for the regulatory speed limit due to existing roadside obstructions in close proximity to the travel way including trees, stone walls, and the existing ground embankment.

A review of the existing features within the sight line looking to the west from Pine Hill Road onto Parmenter Road indicates that to maximize the available sight line the area should be re-graded within the sight line triangle, the stone wall should be removed and reset to a maximum height of 2.5 feet above the adjacent roadway grade and approximately four (4) trees should be removed. With said improvements the sight line looking to the west from Pine Hill Road onto Parmenter Road can be maximized to approximately 250 feet, as shown in **Figure 4**, which correlates to a design speed of approximately 25 mph.

MDM recommends that in the future the sight lines should continue to be maintained and that any new plantings (shrubs, bushes) or physical landscape features to be located within the driveway sight lines should also be maintained at a height of 2.5 feet or less above the adjacent existing roadway grade to ensure unobstructed lines of sight.

- To maximize the available sight line looking west from Pine Hill Road onto Parmenter Road the area within the sight line triangle should be regraded, the stone wall should be removed and reset to a maximum height of 2.5 feet above the adjacent roadway grade and approximately four (4) trees should be removed. With said improvements the sight line (ISD) looking to the west from Pine Hill Road onto Parmenter Road can be maximized to approximately 250 feet which correlates to a design speed of approximately 25 mph.

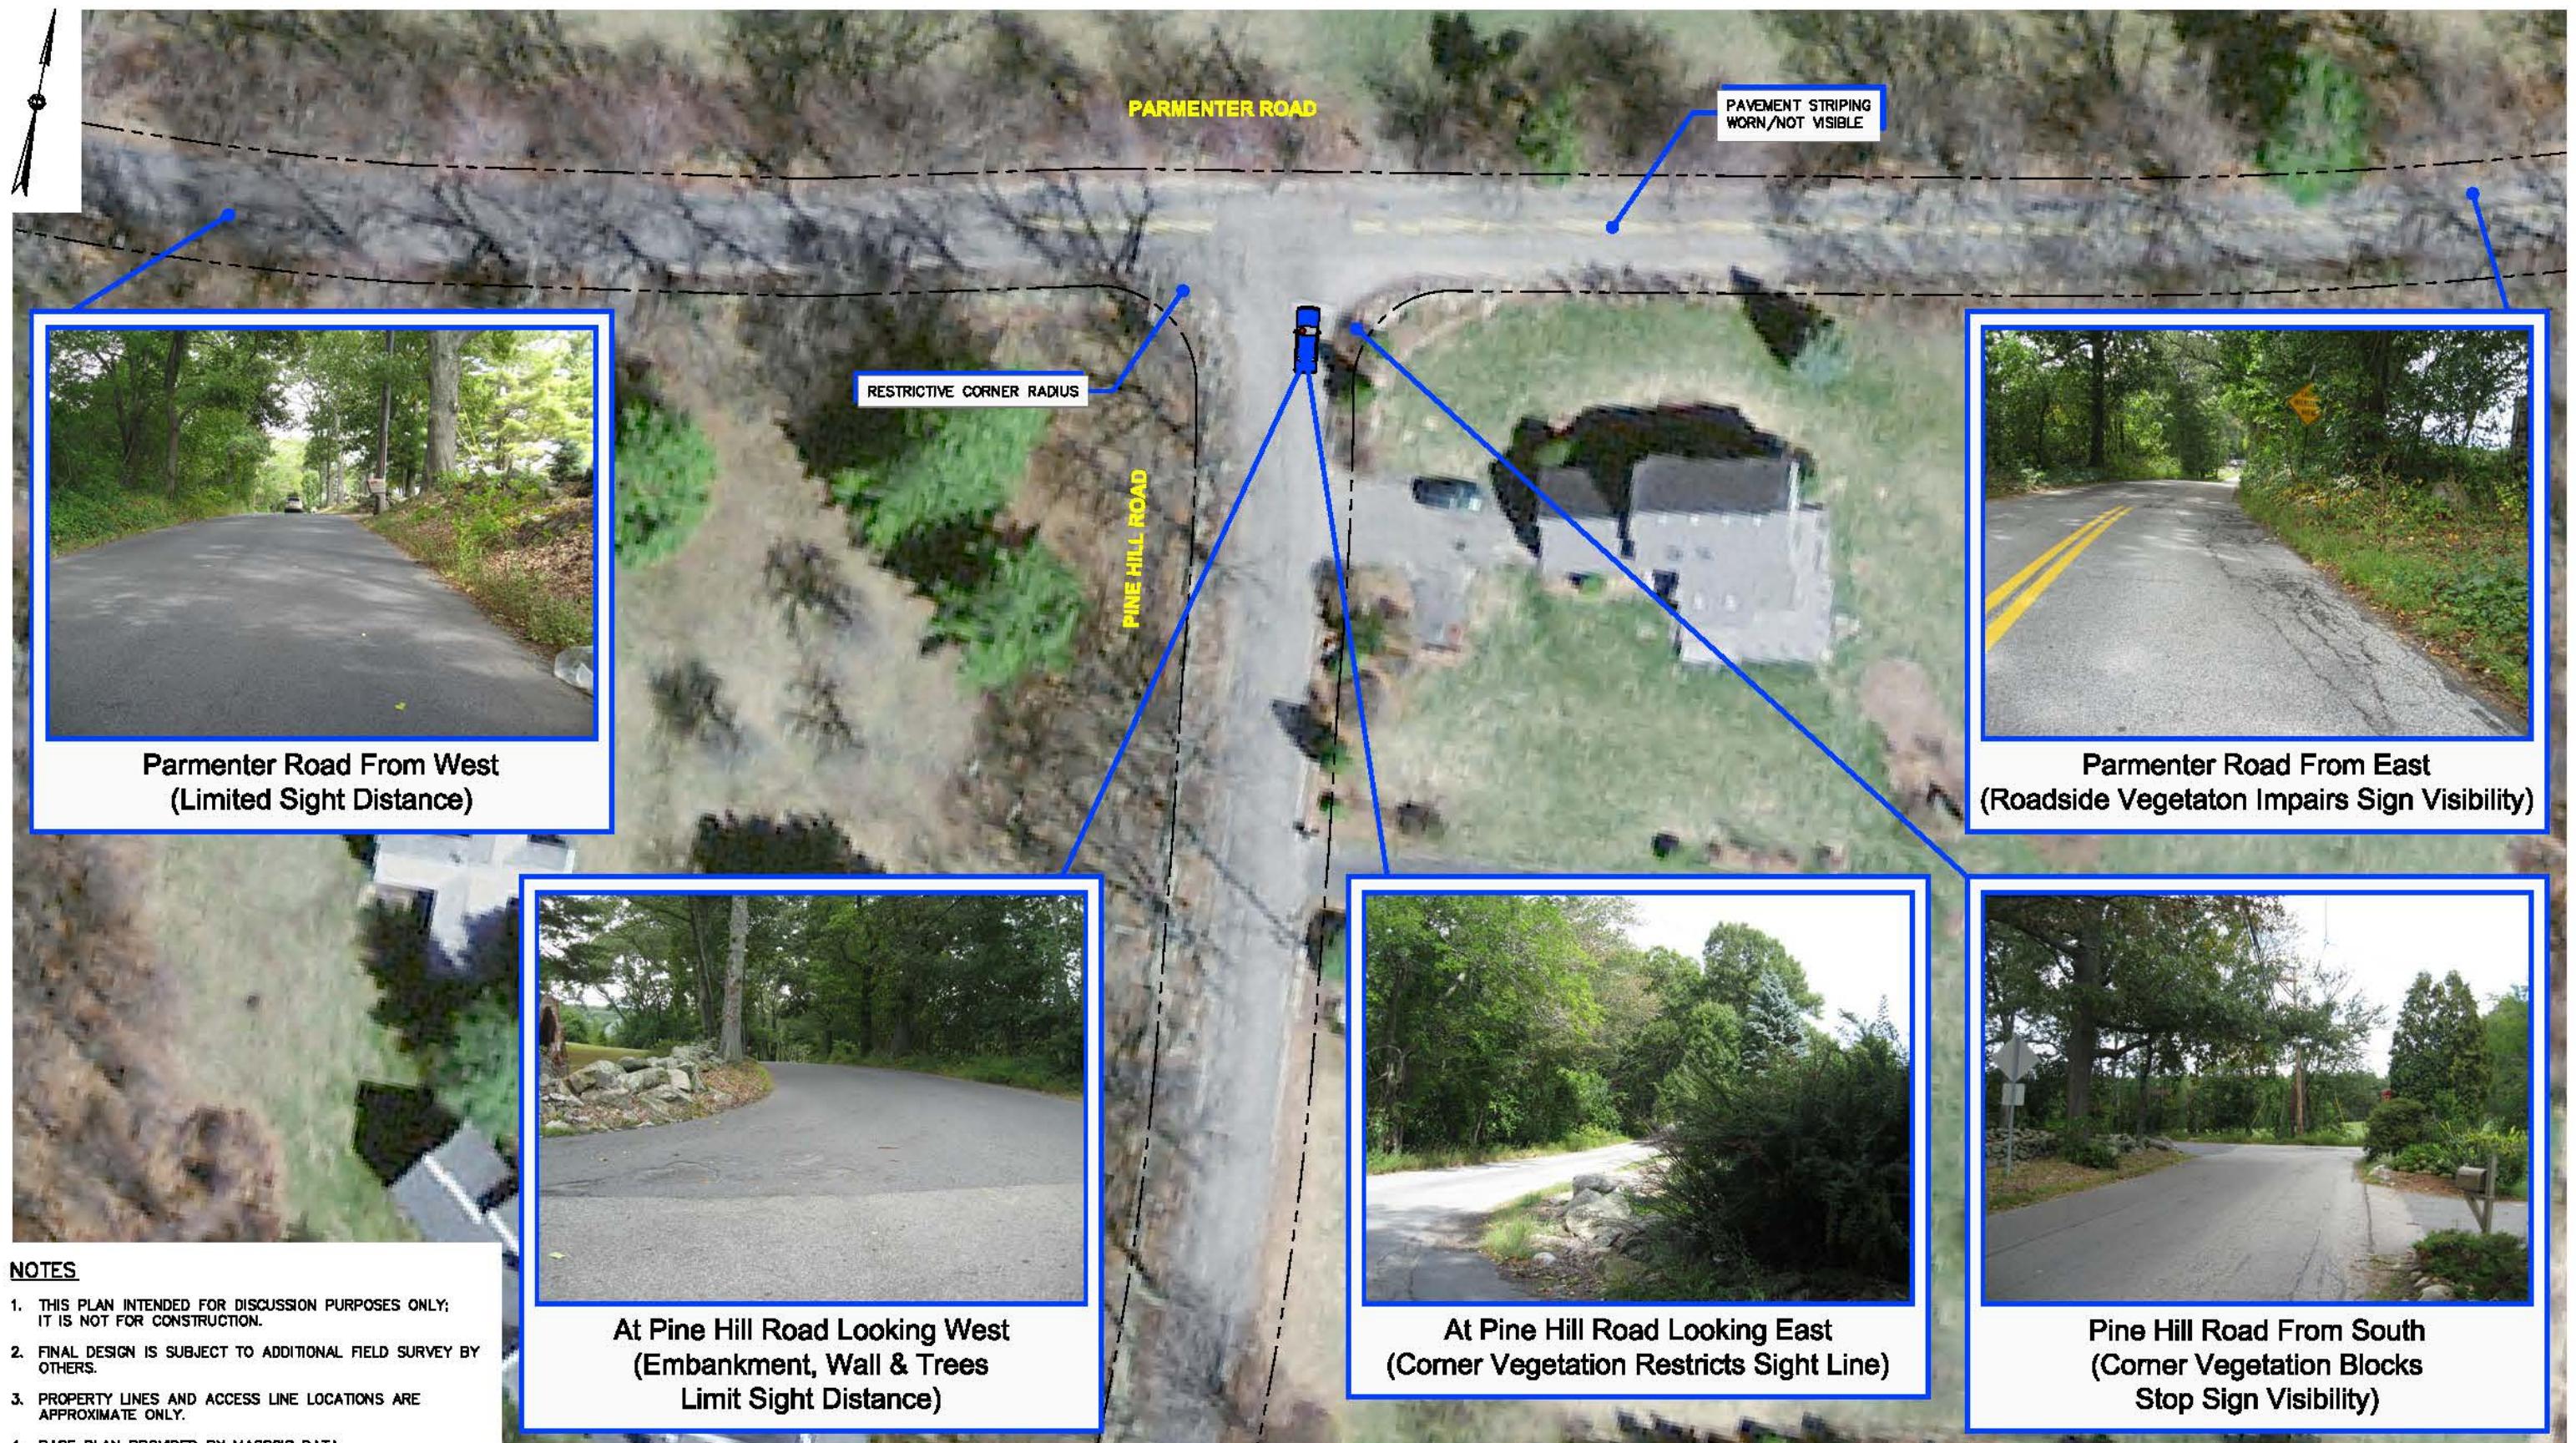
Figure 5
Existing Conditions

The safety and operations evaluation for the intersection of Parmenter Road and Pine Hill Road indicated the following traffic and safety issues as outlined in **Figure 5**:

- Parmenter Road is classified as rolling terrain with both vertical and horizontal curves with roadside obstructions in close proximity to the travel way including vegetation, trees and stone walls.

- While yellow centerlines and single white edge lines are provided in the adjacent communities no pavement markings within the Town of Southborough were evident at the time of this evaluation.

- Roadside vegetation along Parmenter Road impairs visibility to existing signage.
- Stopping sight distance (SSD) along Parmenter Road approaching Pine Hill Road from the west is limited to 250 feet by a vertical crest curve.

- Intersection sight distance (ISD) looking west from Pine Hill Road onto Parmenter Road is severely limited to only 50± feet by an embankment, stone wall, vegetation, and several large trees.

- The “STOP” sign on the Pine Hill northbound approach to Parmenter Road is blocked by vegetation. Said vegetation also impairs ISD looking to the east onto Parmenter Road from a STOP position further from the edge of travel way. A “STOP” line on the Pine Hill Road approach to Parmenter Road is also worn or no existent.

- The right turn corner radius from Parmenter Road to Pine Hill Road is restrictive.
