**TOWN OF SOUTHBOROUGH**  
**Planning Board**  
**Application for a**  
**Scenic Road Stonewall or Tree Removal**

Name of Applicant(s): National Grid (Hazard Tree Program)

## PUBLIC HEARING NOTICE TREE REMOVAL HEARING

Town of Southborough  
NE Hazard Tree Mitigation Program  
Hazard Tree Removal List

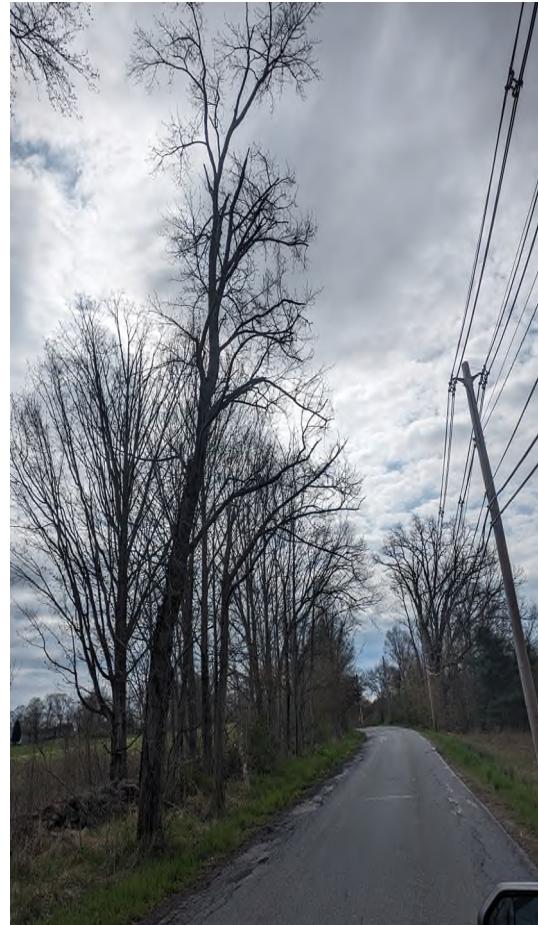
Site ID	Tree #	Street Name	House #	Loc	Pole #	Dia.	Species	# Stems	Defect Condition	Work Proposed
DC10	1	Northborough Rd	Lot	AF	7-6	22	Maple		Lean, weight to line, branch cavities with decay, more than 50% decline	Remove

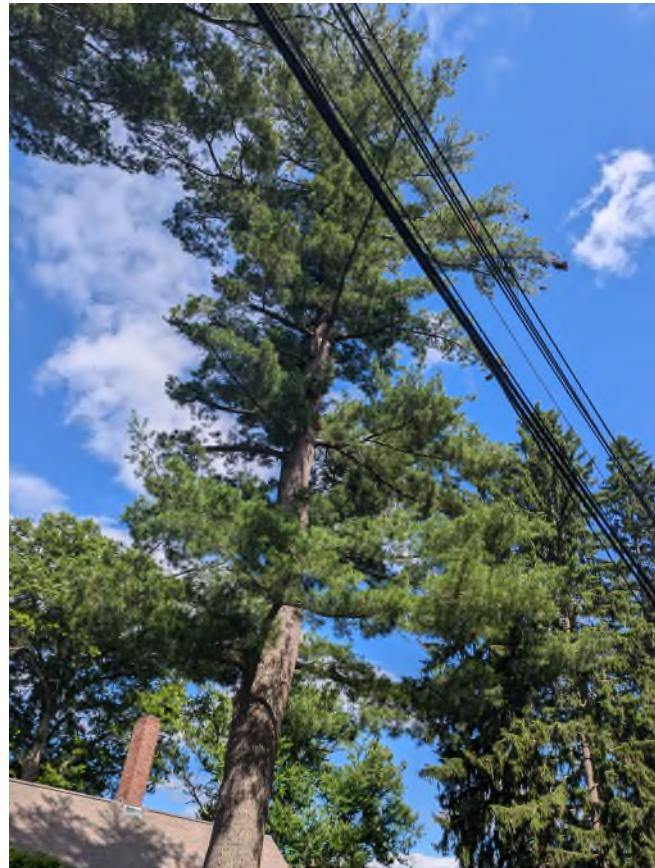
Site ID	Tree #	Street Name	House #	Loc	Pole #	Dia.	Species	# Stems	Defect Condition	Work Proposed
DC20	3	Parkerville Rd	9		101-100	38	Pine		More than 50% decline, weight over lines, wounds on trunk	Remove

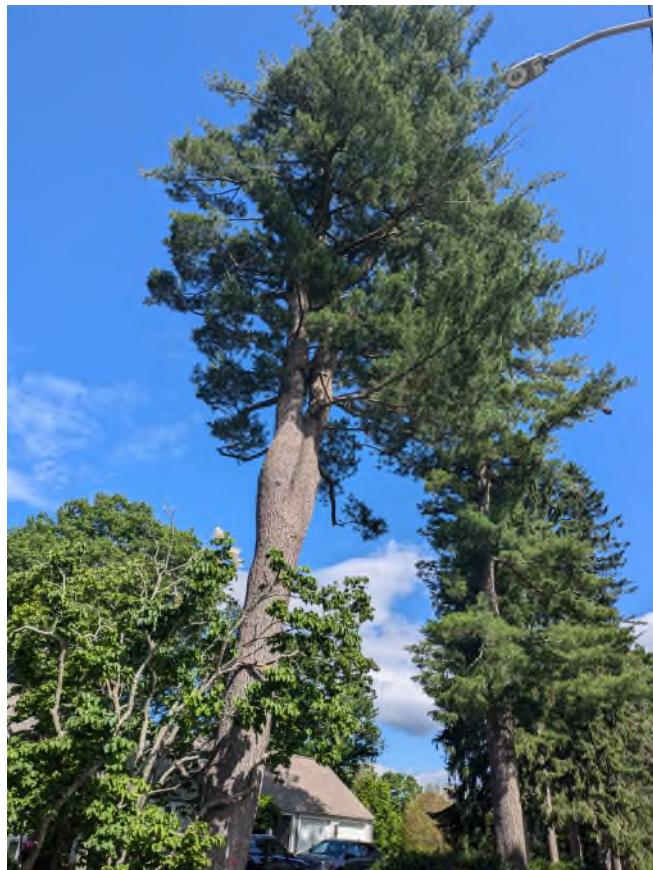
Site ID	Tree #	Street Name	House #	Loc	Pole #	Dia.	Species	# Stems	Defect Condition	Work Proposed
DC20	4	Parkerville Rd	9		101-100	38	Pine		More than 50% decline, weight over lines, wounds on trunk	Remove

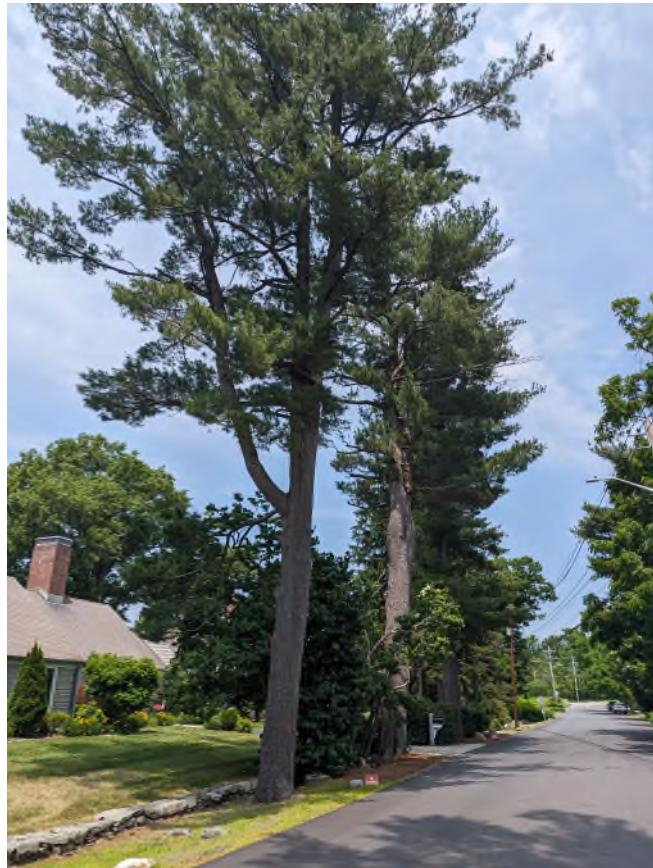
Site ID	Tree #	Street Name	House #	Loc	Pole #	Dia.	Species	# Stems	Defect Condition	Work Proposed
DC20	5	Parkerville Rd	9	AF	100-99	38	Pine		More than 50% decline, weight over lines, wounds on trunk	Remove

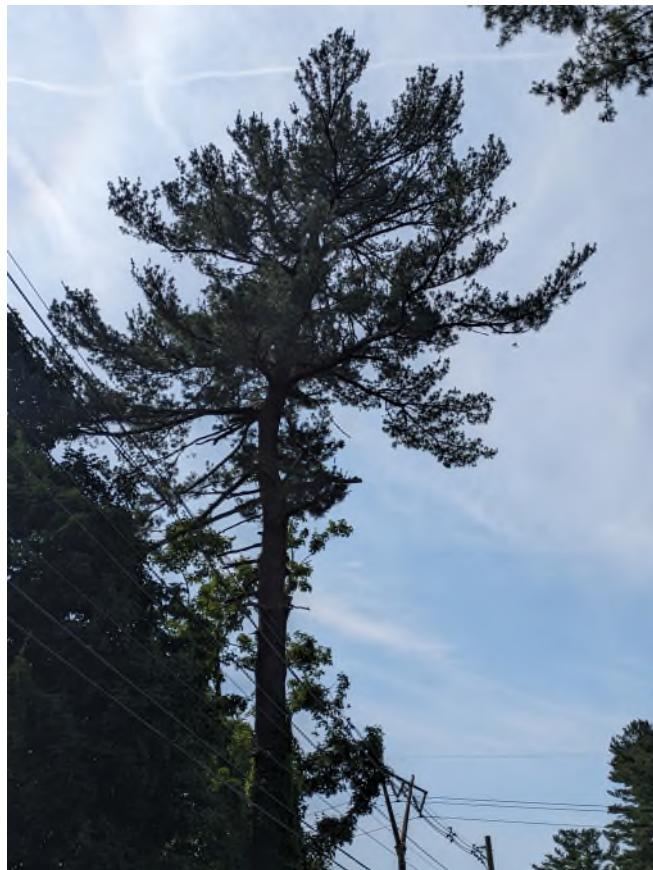
Site ID	Tree #	Street Name	House #	Loc	Pole #	Dia.	Species	# Stems	Defect Condition	Work Proposed
DC21	6	Parkerville Rd	Lot		100-99	34	Pine		Lean, weight over line, more than 50% decline, multiple dead limbs, proximity	Remove

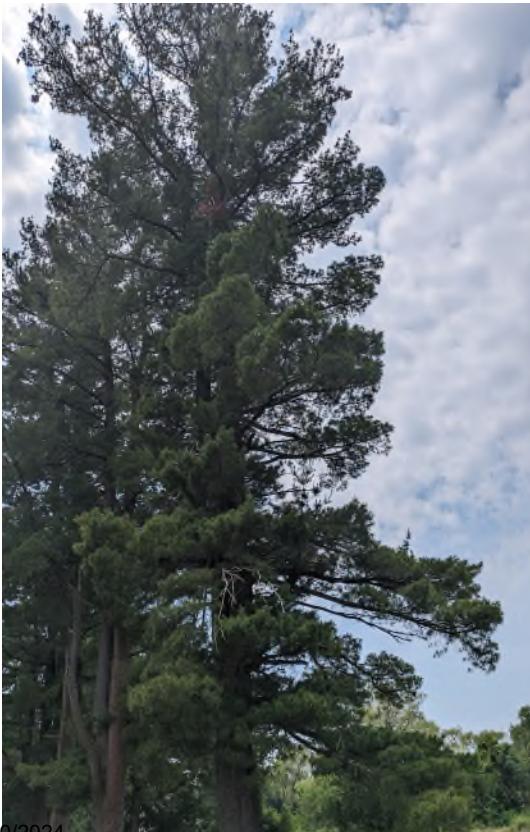
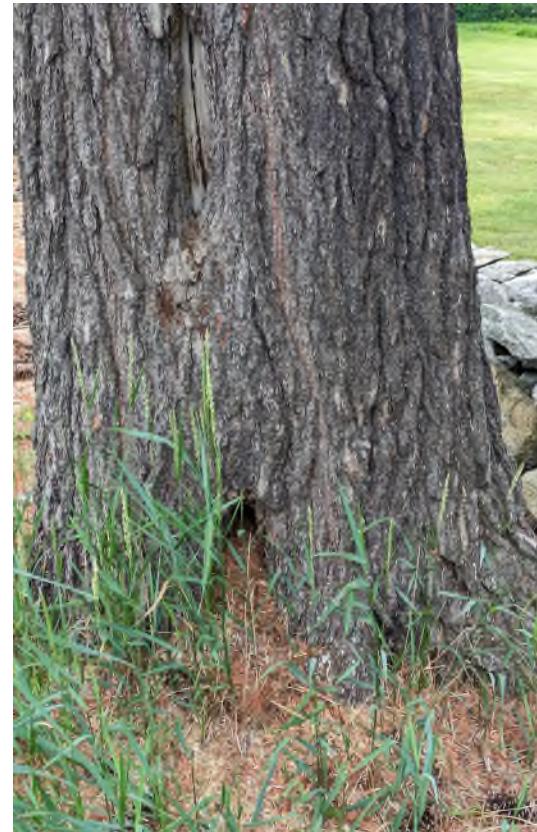
Site ID	Tree #	Street Name	House #	Loc	Pole #	Dia.	Species	# Stems	Defect Condition	Work Proposed
DC22	7	Parkerville Rd	Lot	AF	98-97	38	Pine		Lean, weight to line, more than 25% decline, cavity at base w/decay, sign of insects in trunk	Remove

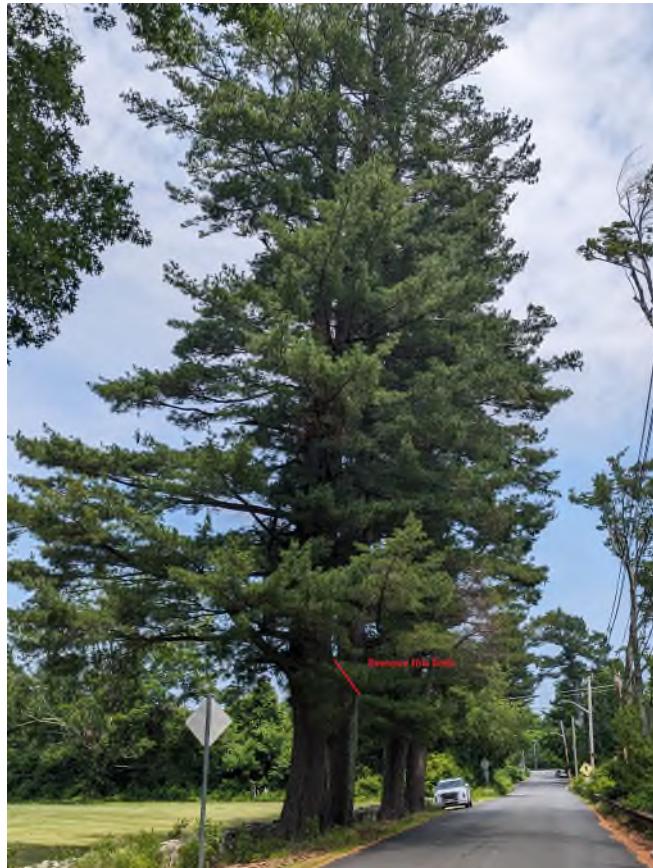
Site ID	Tree #	Street Name	House #	Loc	Pole #	Dia.	Species	# Stems	Defect Condition	Work Proposed
DC22	8	Parkerville Rd	Lot	AF	98-97	38	Pine		Weight to line, weak union. Remove 10" limb about 10' up going to line	Trim

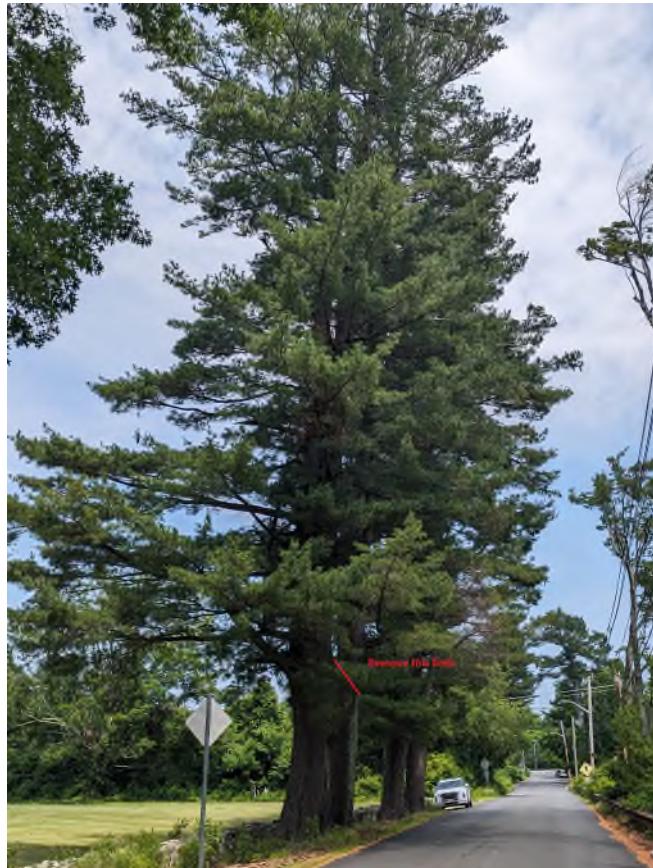
Site ID	Tree #	Street Name	House #	Loc	Pole #	Dia.	Species	# Stems	Defect Condition	Work Proposed
DC22	9	Parkerville Rd	Lot	AF	98-97	36	Pine		Weight to line, more than 50% decline, remove 15" limb about 8' up going to lines	Trim

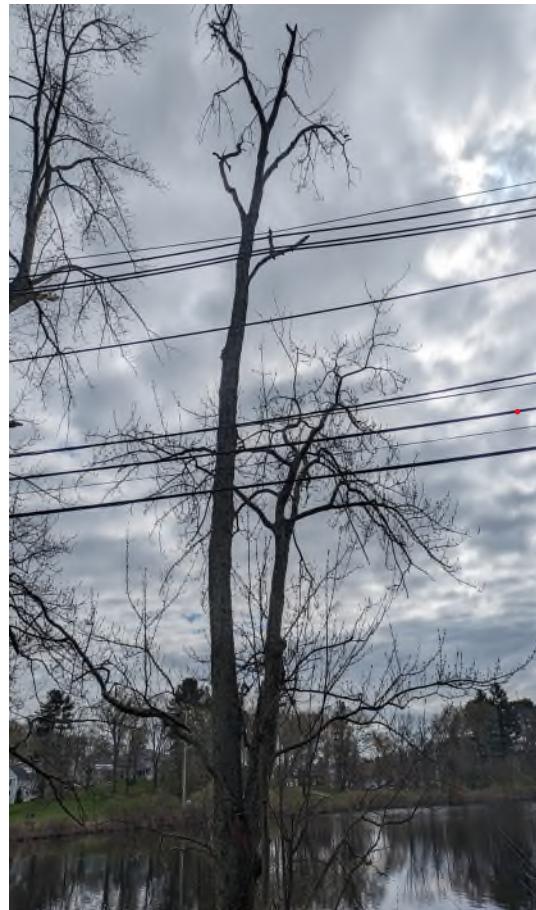
Site ID	Tree #	Street Name	House #	Loc	Pole #	Dia.	Species	# Stems	Defect Condition	Work Proposed
DC23	10	Parkerville Rd	Lot		98-97	16	Maple		More than 75% decline, proximity to lines, cavities w/ decay	Remove

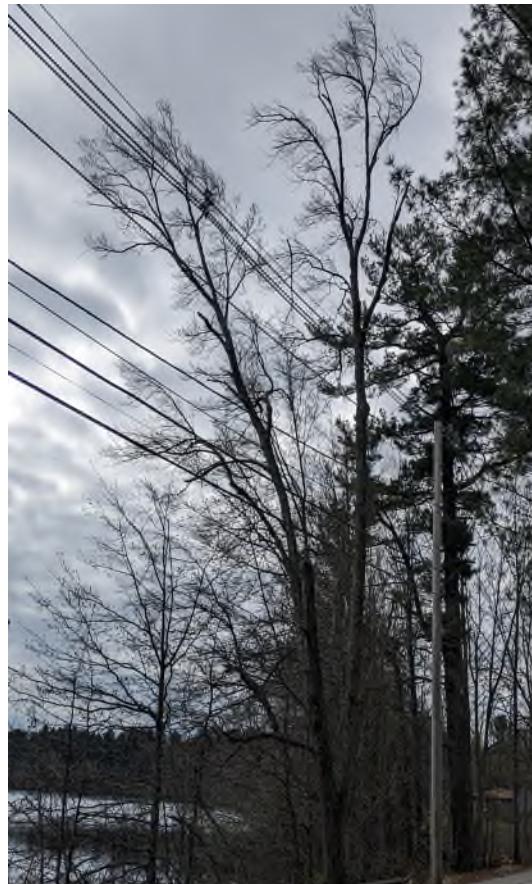
Site ID	Tree #	Street Name	House #	Loc	Pole #	Dia.	Species	# Stems	Defect Condition	Work Proposed
DC23	11	Parkerville Rd	Lot		98-97	24	Maple	2	More than 50% decline, proximity to lines, one lead dead, weight over lines	Remove

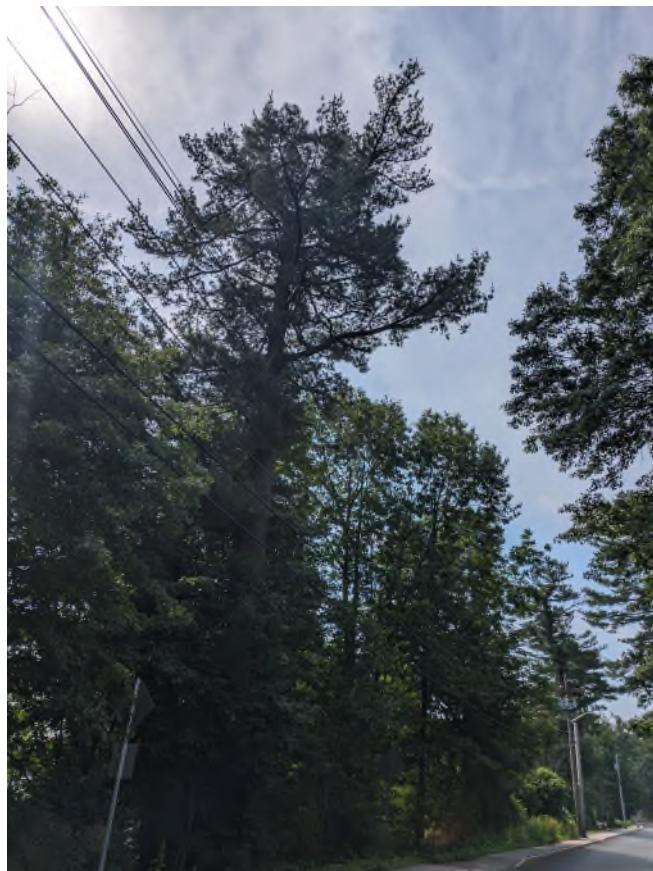
Site ID	Tree #	Street Name	House #	Loc	Pole #	Dia.	Species	# Stems	Defect Condition	Work Proposed
DC23	12	Parkerville Rd	Lot		97-96	35	Pine		Weight over lines, proximity to lines, previous failure	Remove

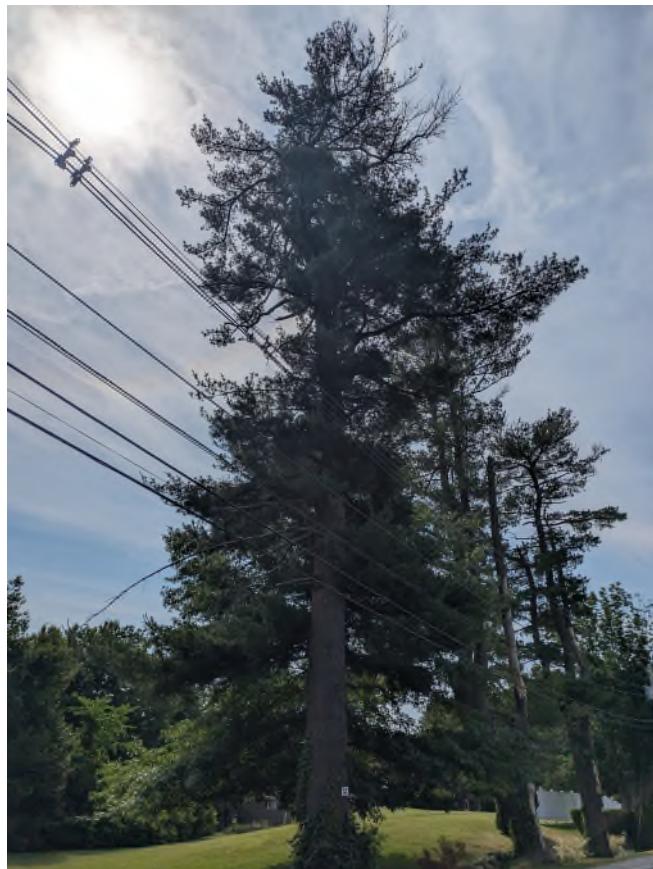
Site ID	Tree #	Street Name	House #	Loc	Pole #	Dia.	Species	# Stems	Defect Condition	Work Proposed
DC24	13	Parkerville Rd	10		96-95	38	Pine		Weight over lines, multiple dead limbs, more than 50% decline	Remove

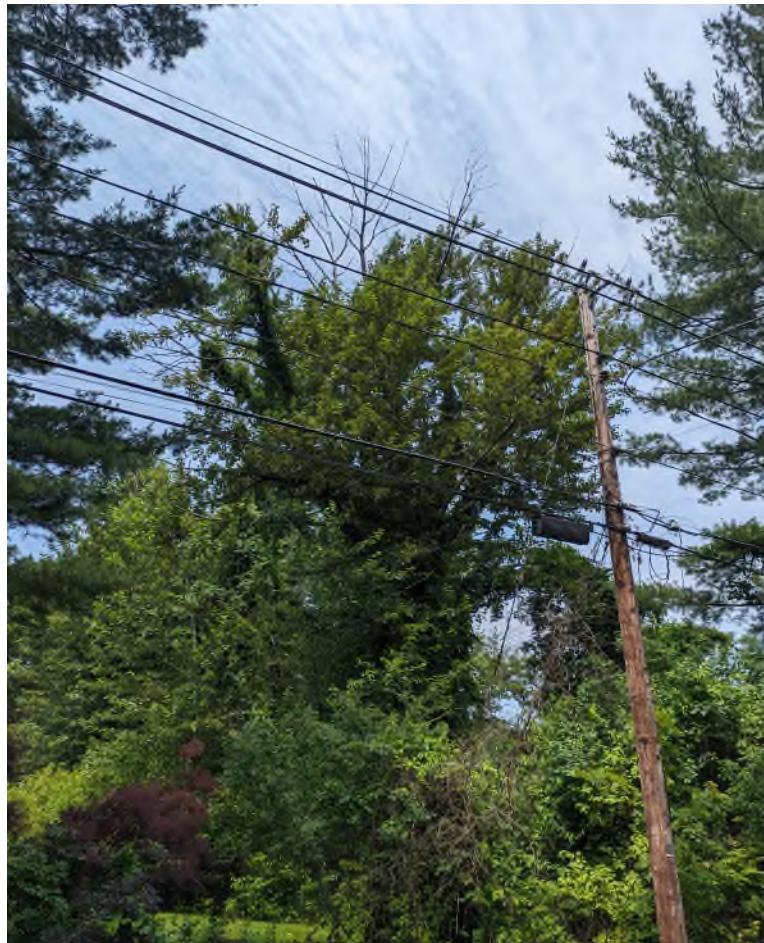
Site ID	Tree #	Street Name	House #	Loc	Pole #	Dia.	Species	# Stems	Defect Condition	Work Proposed
DC25	16	Parkerville Rd	53		94-93	36	Ash		Almost dead	Remove

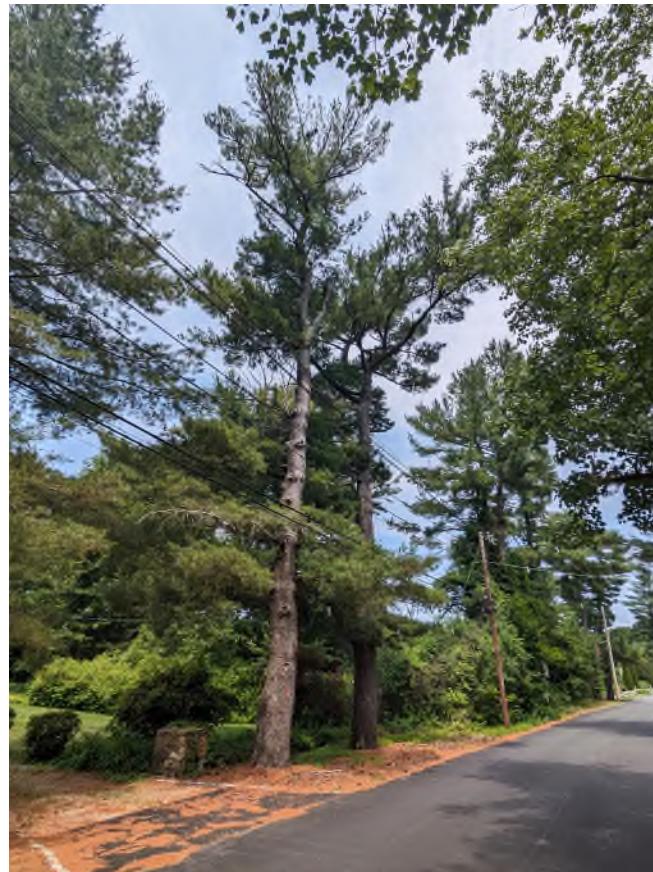
Site ID	Tree #	Street Name	House #	Loc	Pole #	Dia.	Species	# Stems	Defect Condition	Work Proposed
DC26	18	Parkerville Rd	23		93-92	30	Pine		More than 75% decline, multiple cavities w/decay, signs of internal decay	Remove

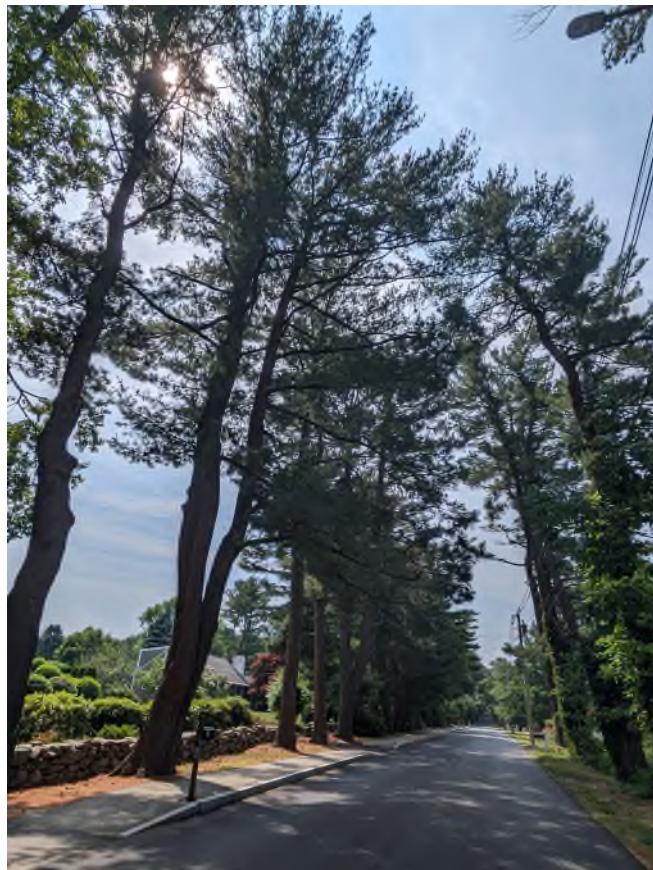
Site ID	Tree #	Street Name	House #	Loc	Pole #	Dia.	Species	# Stems	Defect Condition	Work Proposed
DC28	21	Parkerville Rd	14	AF	92-91	38	Pine		Weight to line, more than 50% decline, codominant w/included bark	Remove

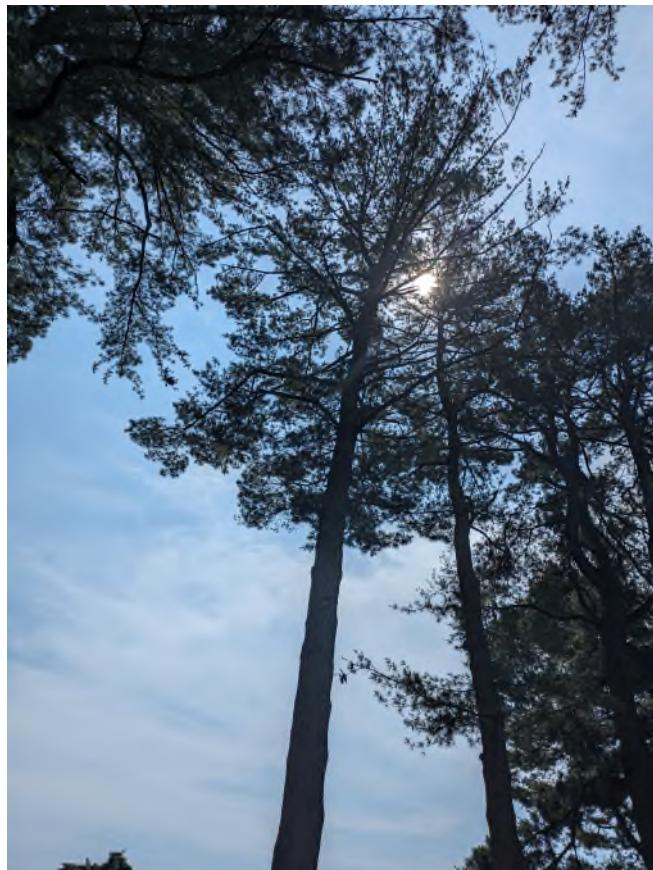
Site ID	Tree #	Street Name	House #	Loc	Pole #	Dia.	Species	# Stems	Defect Condition	Work Proposed
DC28	22	Parkerville Rd	14	AF	92-91	25	Pine		More than 75% decline	Remove

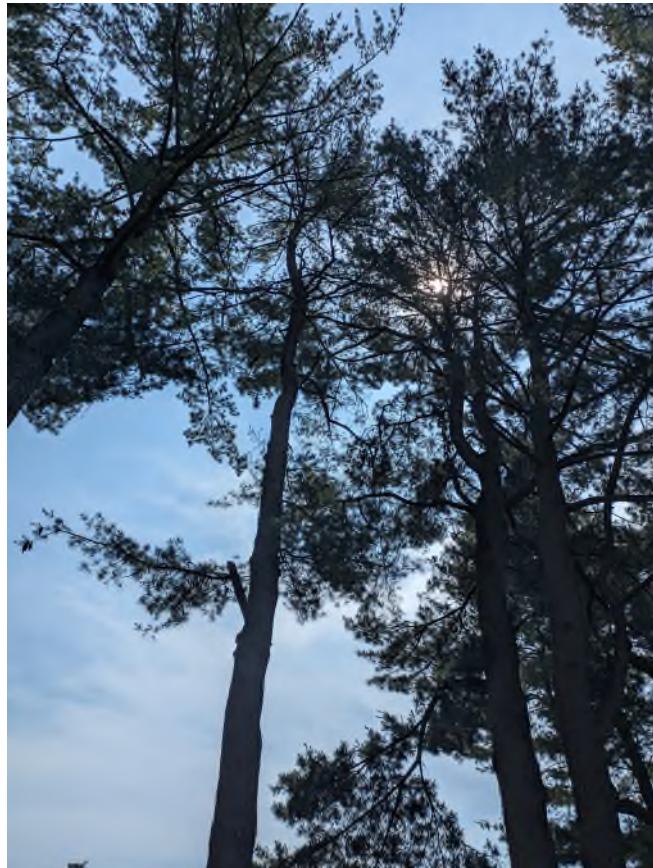
Site ID	Tree #	Street Name	House #	Loc	Pole #	Dia.	Species	# Stems	Defect Condition	Work Proposed
DC28	23	Parkerville Rd	14	AF	92-91	24	Pine		More than 75% decline	Remove

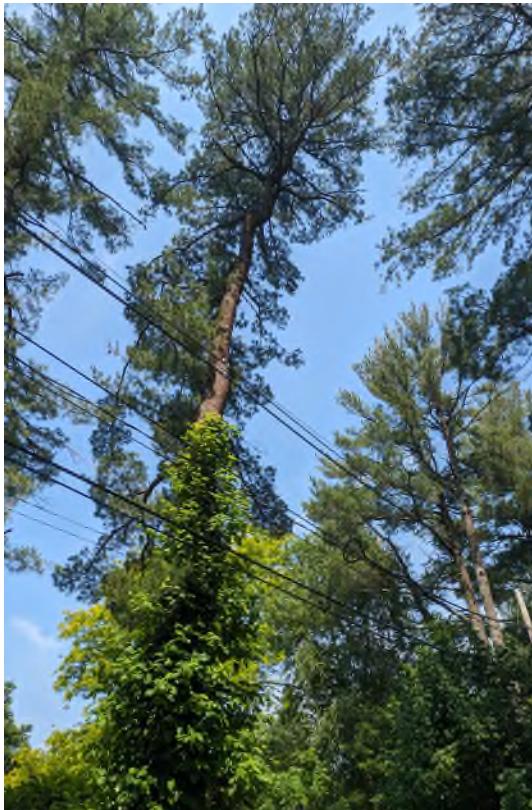
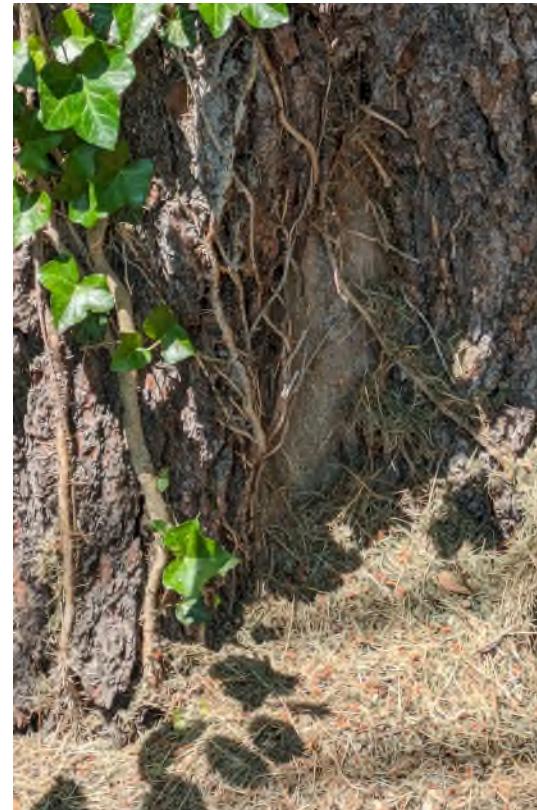
Site ID	Tree #	Street Name	House #	Loc	Pole #	Dia.	Species	# Stems	Defect Condition	Work Proposed
DC29	24	Parkerville Rd	25		92-91	25	Pine	2	Weight over lines, more than 75% decline, one lead broken off, cavity at base w/decay	Remove

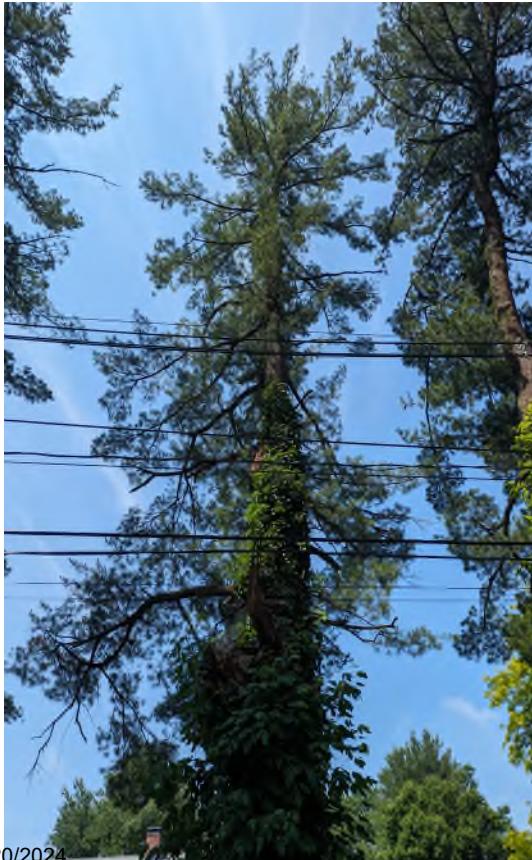
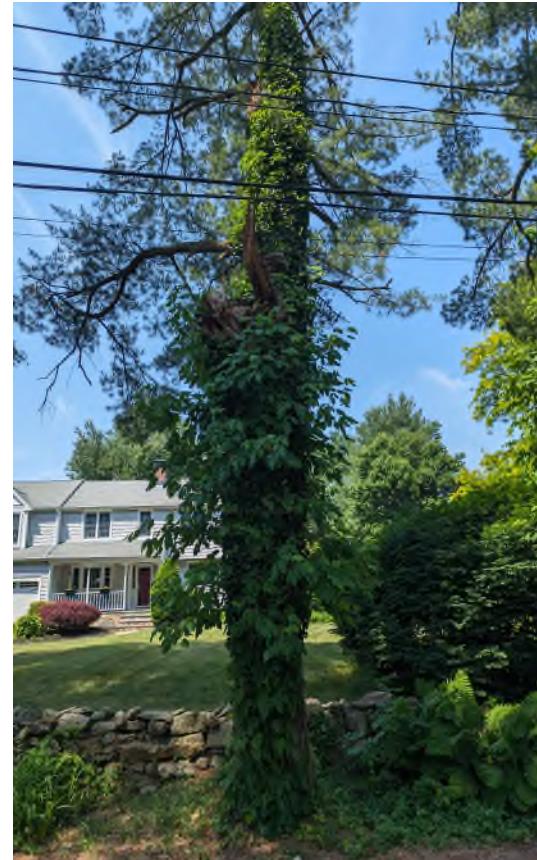
Site ID	Tree #	Street Name	House #	Loc	Pole #	Dia.	Species	# Stems	Defect Condition	Work Proposed
DC29	25	Parkerville Rd	25		92-91	28	Pine	2	Weight over lines, more than 75% decline, one lead broken off, cavity at base with decay	Remove

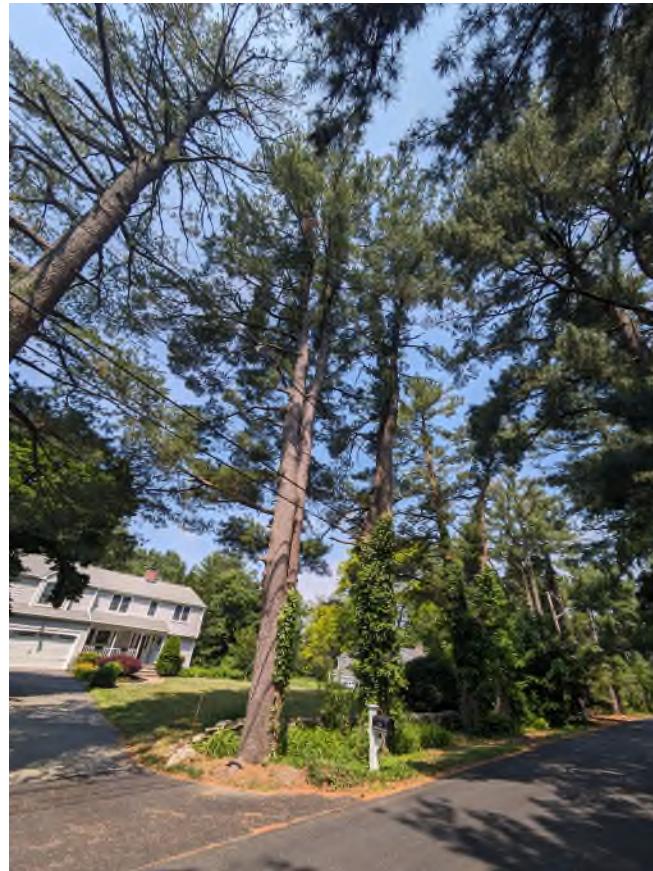
Site ID	Tree #	Street Name	House #	Loc	Pole #	Dia.	Species	# Stems	Defect Condition	Work Proposed
DC29	26	Parkerville Rd	25		92-91	30	Pine		Weight over lines, more than 50% decline, codominant w/included bark	Remove

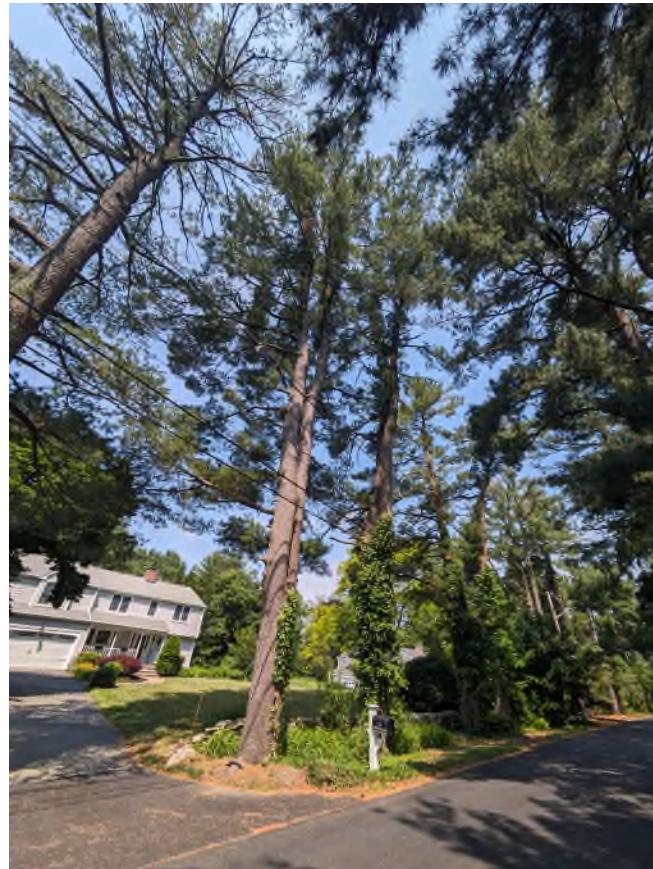
Site ID	Tree #	Street Name	House #	Loc	Pole #	Dia.	Species	# Stems	Defect Condition	Work Proposed
DC29	27	Parkerville Rd	25		92-91	32	Pine		Weight over lines, more than 50% decline, codominant w/included bark	Remove

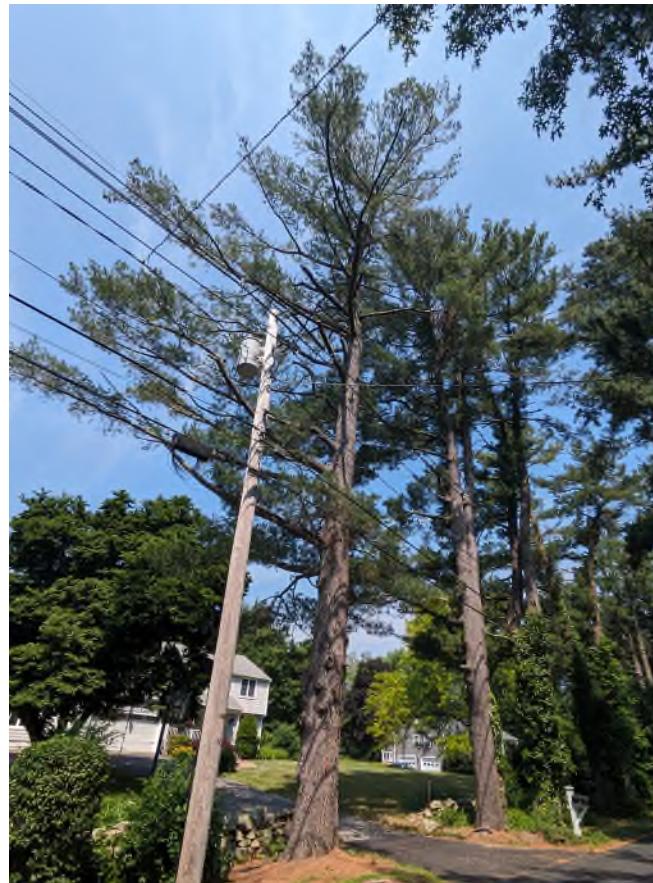
Site ID	Tree #	Street Name	House #	Loc	Pole #	Dia.	Species	# Stems	Defect Condition	Work Proposed
DC29	28	Parkerville Rd	25		92-91	32	Pine		Weight over lines, more than 75% decline, cavities with decay	Remove

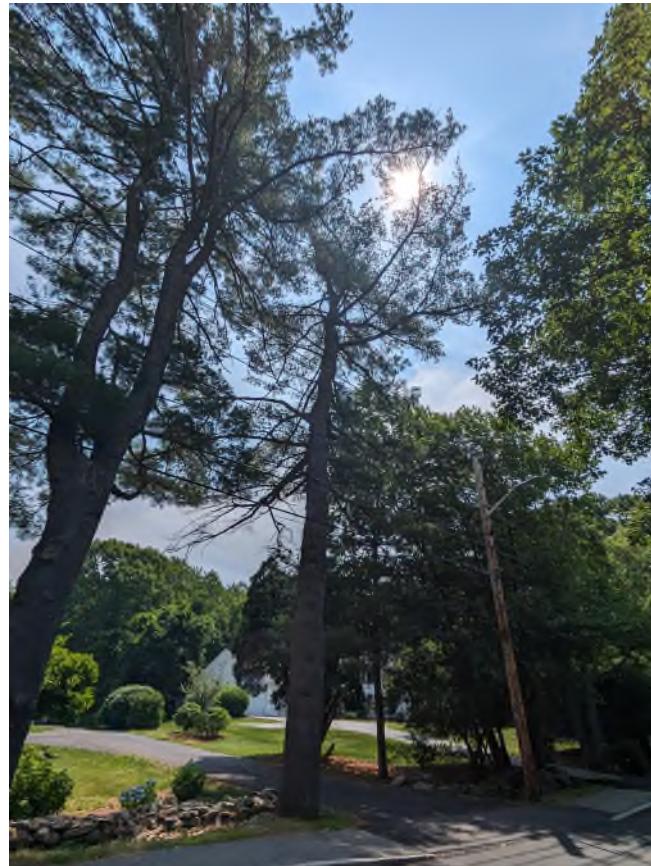
Site ID	Tree #	Street Name	House #	Loc	Pole #	Dia.	Species	# Stems	Defect Condition	Work Proposed
DC31	32	Parkerville Rd	20		89-88	28	Pine		Weight over lines, more than 75% decline, buried to deep, probable root damage	Remove

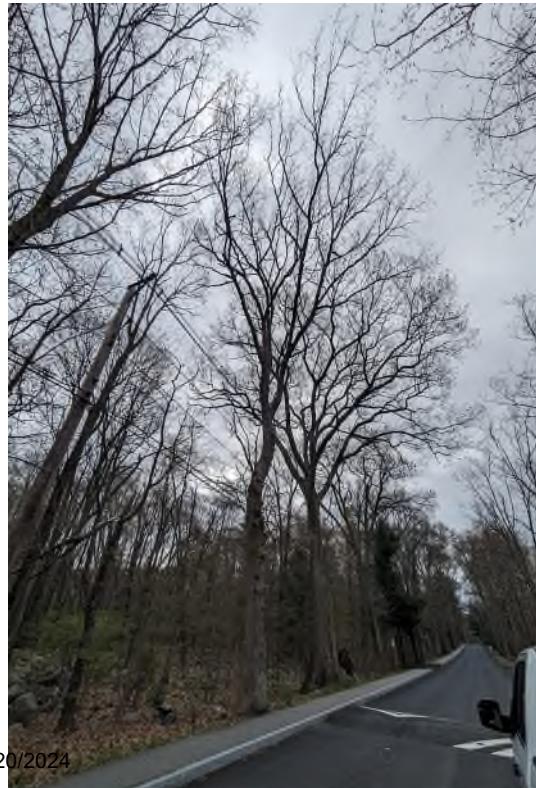
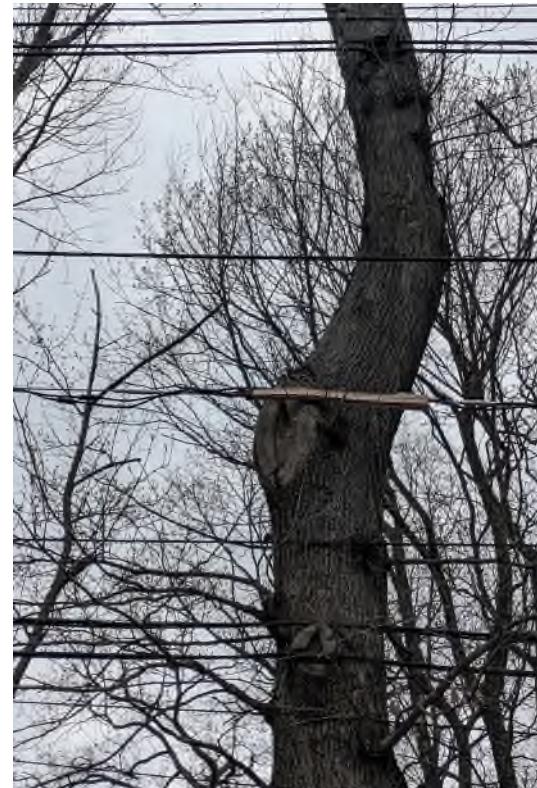
Site ID	Tree #	Street Name	House #	Loc	Pole #	Dia.	Species	# Stems	Defect Condition	Work Proposed
DC32	33	Parkerville Rd	24		87-86	30	Oak		All weight over lines, old branch scars w/decay, electrical burn at line level, signs of root damage from recent walkway construction	Remove

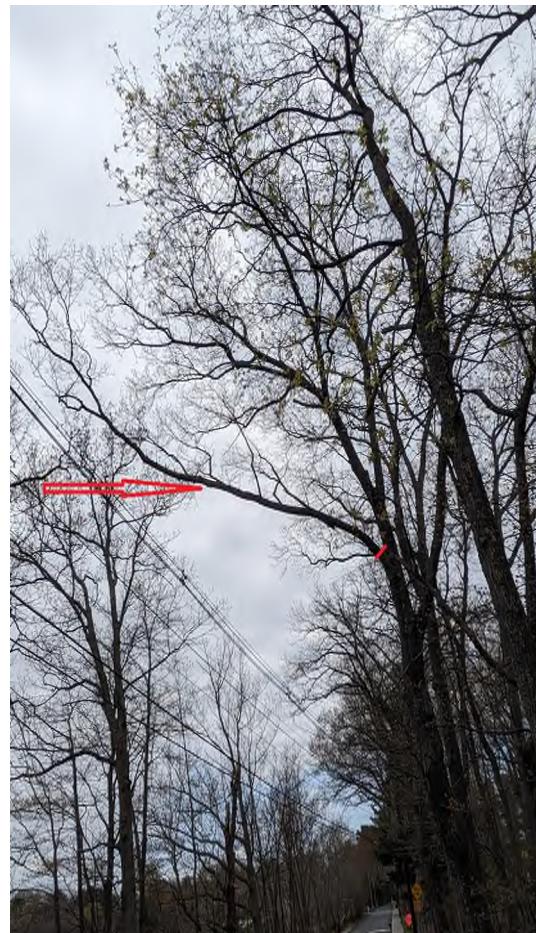
Site ID	Tree #	Street Name	House #	Loc	Pole #	Dia.	Species	# Stems	Defect Condition	Work Proposed
DC33	36	Parkerville Rd	28		86-85	27	Oak		Lean, weight over lines, remove 8" limb directly over lines	Trim

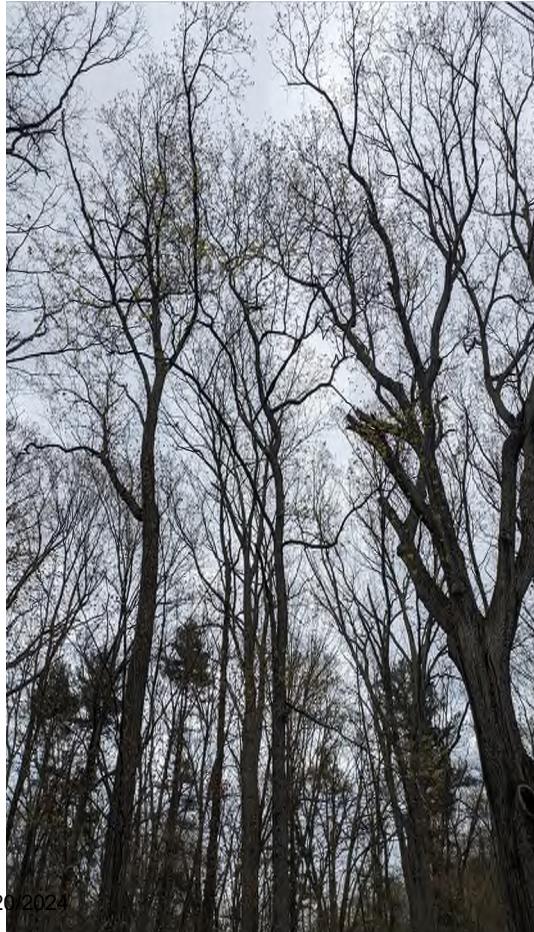
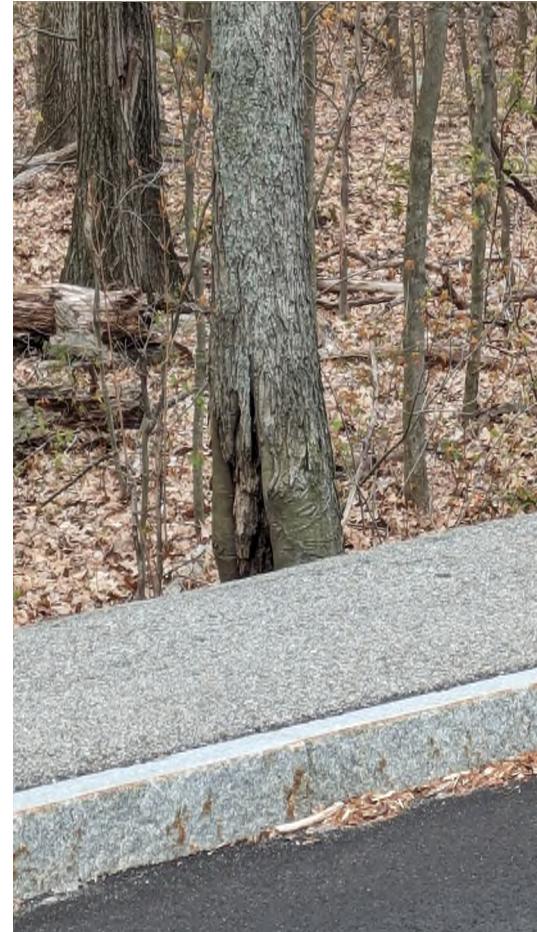
Site ID	Tree #	Street Name	House #	Loc	Pole #	Dia.	Species	# Stems	Defect Condition	Work Proposed
DC33	37	Parkerville Rd	28		86-85	8	Hickory		More than 75% decline, cavity at base w/decay	Remove

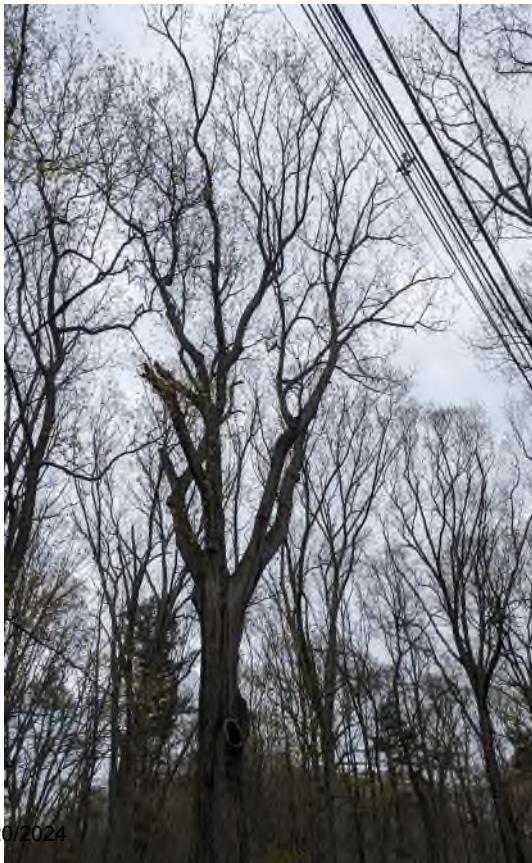
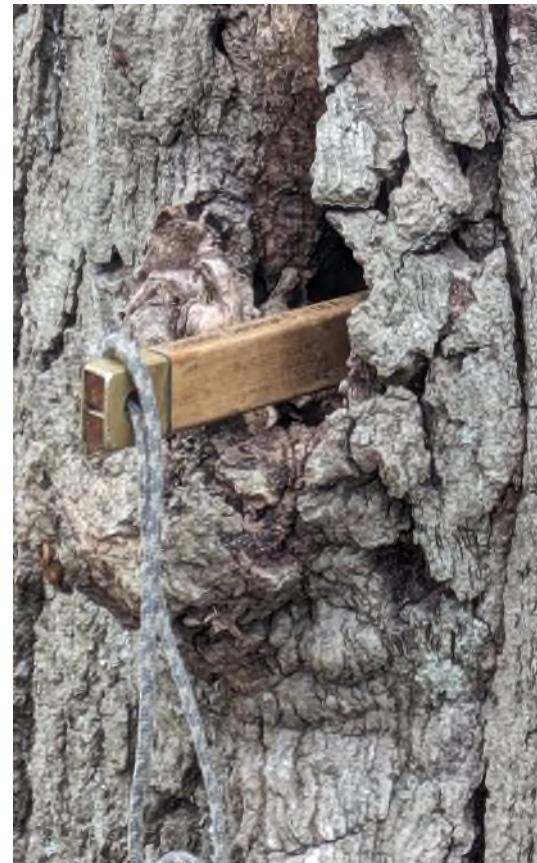
Site ID	Tree #	Street Name	House #	Loc	Pole #	Dia.	Species	# Stems	Defect Condition	Work Proposed
DC33	38	Parkerville Rd	28		86-85	45	Oak		Lean, weight to lines, more than 50% decline, multiple dead branches, internal trunk decay	Remove

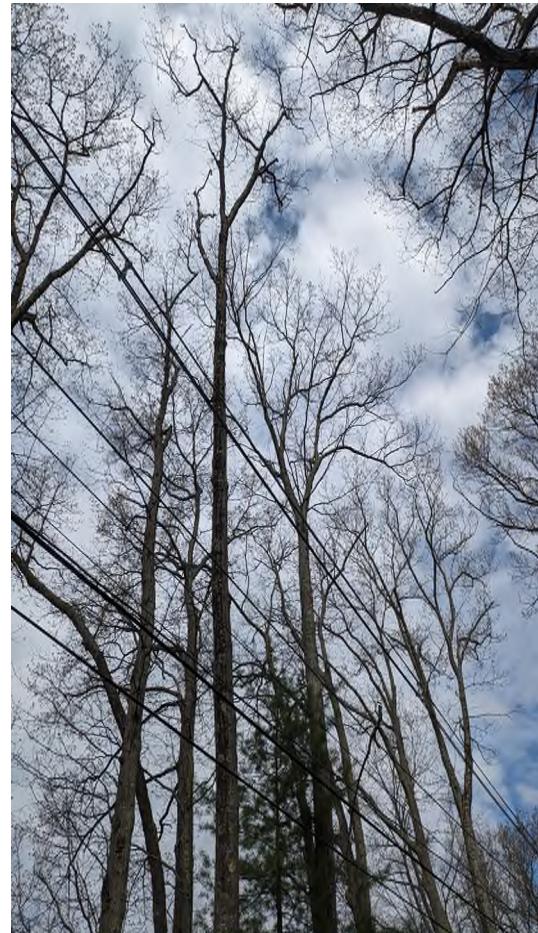
Site ID	Tree #	Street Name	House #	Loc	Pole #	Dia.	Species	# Stems	Defect Condition	Work Proposed
DC34	39	Parkerville Rd	39		85-84	22	Oak		Lean, weight over lines, more than 75% decline, dead limbs	Remove

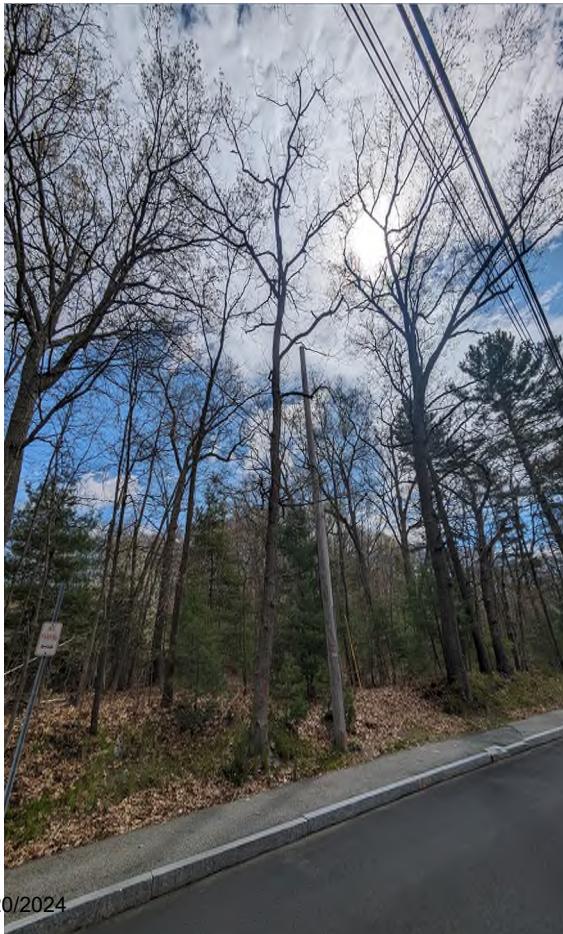
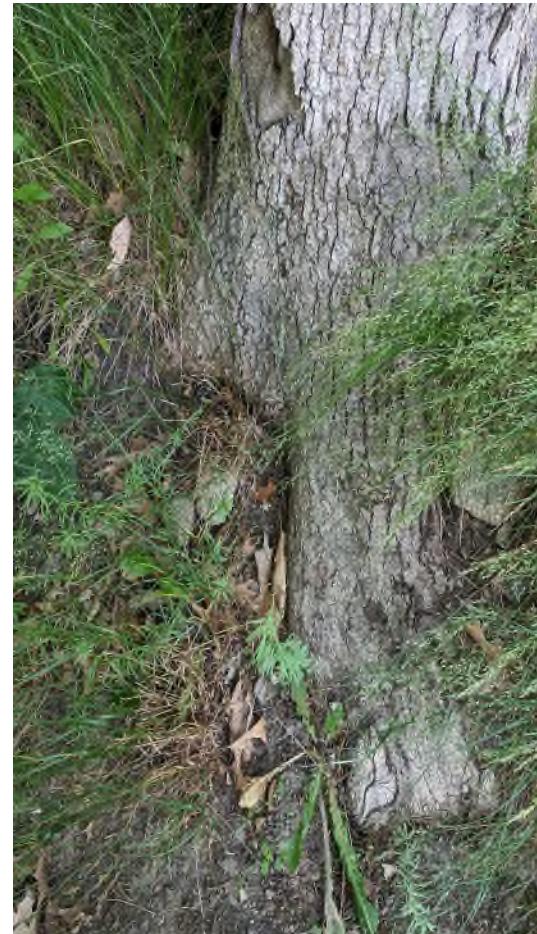
Site ID	Tree #	Street Name	House #	Loc	Pole #	Dia.	Species	# Stems	Defect Condition	Work Proposed
DC35	40	Parkerville Rd	30		83-82	16	Oak		Heavy lean, weight over lines, multiple cavities, root damage visible	Remove

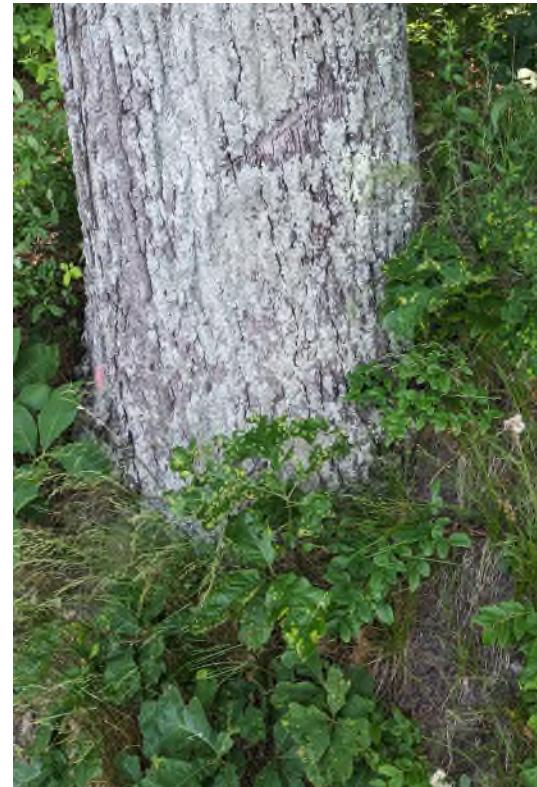
Site ID	Tree #	Street Name	House #	Loc	Pole #	Dia.	Species	# Stems	Defect Condition	Work Proposed
DC35	41	Parkerville Rd	30		83-82	24	Oak		Heavy lean, all weight over line, multiple dead branches, buried to deep backside, suspected root damage from construction	Remove

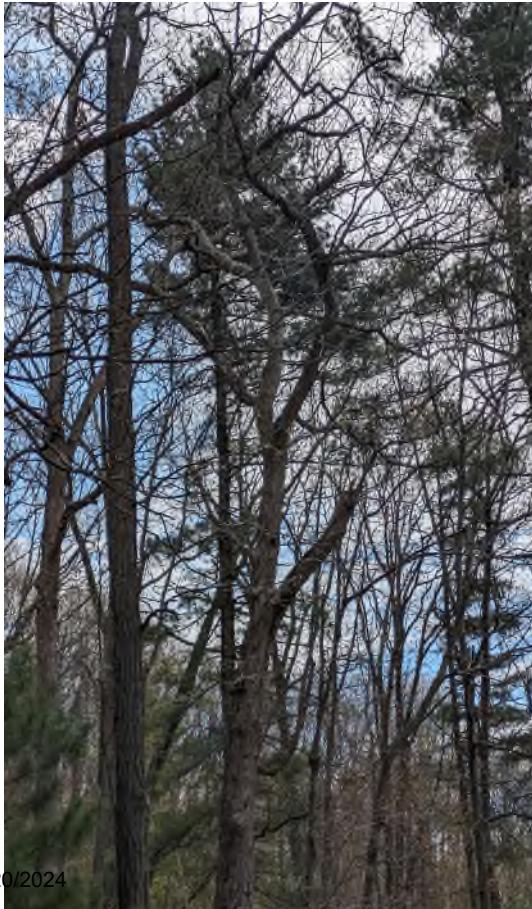
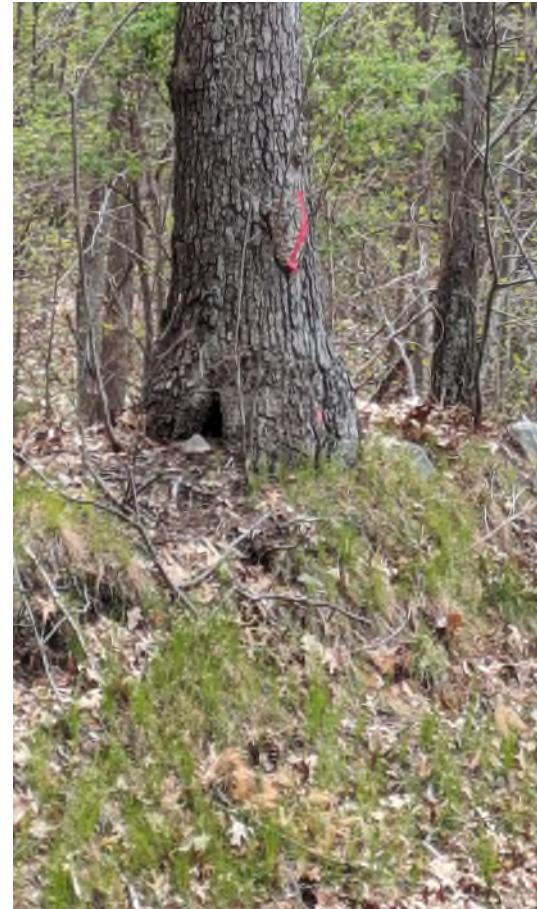
Site ID	Tree #	Street Name	House #	Loc	Pole #	Dia.	Species	# Stems	Defect Condition	Work Proposed
DC35	42	Parkerville Rd	30		83-82	18	Oak		Heavy lean, weight over lines, more than 50% decline, cavity at base w/decay	Remove

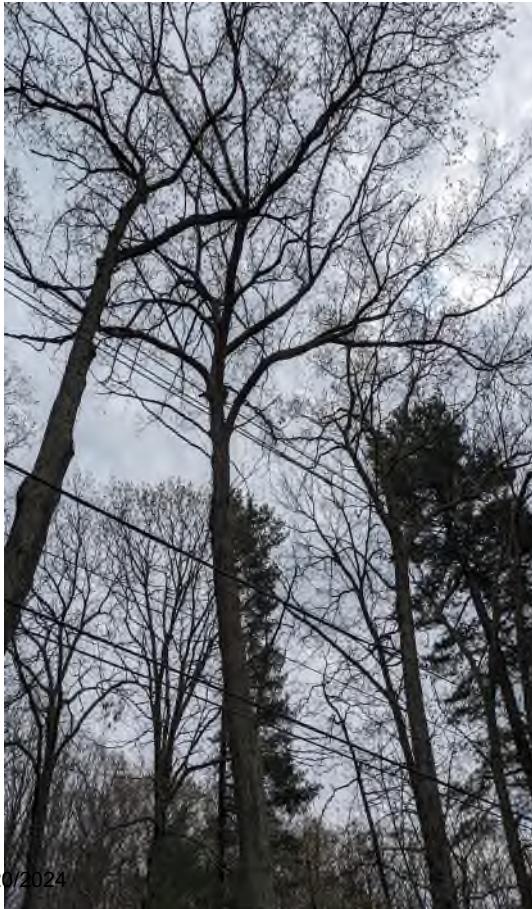
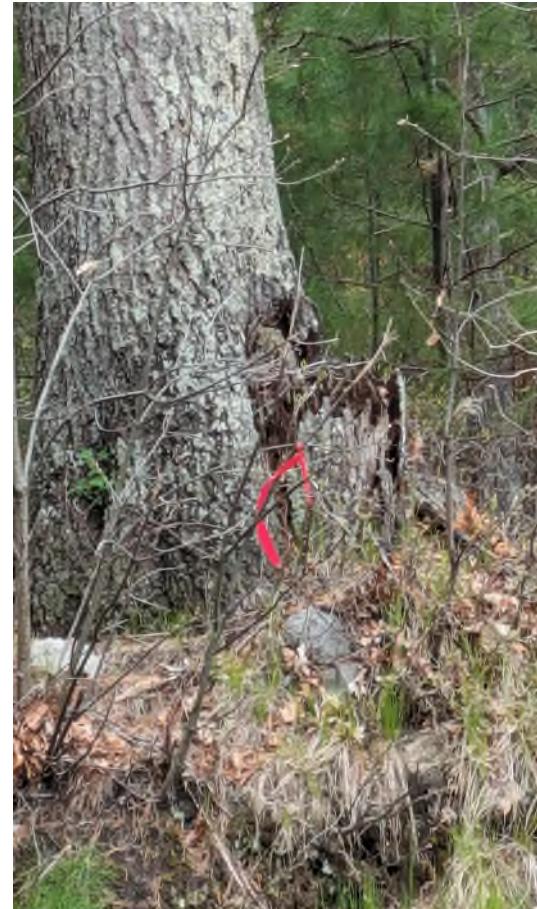
Site ID	Tree #	Street Name	House #	Loc	Pole #	Dia.	Species	# Stems	Defect Condition	Work Proposed
DC36	43	Parkerville Rd	34		82-81	27	Oak		Lean, weight over lines, more than 50% decline, large cavity at base w/decay	Remove
