**TOWN OF SOUTHBOROUGH**  
**Planning Board**  
**Application for a**  
**Scenic Road Stonewall or Tree Removal**

Name of Applicant(s): National Grid (Hazard Tree Program)

## PUBLIC HEARING NOTICE TREE REMOVAL HEARING

Town of Southborough  
NE Hazard Tree Mitigation Program  
Hazard Tree Removal List

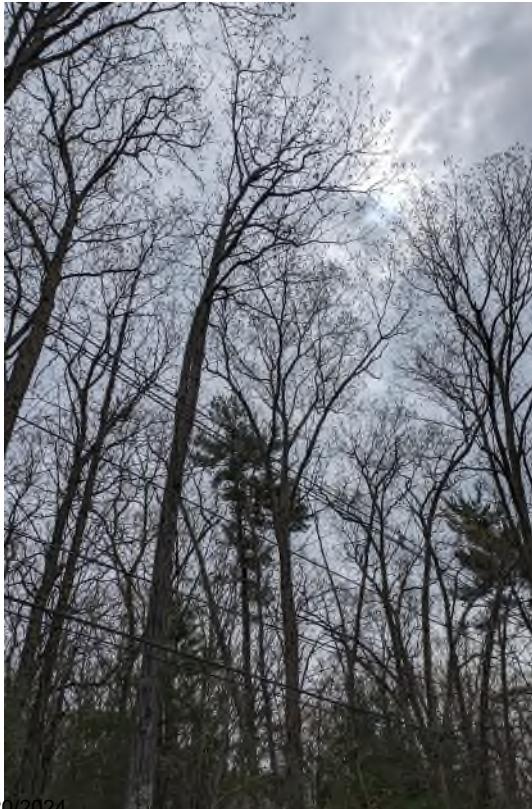
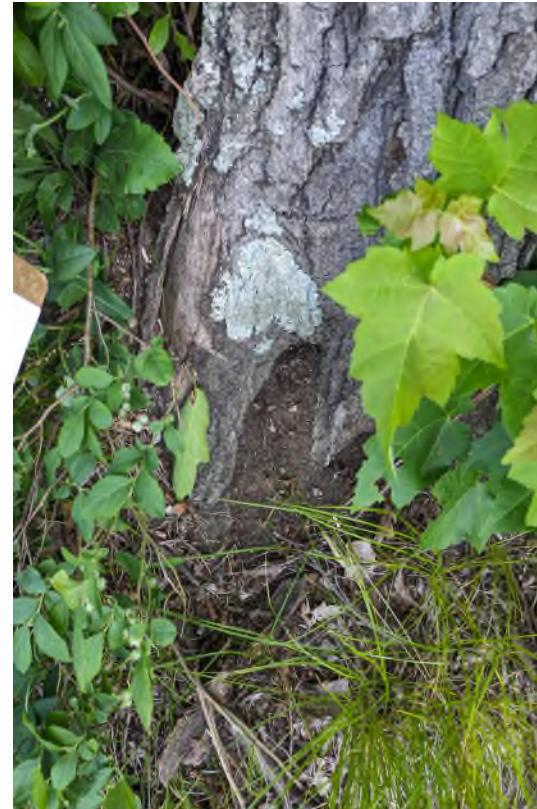
Site ID	Tree #	Street Name	House #	Loc	Pole #	Dia.	Species	# Stems	Defect Condition	Work Proposed
DC37	44	Parkerville Rd	Lot		81-80	18	Oak		Lean, weight over lines, signs of boring insects, hollow area indicating internal decay, root flare injury	Remove

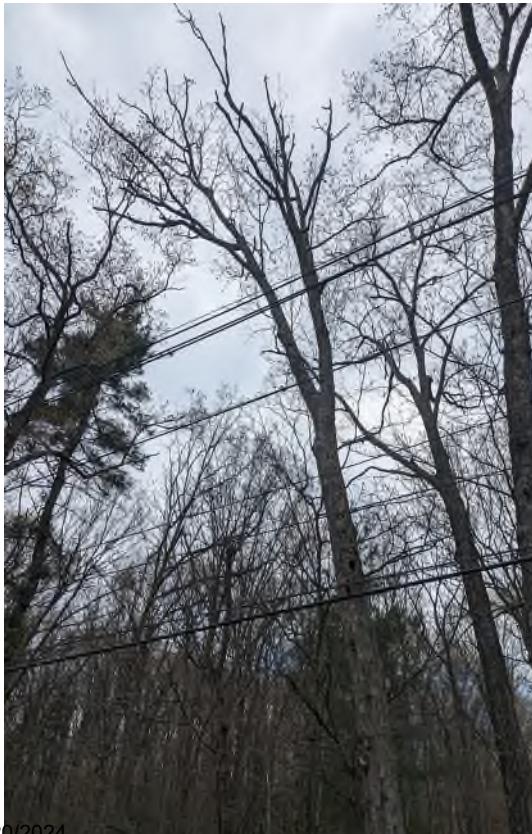
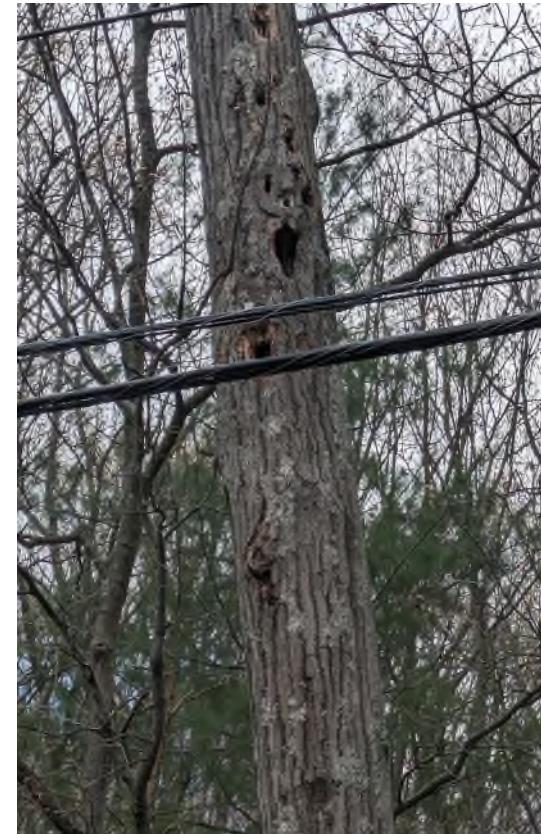
Site ID	Tree #	Street Name	House #	Loc	Pole #	Dia.	Species	# Stems	Defect Condition	Work Proposed
DC37	45	Parkerville Rd	Lot		80-79	18	Oak		Lean, weight over lines, more than 75% decline, multiple cavities w/decay, wood pecker damage	Remove

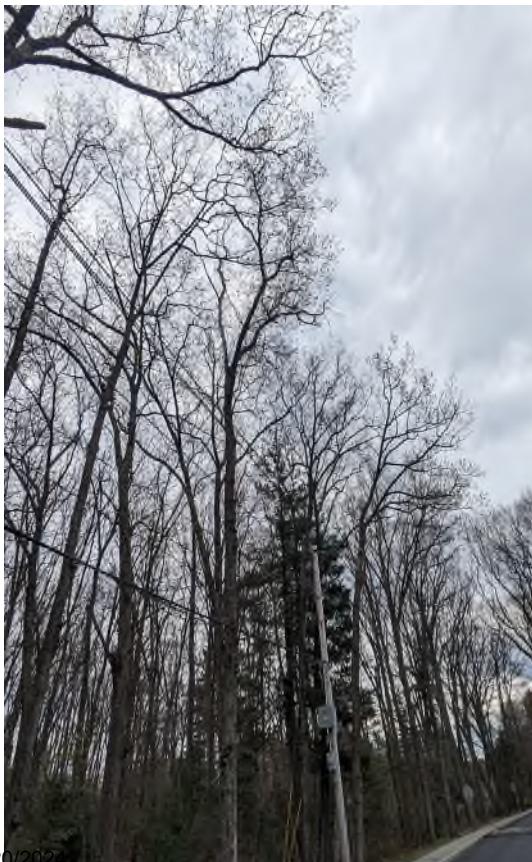
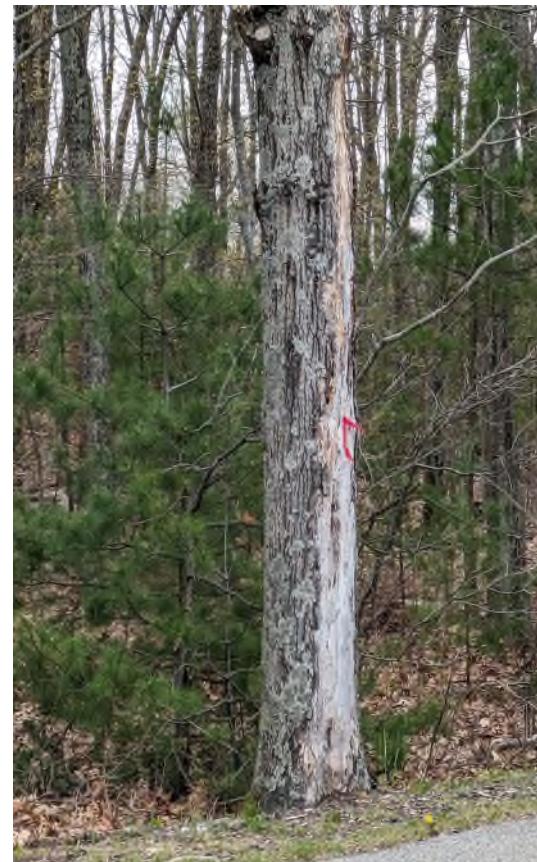
Site ID	Tree #	Street Name	House #	Loc	Pole #	Dia.	Species	# Stems	Defect Condition	Work Proposed
DC37	46	Parkerville Rd	Lot		80-79	18	Oak		Lean, weight to line, more than 50% decline, wound ground to 12' up w/decay	Remove

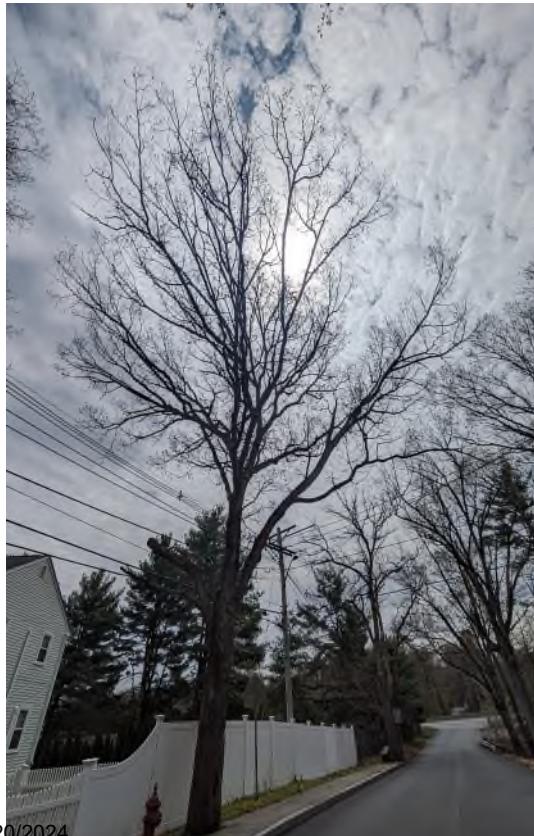
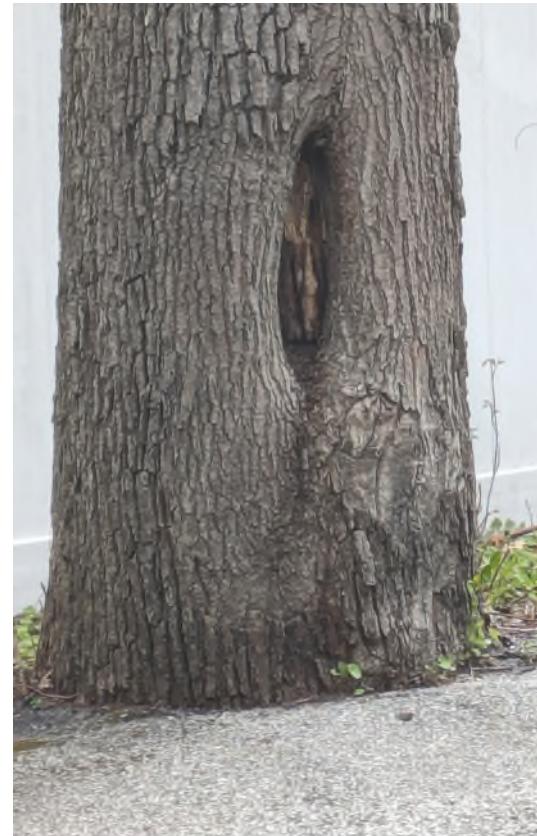
Site ID	Tree #	Street Name	House #	Loc	Pole #	Dia.	Species	# Stems	Defect Condition	Work Proposed
DC40	47	Parkerville Rd	Lot		72-71	26	Oak		No root flare, buried too deep, more than 50% of root system under blacktop, cavity near base w/decay	Remove

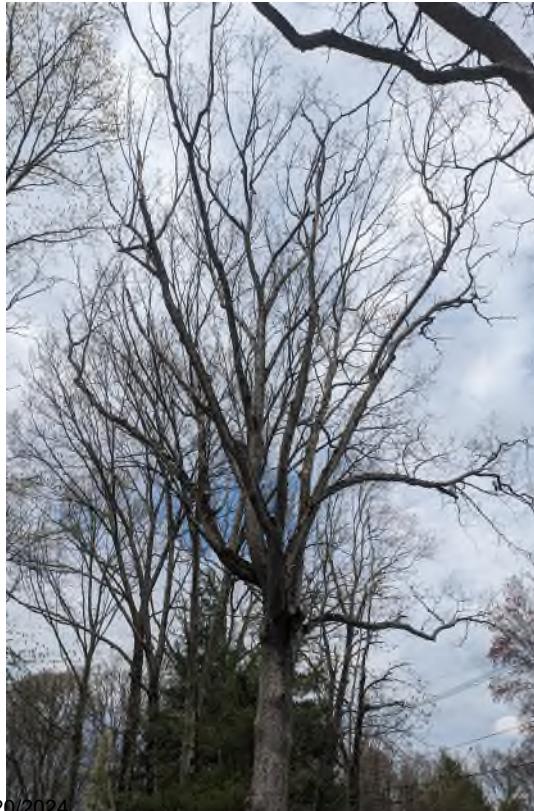
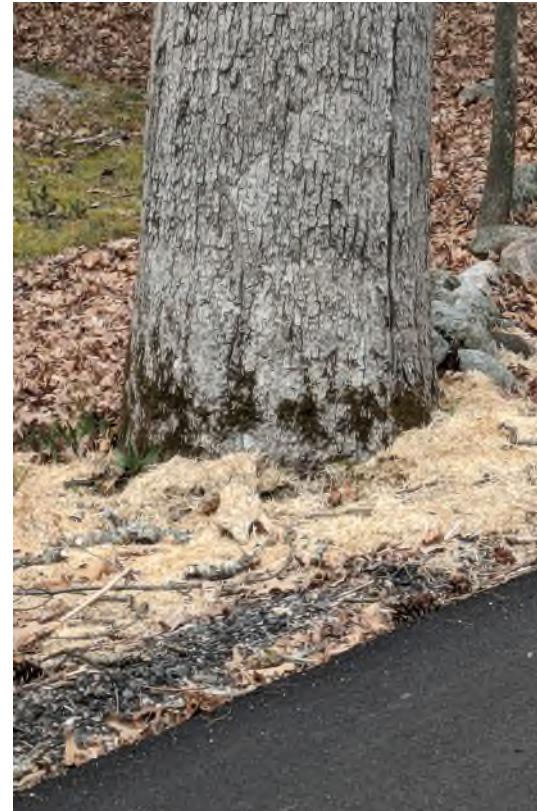
Site ID	Tree #	Street Name	House #	Loc	Pole #	Dia.	Species	# Stems	Defect Condition	Work Proposed
DC42	49	Parkerville Rd	Lot	AF	71-70	30	Oak		More than 50% decline, no root flare, buried too deep, probable root damage from road construction	Remove

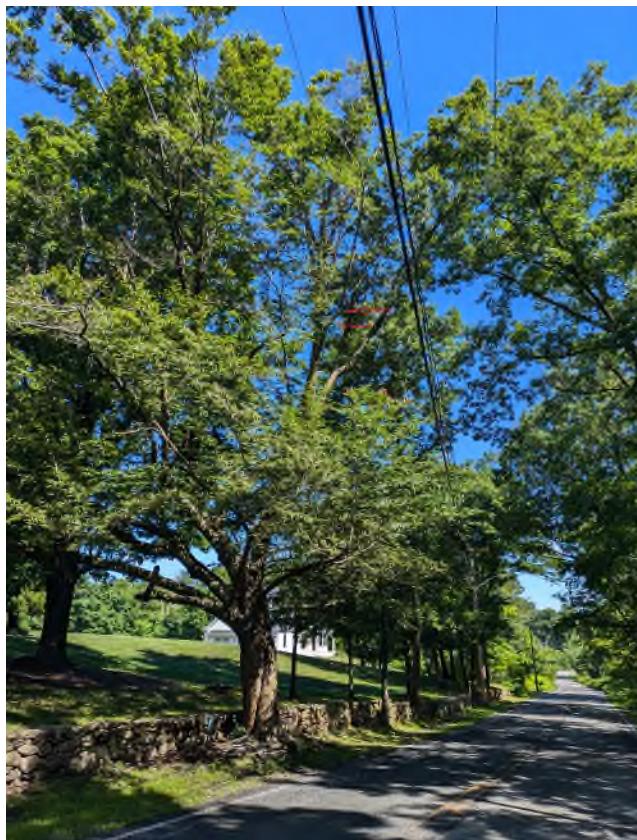
Site ID	Tree #	Street Name	House #	Loc	Pole #	Dia.	Species	# Stems	Defect Condition	Work Proposed
DC52	51	Woodland Rd	21		7-8	32	Beech		Remove 4" dead limb over lines	Remove

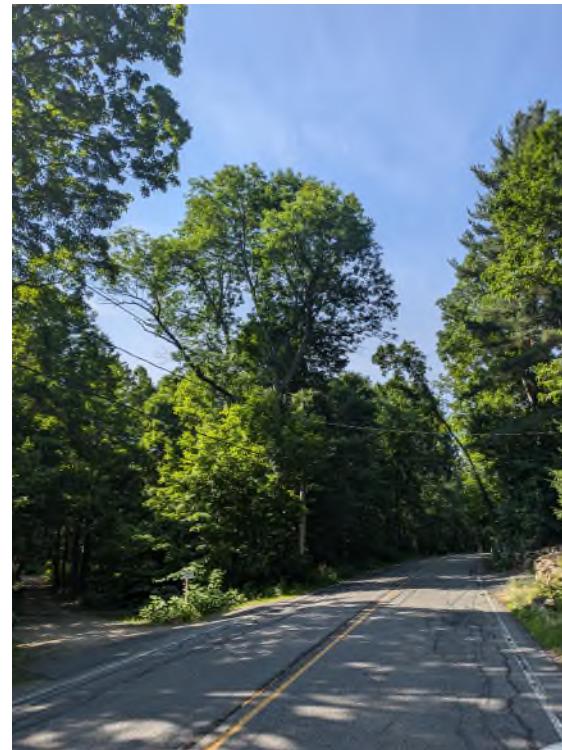
Site ID	Tree #	Street Name	House #	Loc	Pole #	Dia.	Species	# Stems	Defect Condition	Work Proposed
DC54	52	Woodland Rd	42		11-12	35	Ash		Lean, weight over line, more than 50% decline	Remove

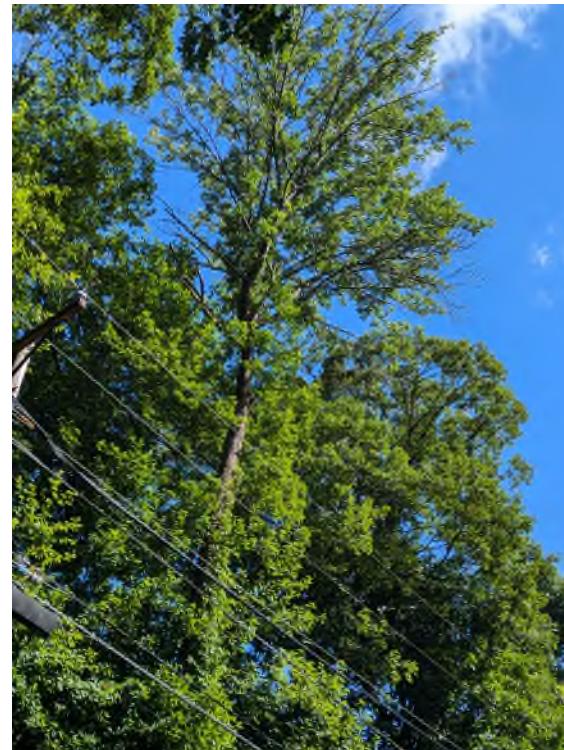
Site ID	Tree #	Street Name	House #	Loc	Pole #	Dia.	Species	# Stems	Defect Condition	Work Proposed
DC57	54	Woodland Rd	43		17-18	24	Ash		Weight over lines, more than 50% decline, borers present, wood pecker damage	Remove

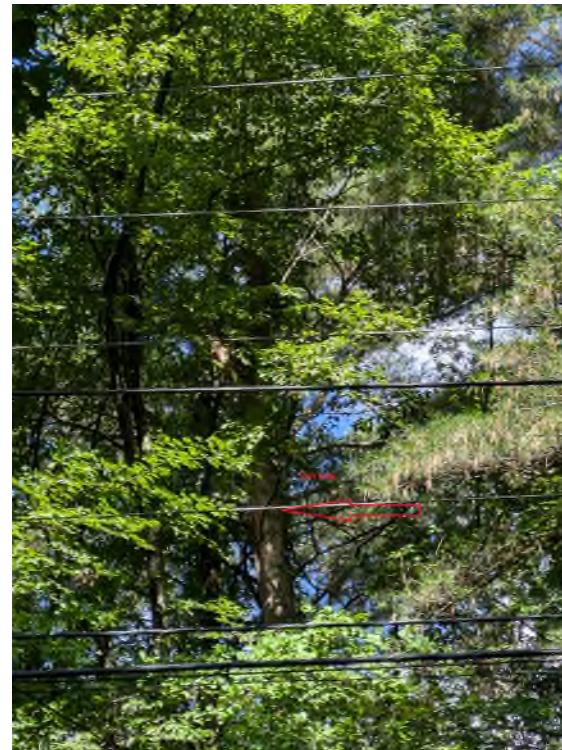
Site ID	Tree #	Street Name	House #	Loc	Pole #	Dia.	Species	# Stems	Defect Condition	Work Proposed
DC60	55	Woodland Rd	59		24-26	22	Oak		Dead	Remove

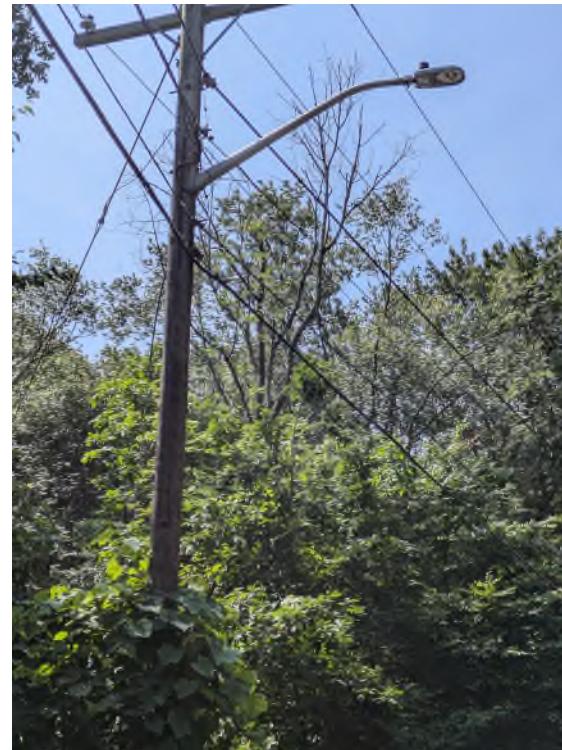
Site ID	Tree #	Street Name	House #	Loc	Pole #	Dia.	Species	# Stems	Defect Condition	Work Proposed
DC66	67	Woodland Rd	Lot		32-34	12	Ash	2	Dead	Remove

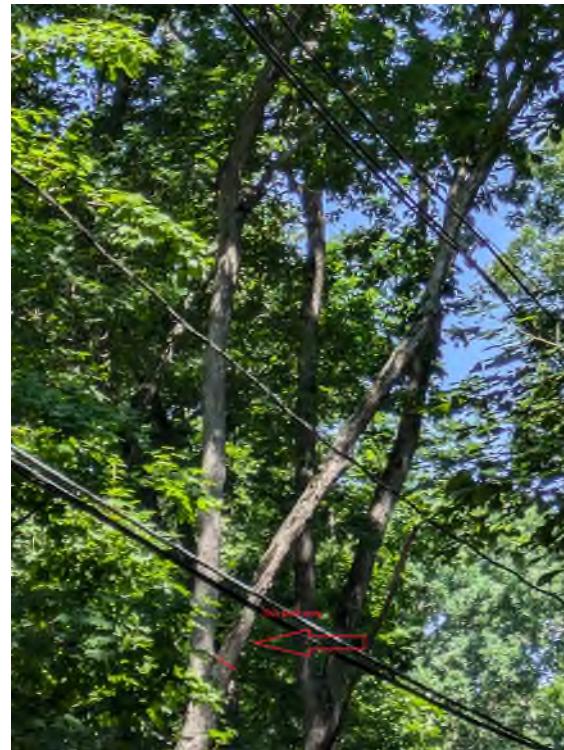
Site ID	Tree #	Street Name	House #	Loc	Pole #	Dia.	Species	# Stems	Defect Condition	Work Proposed
DC07	83	Lovers Lane	29		17/50-17	16	Oak		Remove 6" limb back to union	Trim

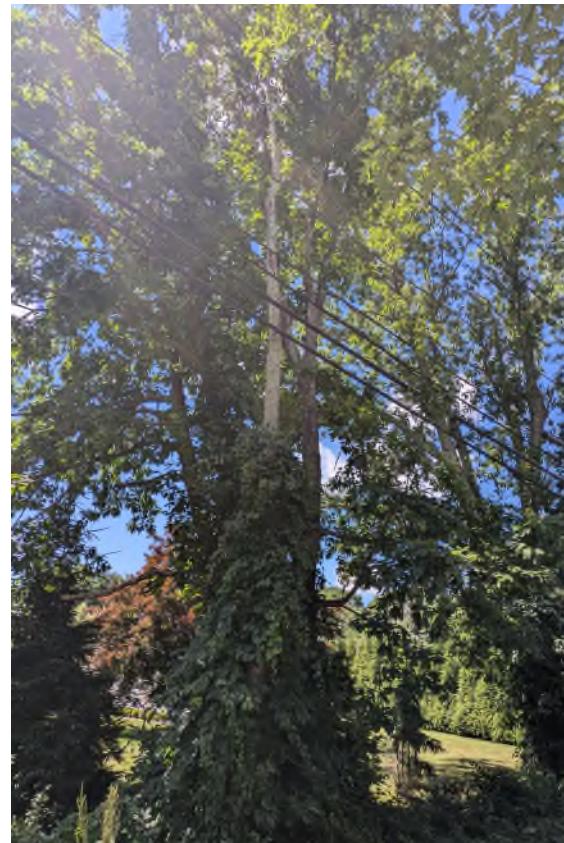
Site ID	Tree #	Street Name	House #	Loc	Pole #	Dia.	Species	# Stems	Defect Condition	Work Proposed
DC22	99	Flagg Rd	14		12-14	13	Arborvitae		Dead	Remove

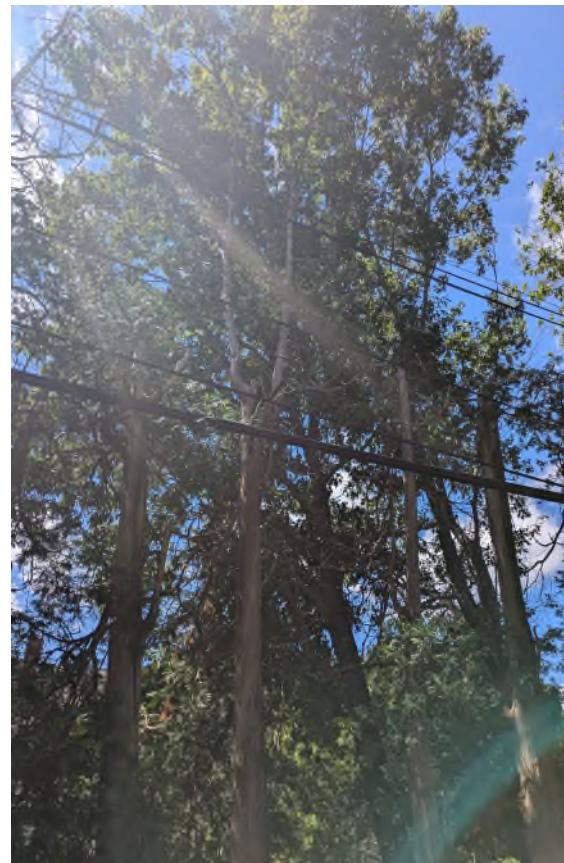
Site ID	Tree #	Street Name	House #	Loc	Pole #	Dia.	Species	# Stems	Defect Condition	Work Proposed
DC22	100	Flagg Rd	14		12-14	16	Arbovitae		More than 90% decline	Remove

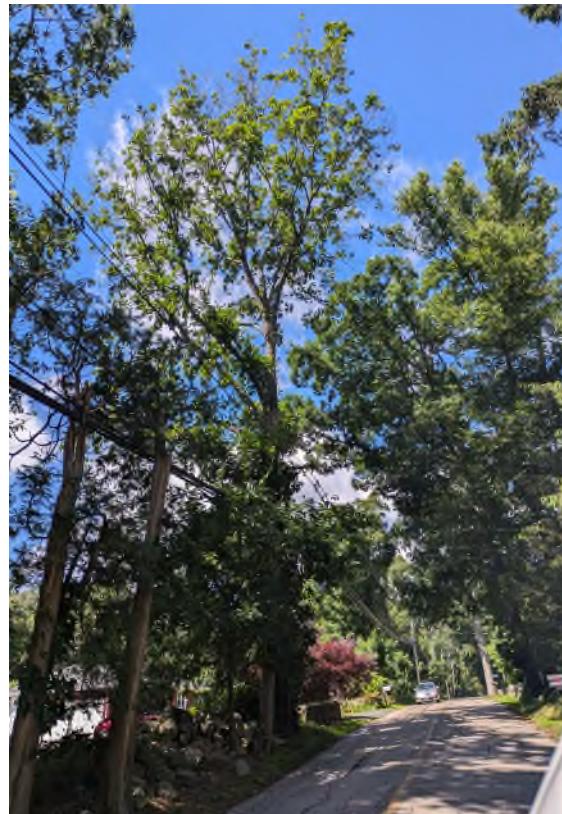
Site ID	Tree #	Street Name	House #	Loc	Pole #	Dia.	Species	# Stems	Defect Condition	Work Proposed
DC22	101	Flagg Rd	14		12-14	24	Hickory		Weight over line, more than 75% decline	Remove

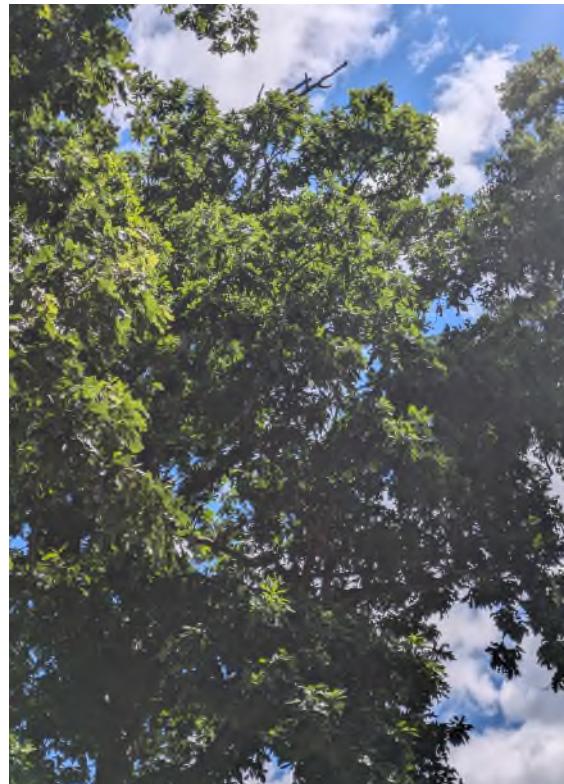
Site ID	Tree #	Street Name	House #	Loc	Pole #	Dia.	Species	# Stems	Defect Condition	Work Proposed
DC24	102	Flagg Rd	Lot	AF	17-18	24	Oak		Lean, weight to line, more than 75% decline, leaves seem to have stunted growth	Remove
