Southborough Rural Cemetery

Retaining Wall Evaluation

February 2021

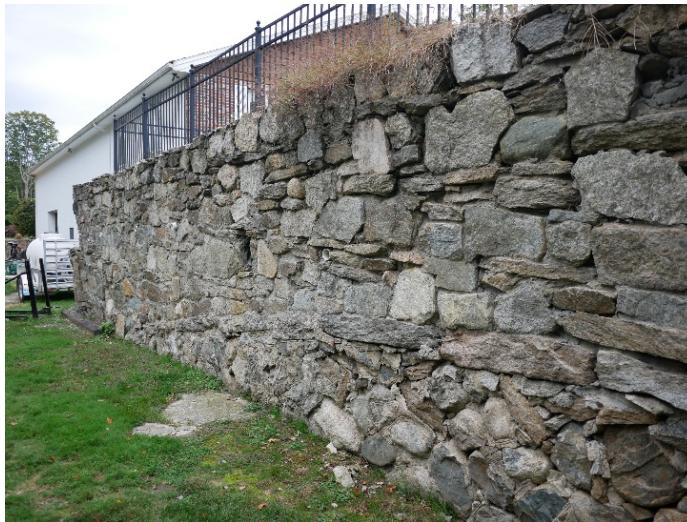
North Wall

The north wall is approximately 44 ft. long and 8 ft. 6 in. high. The face contains a course of large flat stones running through it, which may be the top level of earlier construction which was subsequently built up to the present height of the wall. This possibility is supported by the fact that the construction above the line is noticeably different from that below. However, this remains speculation as there is no documentary evidence regarding the age and construction history of the masonry sections of wall.

Both north and south stone walls exhibit a visible lean, particularly noticeable towards the north end of the south wall and at the north end of the north wall where the wall meets a set of stone steps and cracks in the end of the wall are visible. The lean of the walls is discussed further in Section 2 of this report.

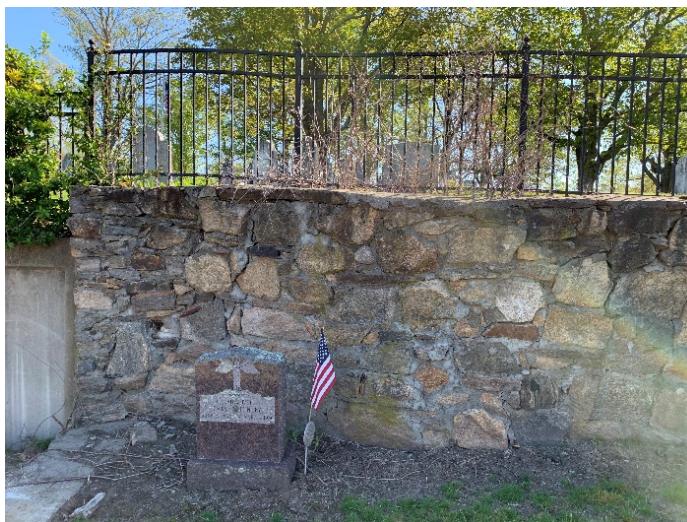
South Wall

The south wall is approximately 70 ft. long and 5 ft. 6 in. high.

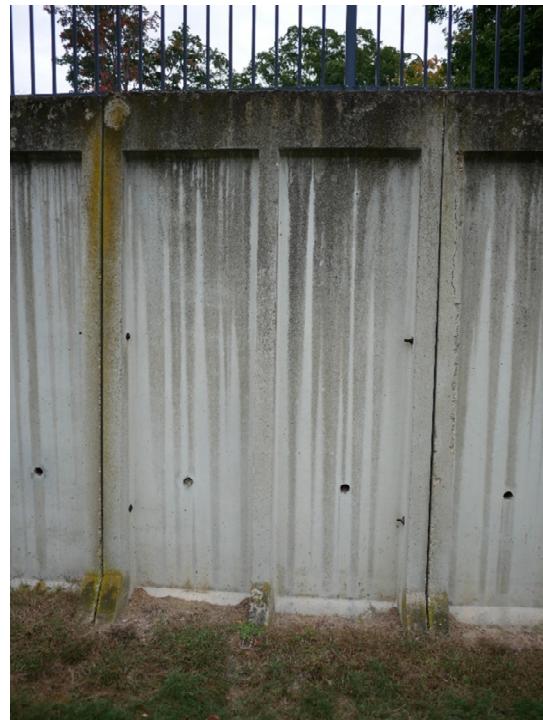
Intermediate Wall Panel

Most of the precast concrete panels exhibit significant cracking and spalling, particularly at the ribs. The deterioration of the concrete is discussed further in Section 2 of this report – Condition Evaluation.

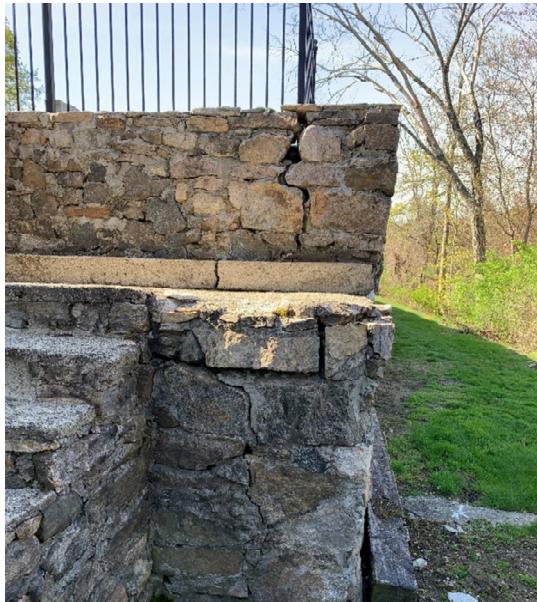
North End of North Wall

The most obvious sign of movement of the stone masonry walls is at the north end of the north wall where cracks are visible at the end of the wall adjacent to the stone steps. The south wall is also clearly leaning, particularly towards the north end.

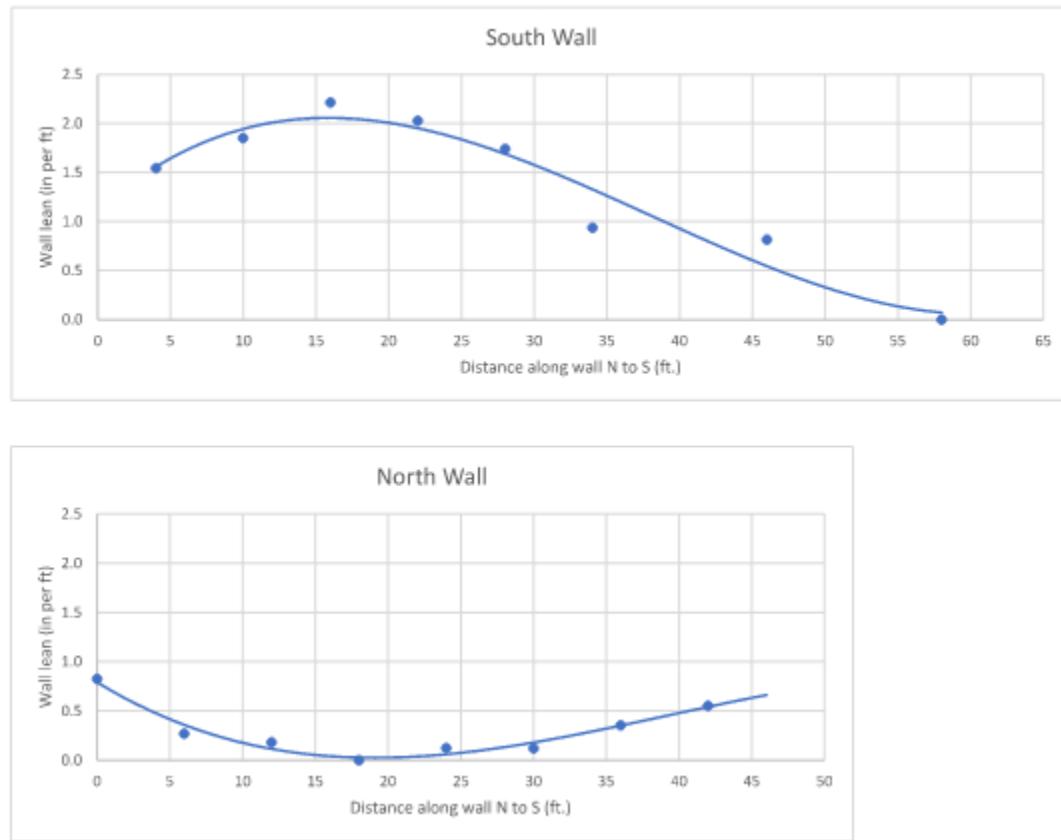
Figure 1 Verticality Survey

Looking first at the south wall, the survey shows the lean of the wall varies from zero at the south end to a maximum of approximately 2 in/ft (2 in 12) towards the north end of the wall.

The north wall is also leaning but to a lesser degree. It can be seen from Figure 1 that this wall has a lean at each end but is vertical in the center. The maximum lean is approximately 1 in/ft (1 in 12).

As shown in Section 2 of this report, a verticality survey was carried out, measuring the variation in the lean of the stone walls along their length. It is recommended that similar surveys be carried out at regular intervals (say 6 months) and compared with previous results in order to monitor the rate of movement of the wall.

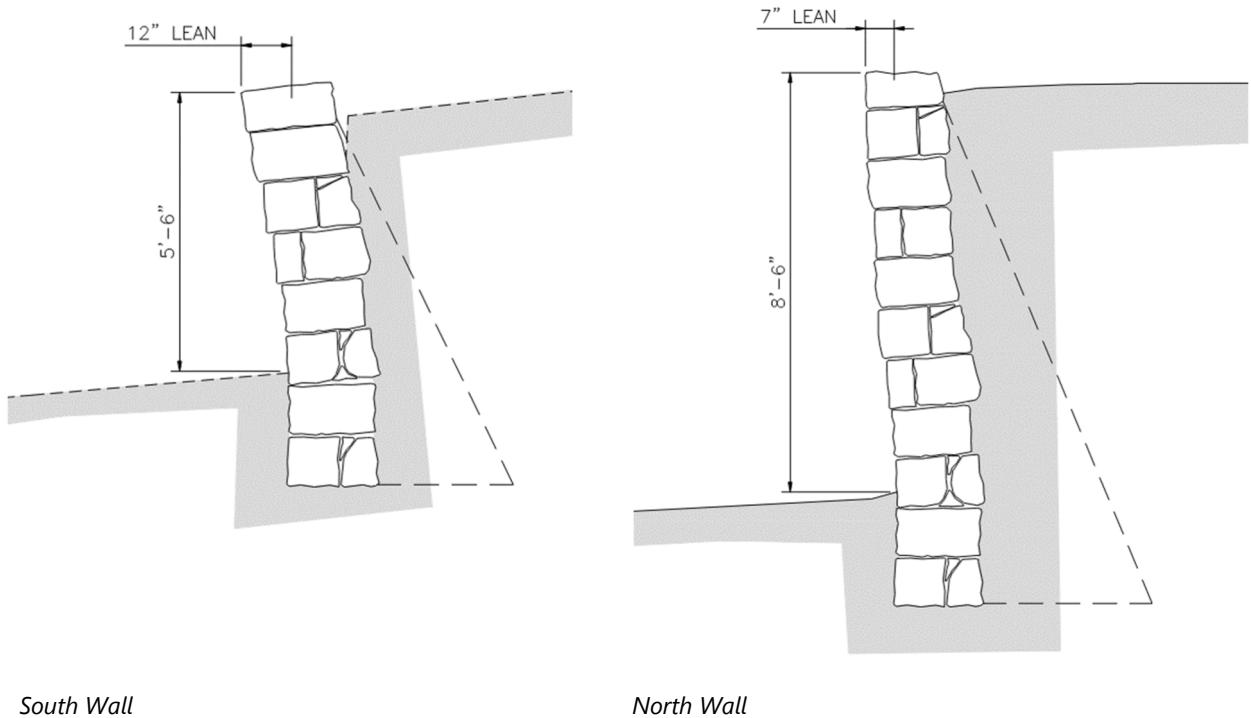
Figure 2 Existing Wall Cross-sections

The maximum lean of each wall is shown in the sketches of Figures 2. The dashed outline behind each wall indicates where the back of the wall may be. Typically, walls of this type have a sloping back and are significantly thicker at the base than at the top. This helps the wall remain stable under the lateral pressure of earth and water behind. However, without construction records or excavating a trial pit behind the wall, the profile is not known and can only be guessed at.

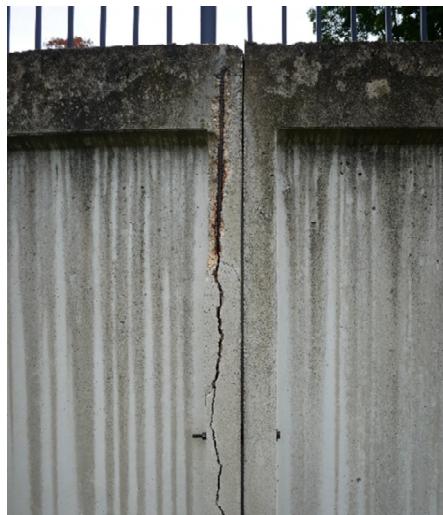
Typical Cracked Rib at Panel Joint

The cracking of these thickening ribs does not appear to be structural in nature. It is likely that the cracking is caused by a combination of factors:

- The as-cast durability of the concrete may be less than that of a modern precast component and has probably deteriorated over its 40-year life.
- The repeated action of freeze-thaw on the relatively thin ribs may have contributed to the deterioration of the concrete and initiated cracking.
- The reinforcing bars in the ribs that have failed are often very close to the surface. Adequate concrete cover to the reinforcing bars is probably the most important factor in a long-lasting concrete element.

Twenty-one out of the twenty-nine wall panels exhibit some visible cracking of the vertical ribs. In many cases this cracking is extensive with large cracks or spalls. However, preliminary calculations indicate that the walls have sufficient strength. The damage is therefore mostly cosmetic at this stage, although if allowed to progress, sooner or later panels will begin to fail.

Repairing the concrete wall will be difficult and costly and even if all currently visible cracks and spalls are repaired, this will still be a 40-year-old wall which will soon be subject to further deterioration and cracking. Replacement is the recommended option.

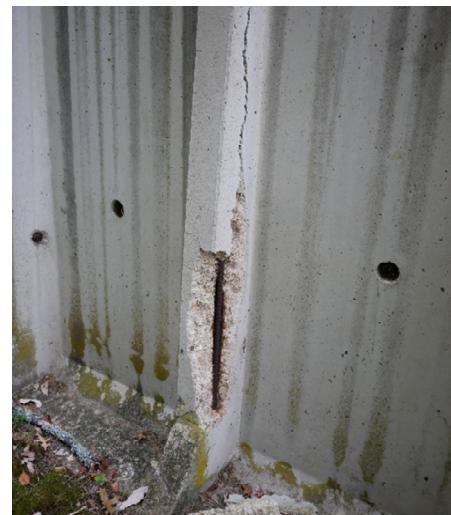
Typical Cracked Center Rib
