**TOWN OF SOUTHBOROUGH**  
**Planning Board**  
**Application for a**  
**Scenic Road Stonewall or Tree Removal**

Name of Applicant(s): National Grid (Hazard Tree Program)

## PUBLIC HEARING NOTICE TREE REMOVAL HEARING

Town of Southborough  
NE Hazard Tree Mitigation Program  
Hazard Tree Removal List

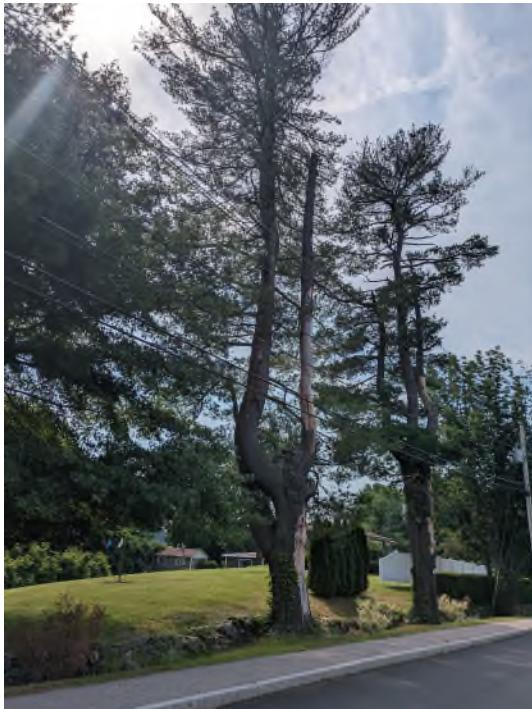
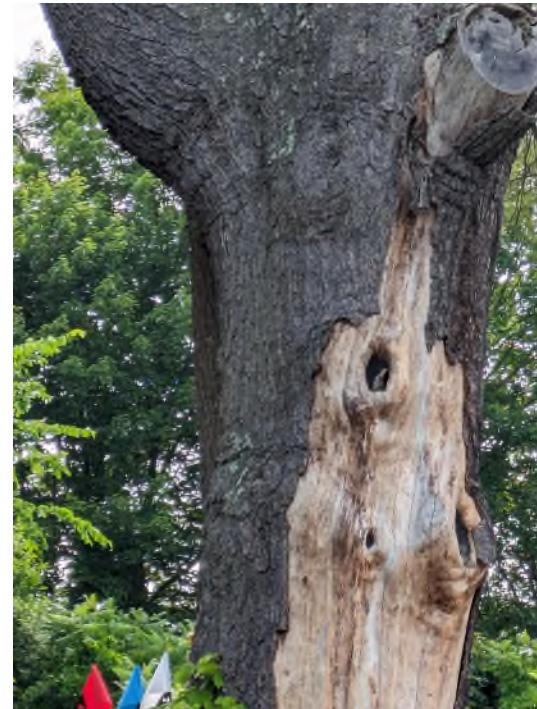
Site ID	Tree #	Street Name	House #	Loc	Pole #	Dia.	Species	# Stems	Defect Condition	Work Proposed
DC24	14	Parkerville Rd	10		96-95	38	Pine		Weight over lines, more than 75% decline, one lead dead, multiple cavities w/decay	Remove

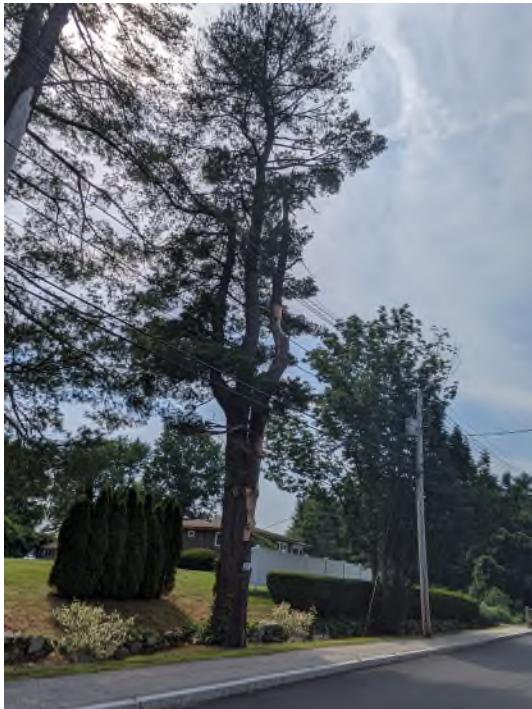
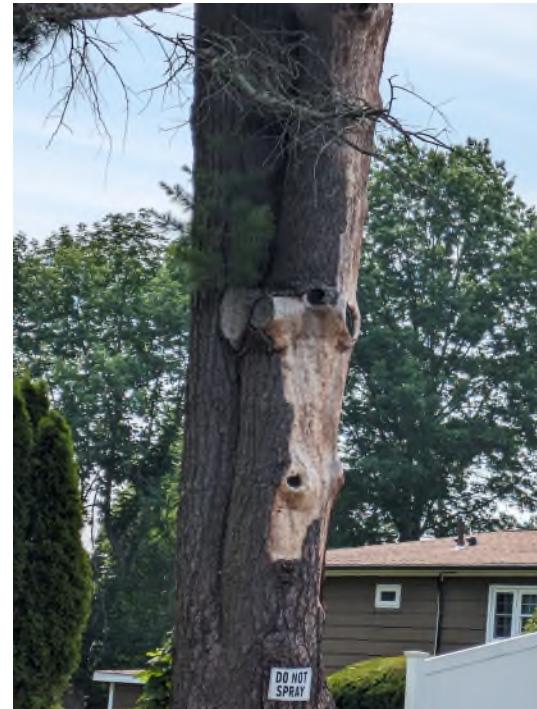
Site ID	Tree #	Street Name	House #	Loc	Pole #	Dia.	Species	# Stems	Defect Condition	Work Proposed
DC24	15	Parkerville Rd	10		96-95	36	Pine		Weight over lines, codominant, one lead dead, multiple cavities w/decay	Remove

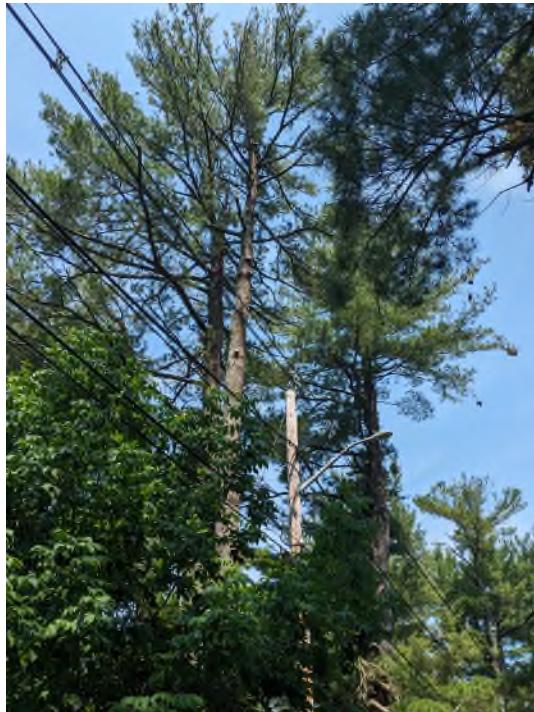
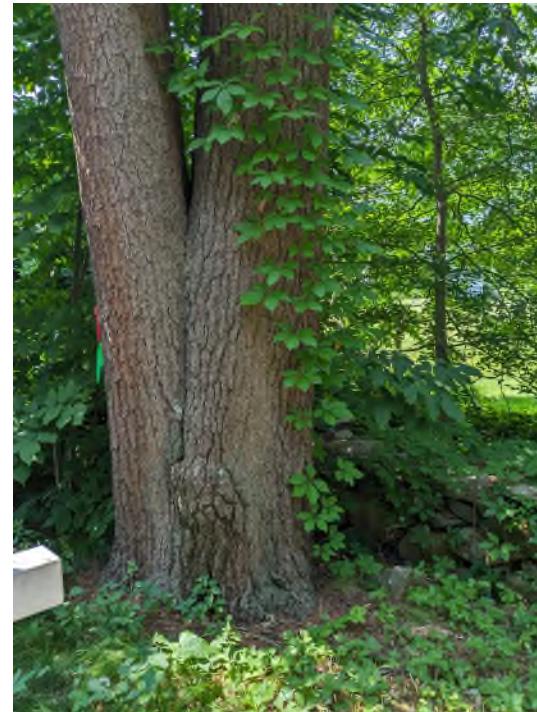
Site ID	Tree #	Street Name	House #	Loc	Pole #	Dia.	Species	# Stems	Defect Condition	Work Proposed
DC26	17	Parkerville Rd	23		93-92	25	Pine	2	Weight over lines, more than 75% decline, codominant w/included bark	Remove

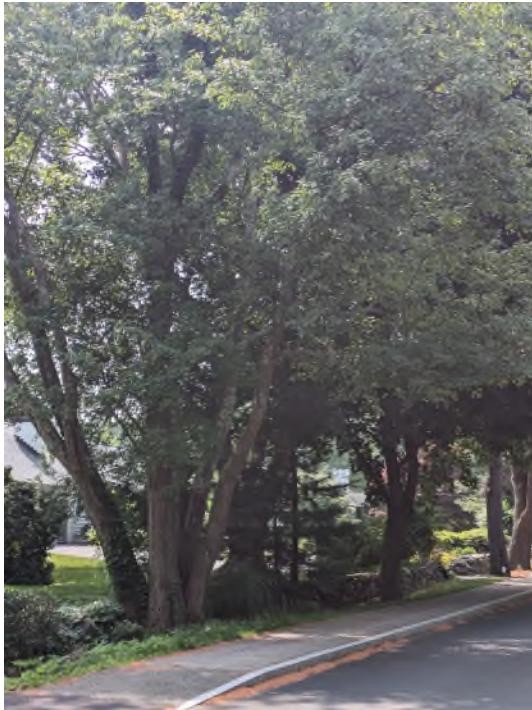
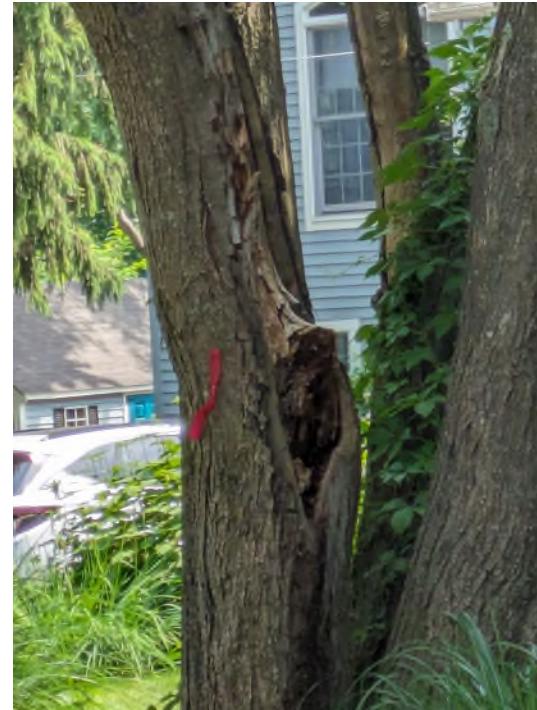
Site ID	Tree #	Street Name	House #	Loc	Pole #	Dia.	Species	# Stems	Defect Condition	Work Proposed
DC27	19	Parkerville Rd	12	AF	93-92	18	Maple	4	Large cavity in lead leaning to line. remove that lead only	Remove

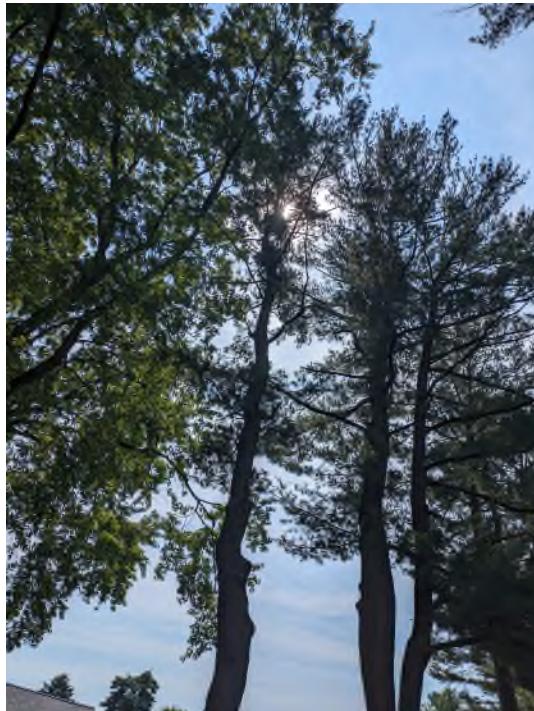
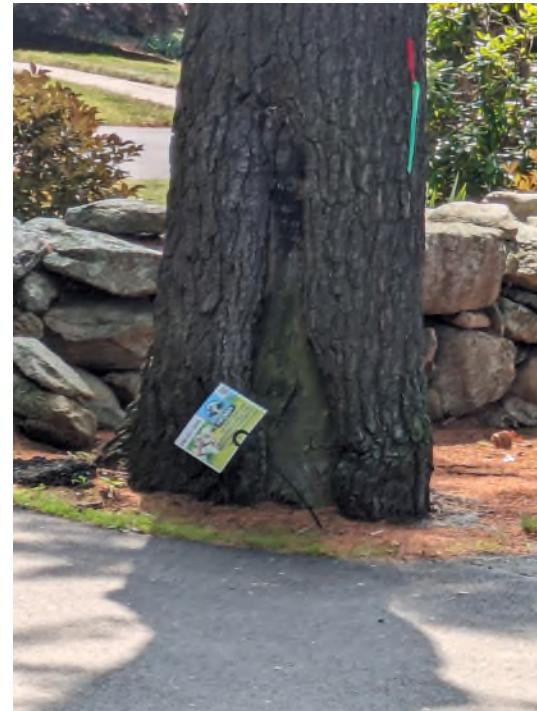
Site ID	Tree #	Street Name	House #	Loc	Pole #	Dia.	Species	# Stems	Defect Condition	Work Proposed
DC28	20	Parkerville Rd	14	AF	92-91	25	Pine		More than 75% decline, cavity at base	Remove

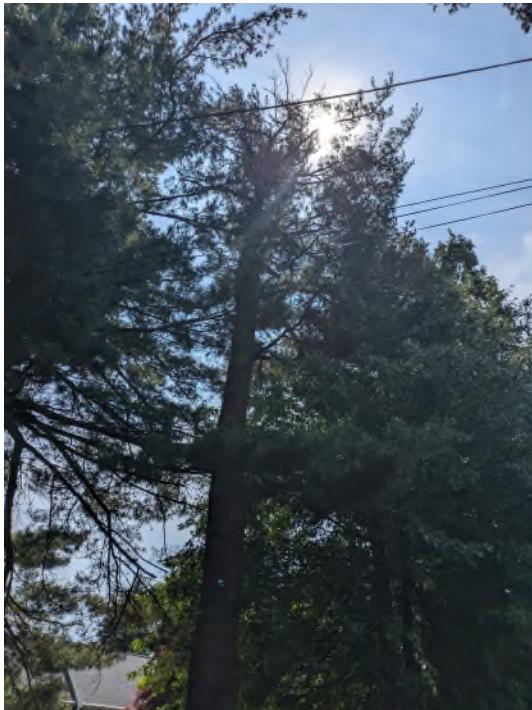
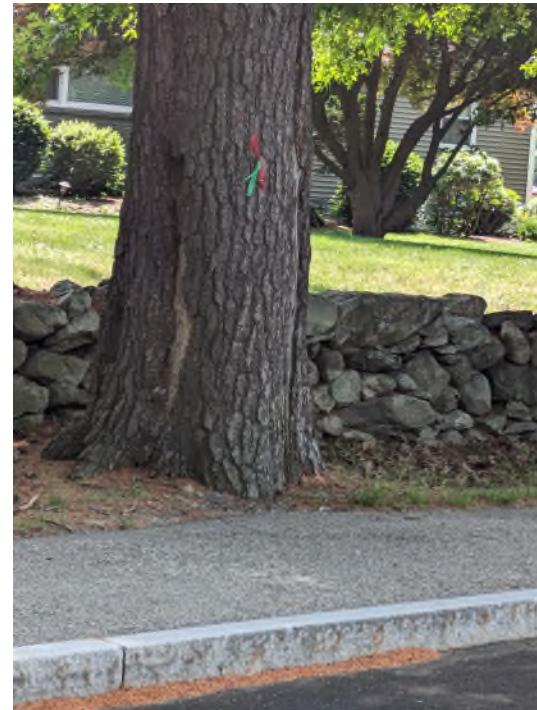
Site ID	Tree #	Street Name	House #	Loc	Pole #	Dia.	Species	# Stems	Defect Condition	Work Proposed
DC30	29	Parkerville Rd	16	AP	91	34	Pine		Weight to lines, more than 50% decline, multiple cracks up trunk with decay	Remove

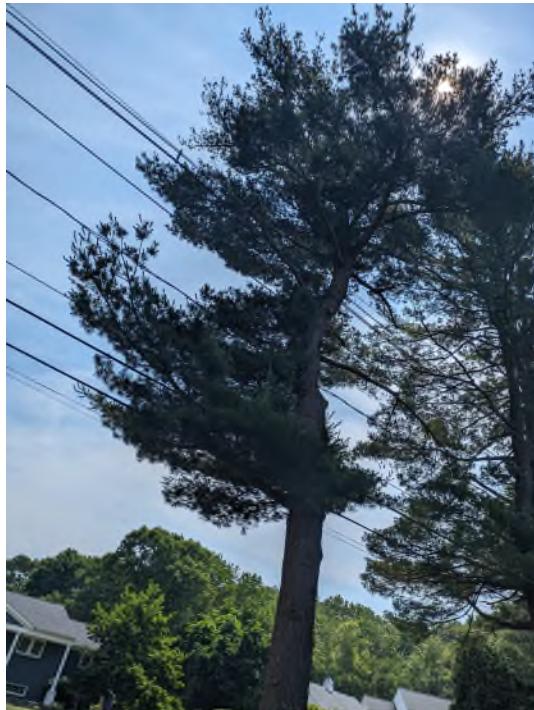
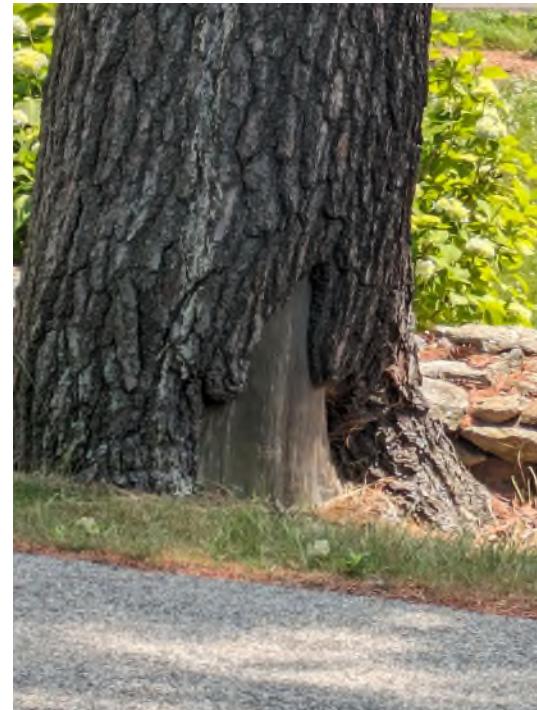
Site ID	Tree #	Street Name	House #	Loc	Pole #	Dia.	Species	# Stems	Defect Condition	Work Proposed
DC31	30	Parkerville Rd	20		89-88	28	Pine		Weight over lines, cavity at base w/decay	Remove

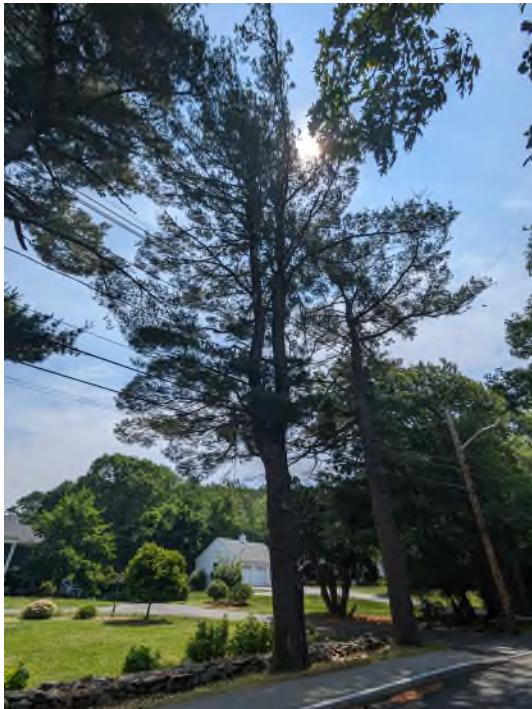
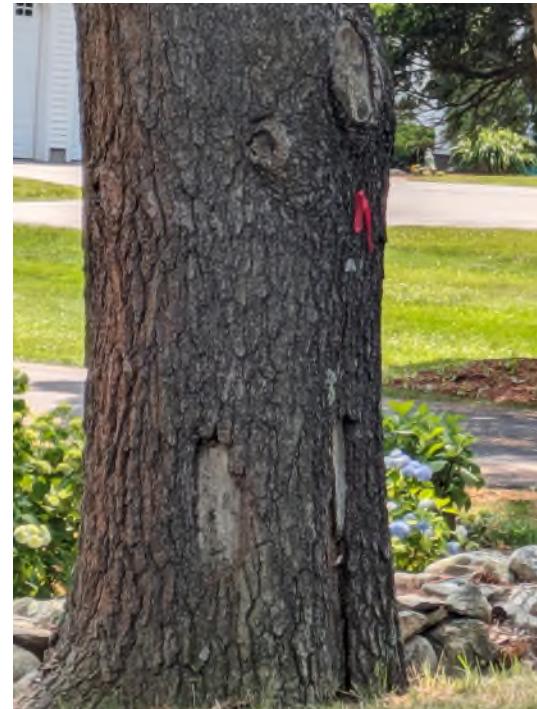
Site ID	Tree #	Street Name	House #	Loc	Pole #	Dia.	Species	# Stems	Defect Condition	Work Proposed
DC31	31	Parkerville Rd	20		89-88	30	Pine		Weight over lines, cavity at base w/decay, more than 50% decline, wounds w/dryrot, codominant w/included bark	Remove

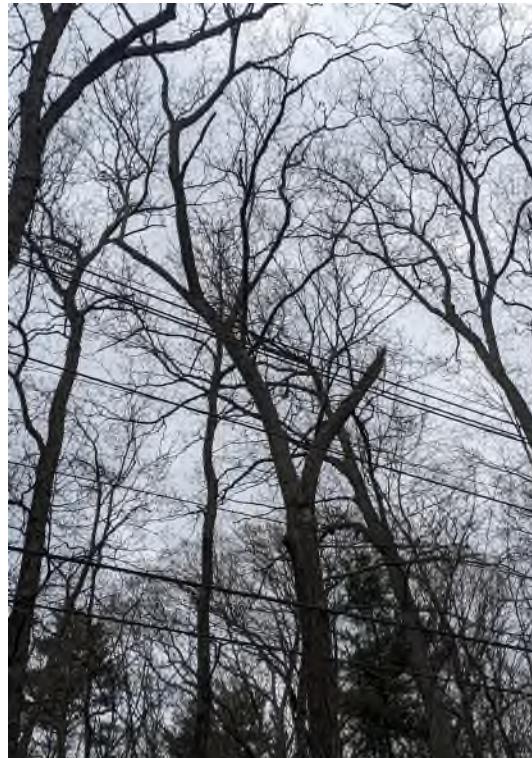
Site ID	Tree #	Street Name	House #	Loc	Pole #	Dia.	Species	# Stems	Defect Condition	Work Proposed
DC33	35	Parkerville Rd	28		86-85	18	Hickory		Weight over lines, more than 75% decline, previous failure in one large branch showing signs of decay, mushrooms on trunk indicating trunk decay	Remove

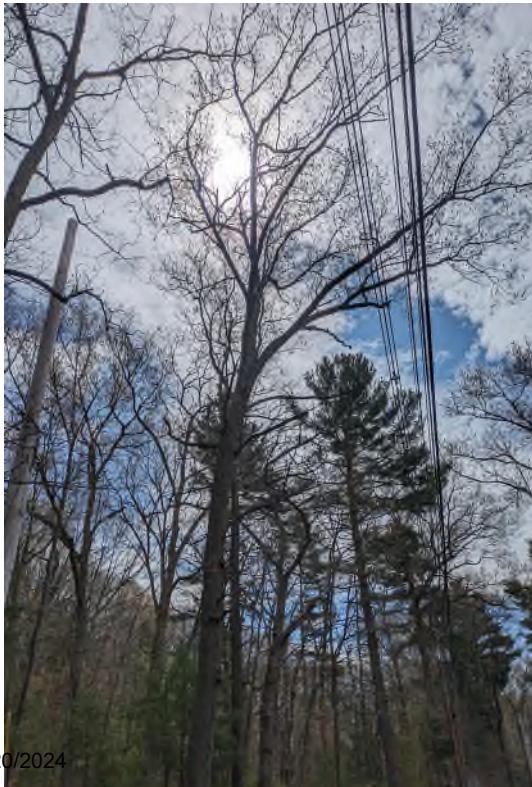
Site ID	Tree #	Street Name	House #	Loc	Pole #	Dia.	Species	# Stems	Defect Condition	Work Proposed
DC35	41	Parkerville Rd	30		83-82	24	Oak		Heavy lean, all weight over line, multiple dead branches, buried to deep backside, suspected root damage from construction	Remove

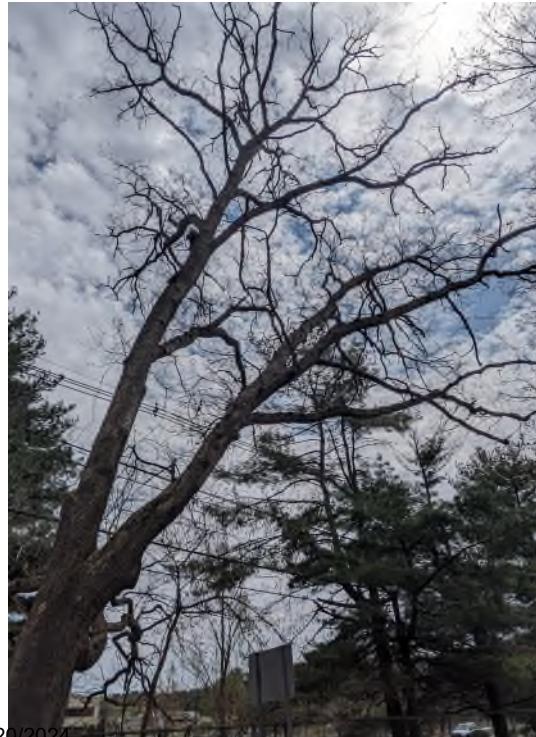
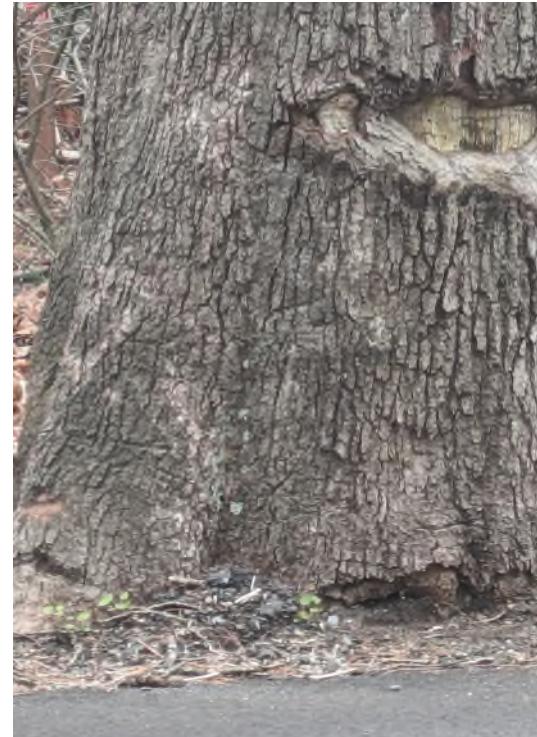
Site ID	Tree #	Street Name	House #	Loc	Pole #	Dia.	Species	# Stems	Defect Condition	Work Proposed
DC41	48	Parkerville Rd	Lot		71-70	36	Oak		Lean, weight over lines, construction wounds w/dry rot, definite construction damage to root system, cavity ground level w/decay	Remove

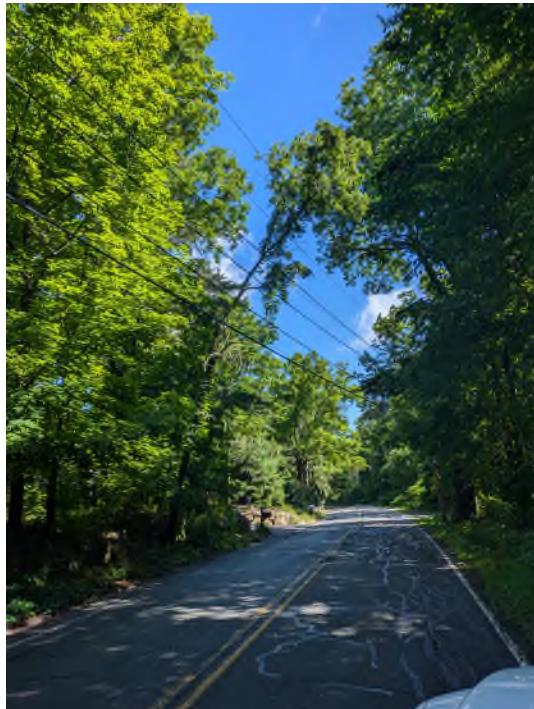
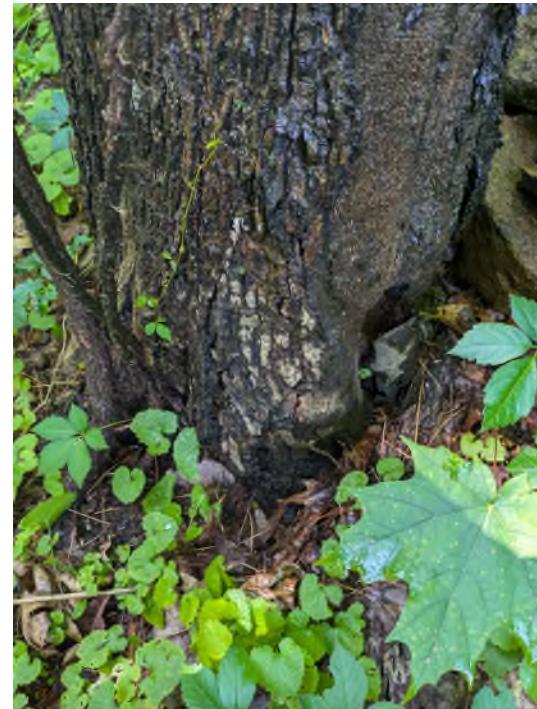
Site ID	Tree #	Street Name	House #	Loc	Pole #	Dia.	Species	# Stems	Defect Condition	Work Proposed
DC55	53	Woodland Rd	31		11-12	12	Hickory		Heavy lean, weight over lines, cavity w/decay at ground level	Remove

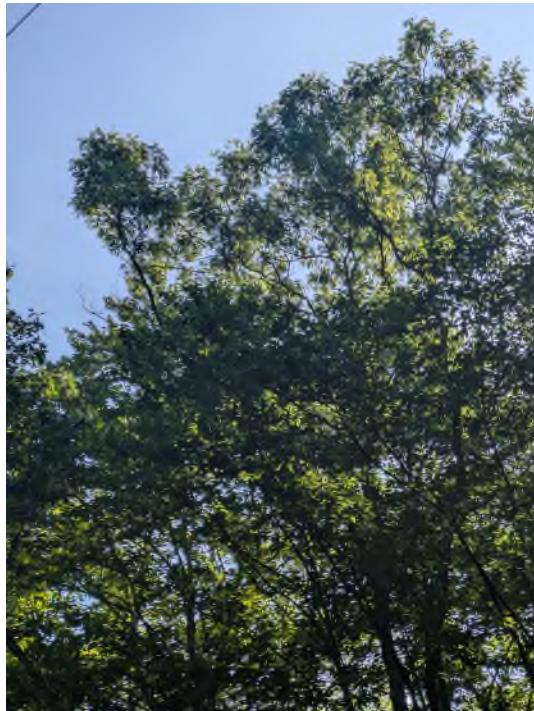
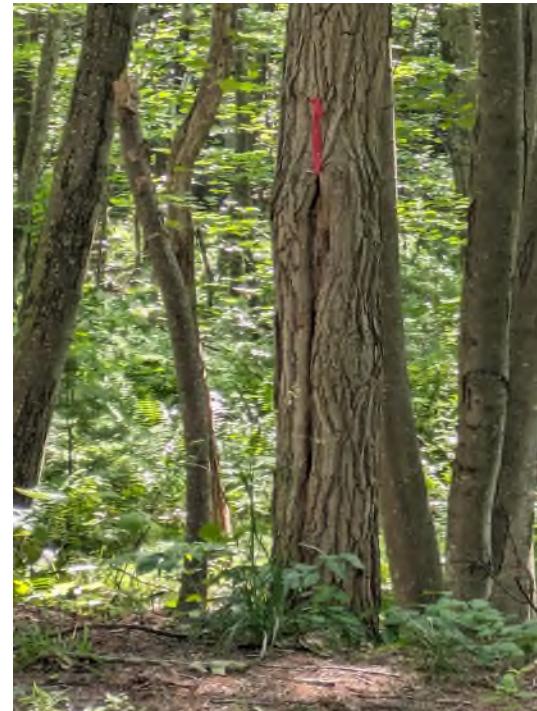
Site ID	Tree #	Street Name	House #	Loc	Pole #	Dia.	Species	# Stems	Defect Condition	Work Proposed
DC61	56	Woodland Rd	Lot	AF	24-26	12	Locust		Cavity at base w/decay, more than 50% decline	Remove

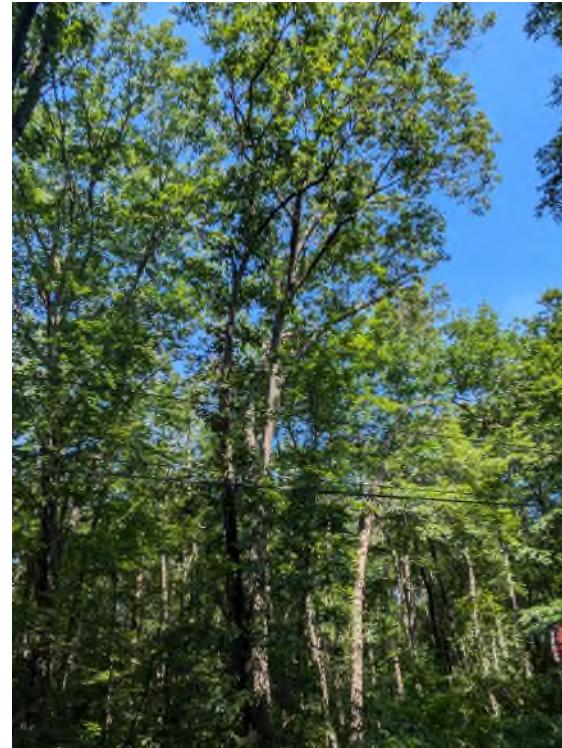
Site ID	Tree #	Street Name	House #	Loc	Pole #	Dia.	Species	# Stems	Defect Condition	Work Proposed
DC62	57	Woodland Rd	Lot		26-27	13	Oak		Heavy lean, weight over lines, more than 75% decline	Remove

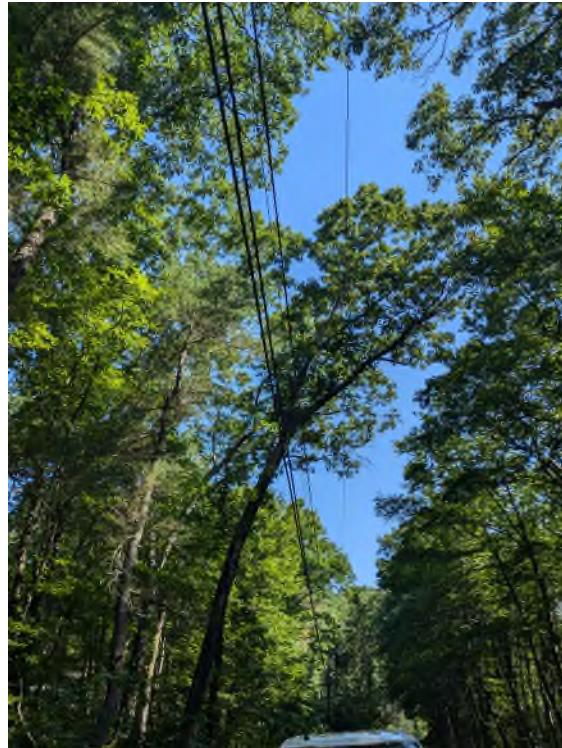
Site ID	Tree #	Street Name	House #	Loc	Pole #	Dia.	Species	# Stems	Defect Condition	Work Proposed
DC62	58	Woodland Rd	Lot		26-27	18	Oak		Heavy lean, weight over lines, more than 75% decline	Remove

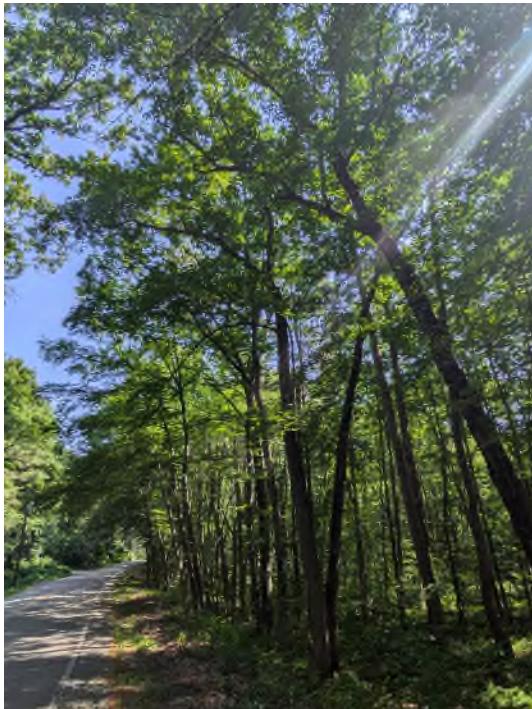
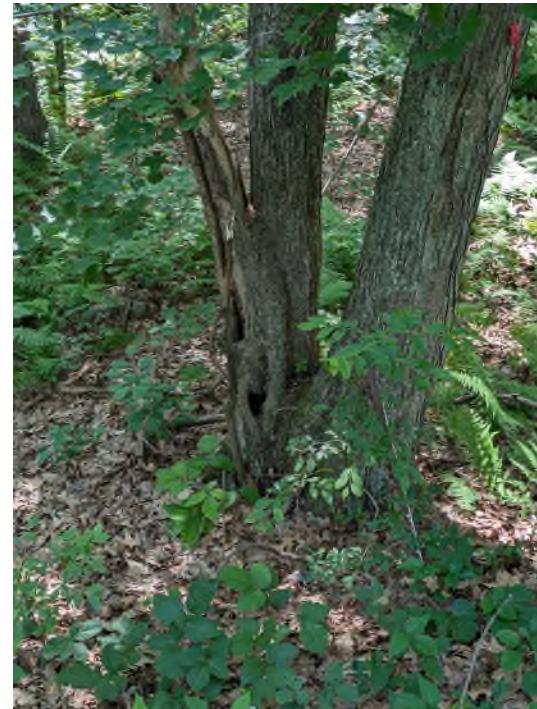
Site ID	Tree #	Street Name	House #	Loc	Pole #	Dia.	Species	# Stems	Defect Condition	Work Proposed
DC63	60	Woodland Rd	Lot	AF	26-27	18	Maple	2	Lean, weight to line, more than 50% decline, cavity w/decay	Remove

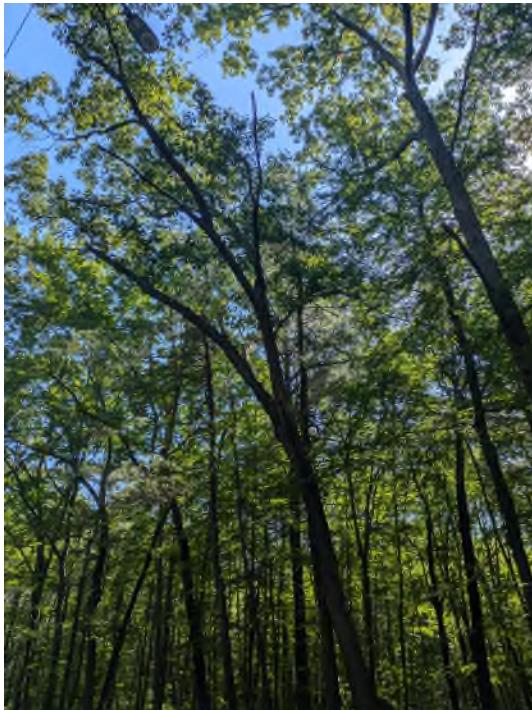
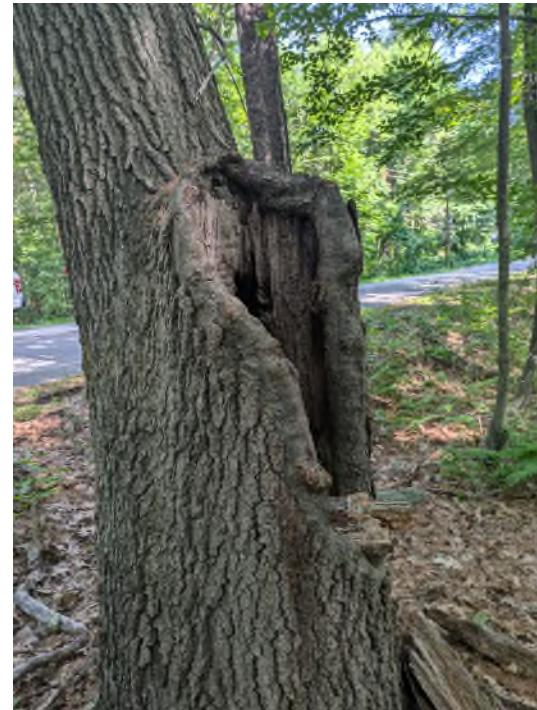
Site ID	Tree #	Street Name	House #	Loc	Pole #	Dia.	Species	# Stems	Defect Condition	Work Proposed
DC63	61	Woodland Rd	Lot	AF	26-27	32	Oak		Heavy lean, weight over lines, more than 75% decline, large cavity backside w/decay	Remove

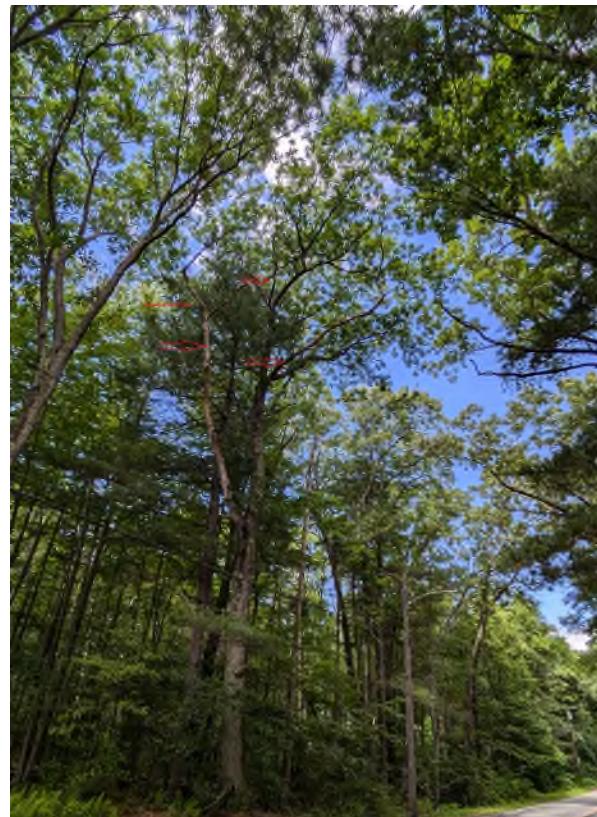
Site ID	Tree #	Street Name	House #	Loc	Pole #	Dia.	Species	# Stems	Defect Condition	Work Proposed
DC64	63	Woodland Rd	Lot		27-29	30	Oak		Dead limbs over lines. Remove 8", 6", 3" dead limbs	Trim

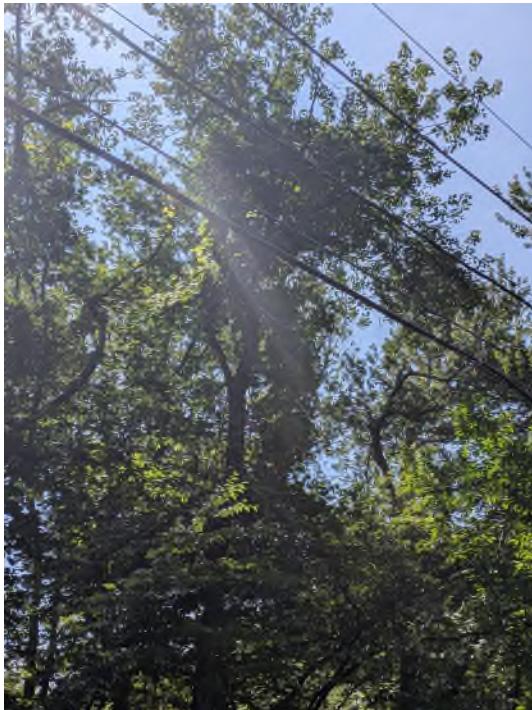
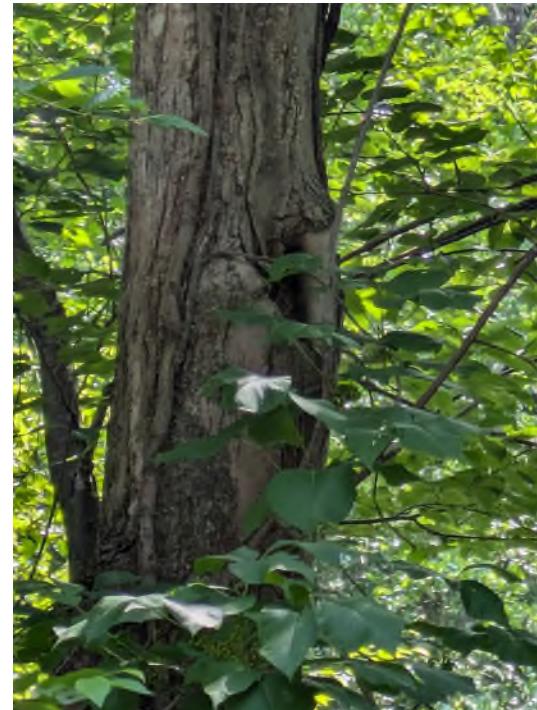
Site ID	Tree #	Street Name	House #	Loc	Pole #	Dia.	Species	# Stems	Defect Condition	Work Proposed
DC66	65	Woodland Rd	Lot		31-32	18	Maple		Lean, weight to line, more than 50% decline, cavity in trunk w/decay	Remove

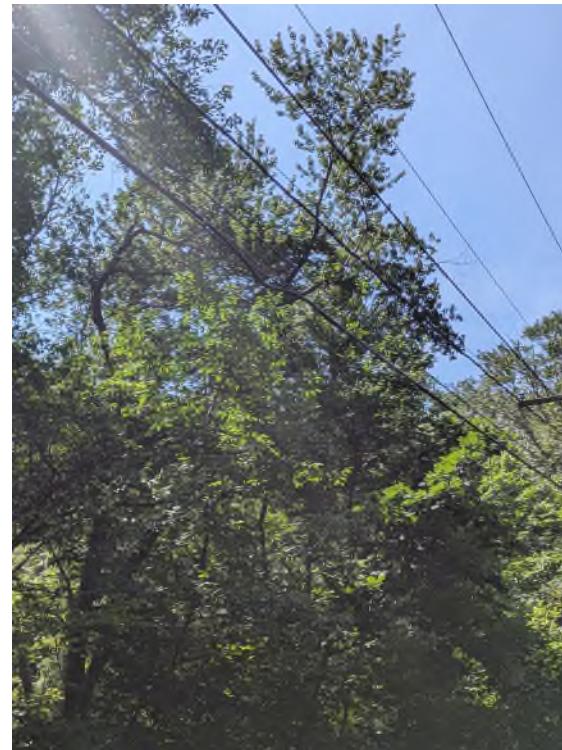
Site ID	Tree #	Street Name	House #	Loc	Pole #	Dia.	Species	# Stems	Defect Condition	Work Proposed
DC66	66	Woodland Rd	Lot		31-32	18	Maple	2	Remove lead to line that is almost dead	Trim

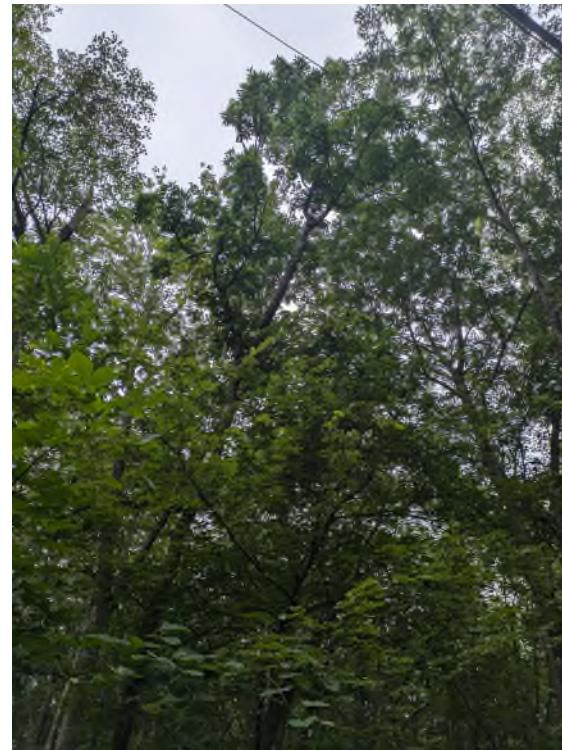
Site ID	Tree #	Street Name	House #	Loc	Pole #	Dia.	Species	# Stems	Defect Condition	Work Proposed
DC66	68	Woodland Rd	Lot		32-34	12	Ash		Lean, weight over line, more than 75% decline, cavity at base w/ decay	Remove

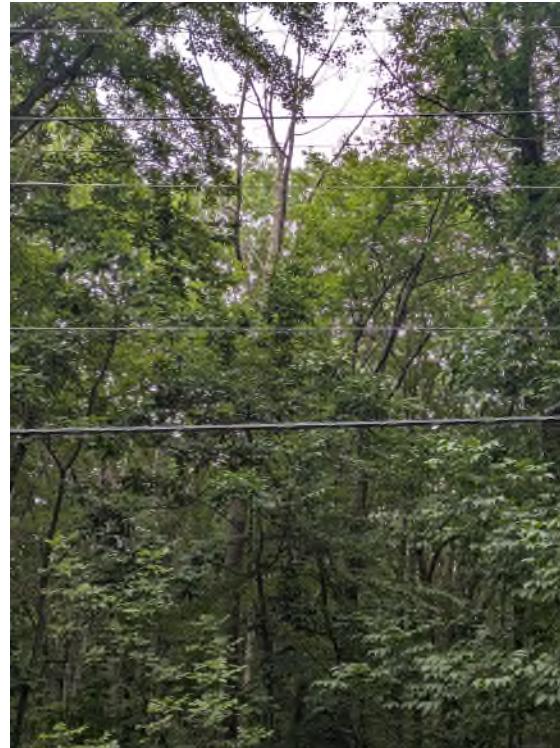
Site ID	Tree #	Street Name	House #	Loc	Pole #	Dia.	Species	# Stems	Defect Condition	Work Proposed
DC66	69	Woodland Rd	Lot		32-34	24	Ash		Dead	Remove

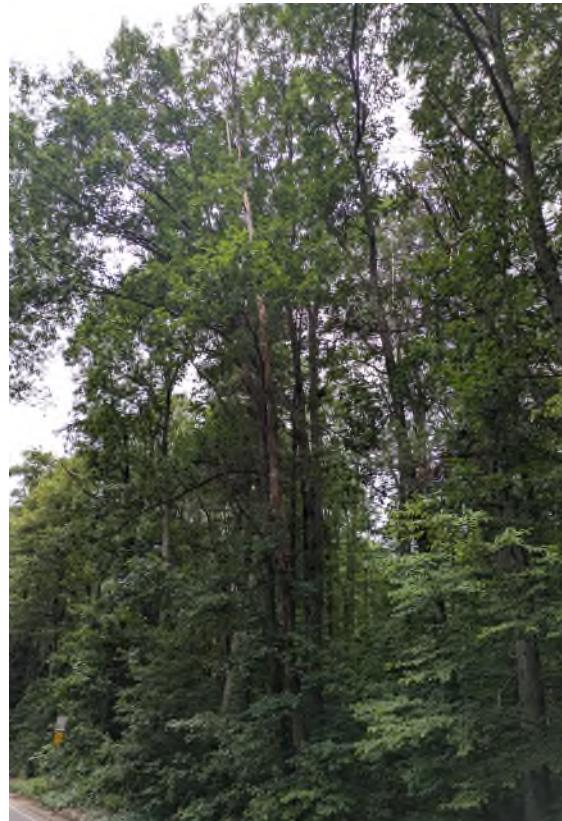
Site ID	Tree #	Street Name	House #	Loc	Pole #	Dia.	Species	# Stems	Defect Condition	Work Proposed
DC68	70	Woodland Rd	81	AF	34-36	16	Oak		Dead	Remove

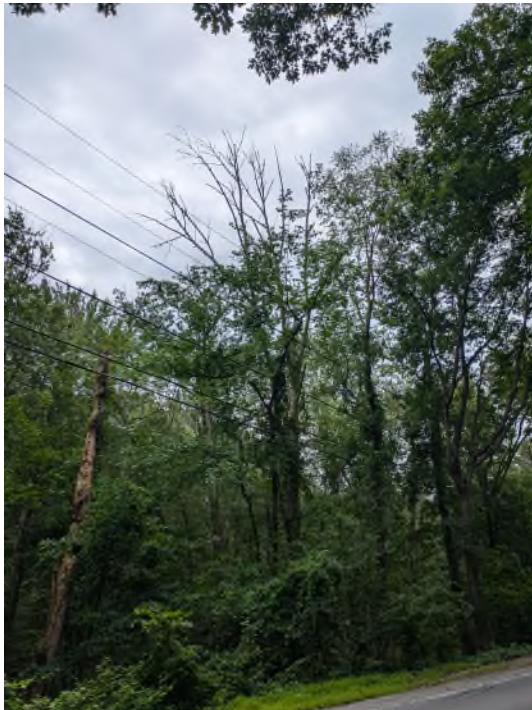
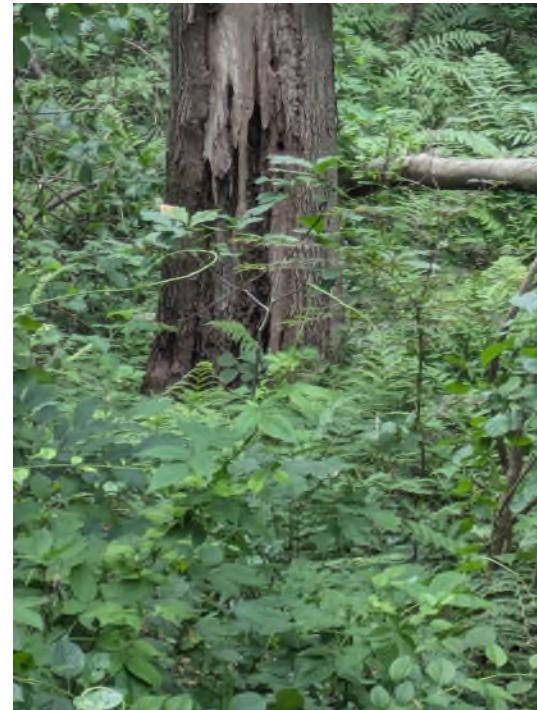
Site ID	Tree #	Street Name	House #	Loc	Pole #	Dia.	Species	# Stems	Defect Condition	Work Proposed
DC69	71	Woodland Rd	Lot		34-36	24	Ash		Dead, large cavity at base with decay	Remove

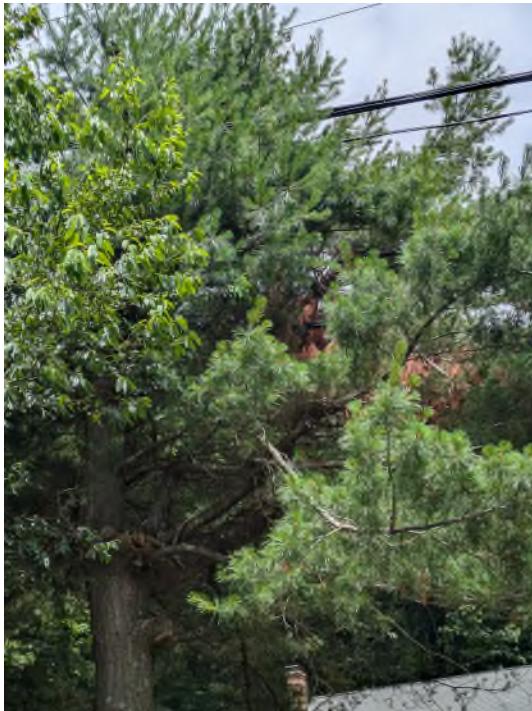
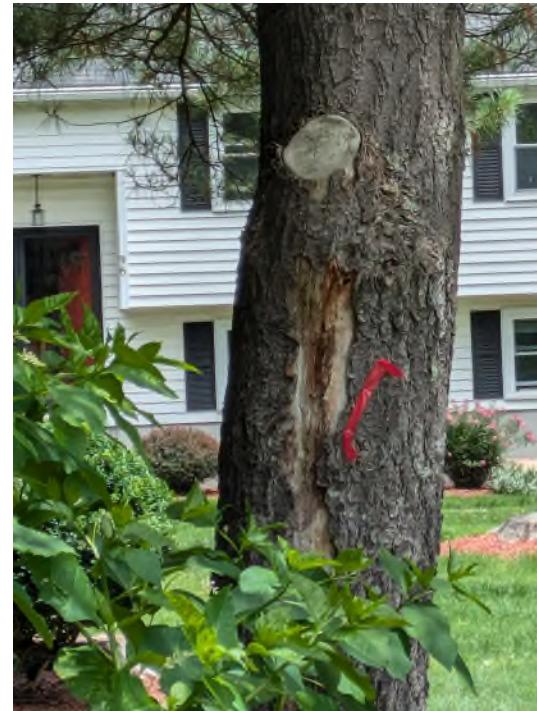
Site ID	Tree #	Street Name	House #	Loc	Pole #	Dia.	Species	# Stems	Defect Condition	Work Proposed
DC71	77	Breakneck Hill Rd	96		45-44	18	Pine		Entangled in the wires, bark peeling off ground to 4' up w/decay present	Remove

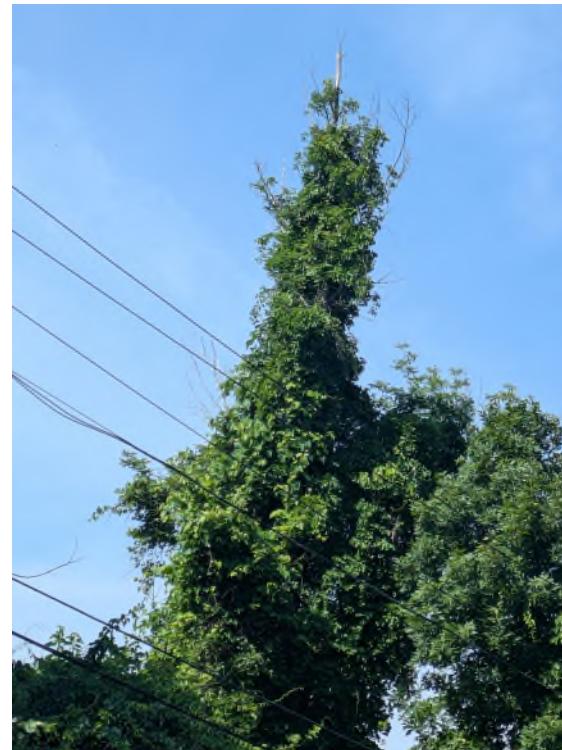
Site ID	Tree #	Street Name	House #	Loc	Pole #	Dia.	Species	# Stems	Defect Condition	Work Proposed
DC73	78	Middle Rd	Lot		52/3-52/4	25	Ash		Dead	Remove

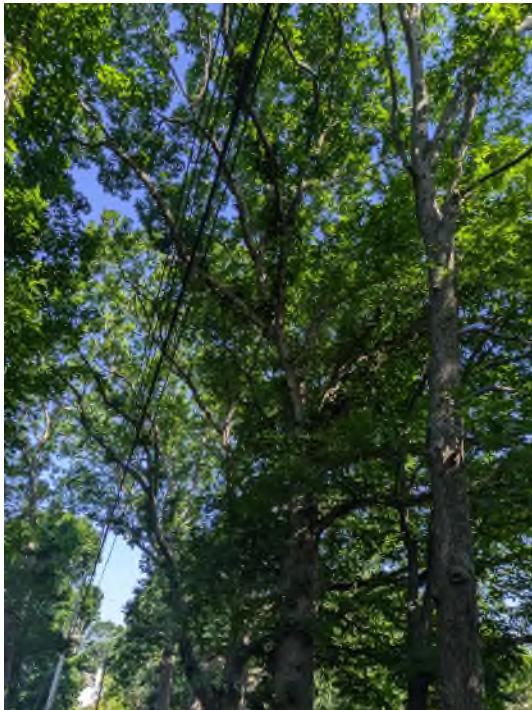
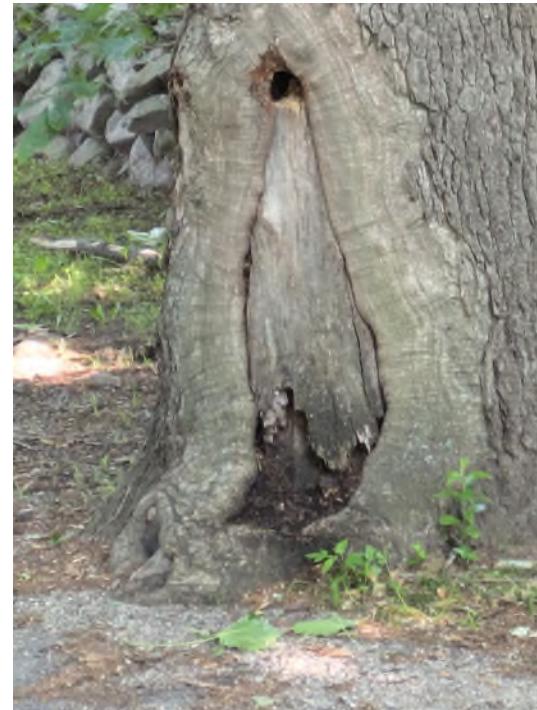
Site ID	Tree #	Street Name	House #	Loc	Pole #	Dia.	Species	# Stems	Defect Condition	Work Proposed
DC03	80	Lovers Lane	40		24-23	26	Oak		Weight over lines, root damage, large wound at base w/decay, half roots under pavement, signs of internal decay	Remove

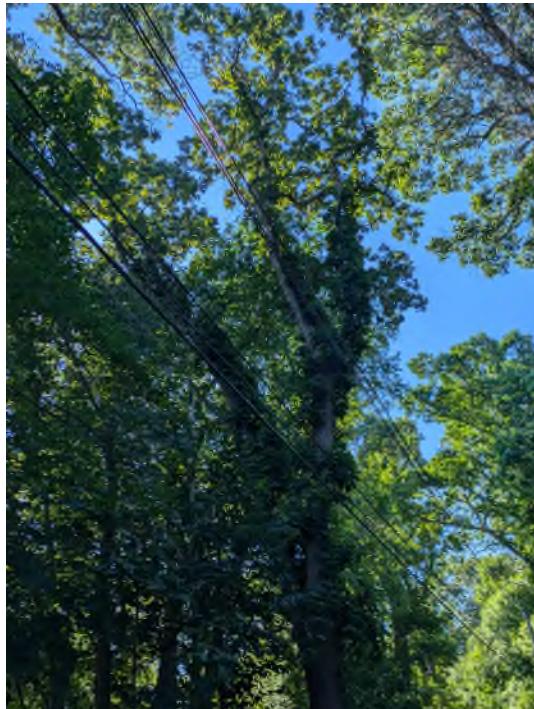
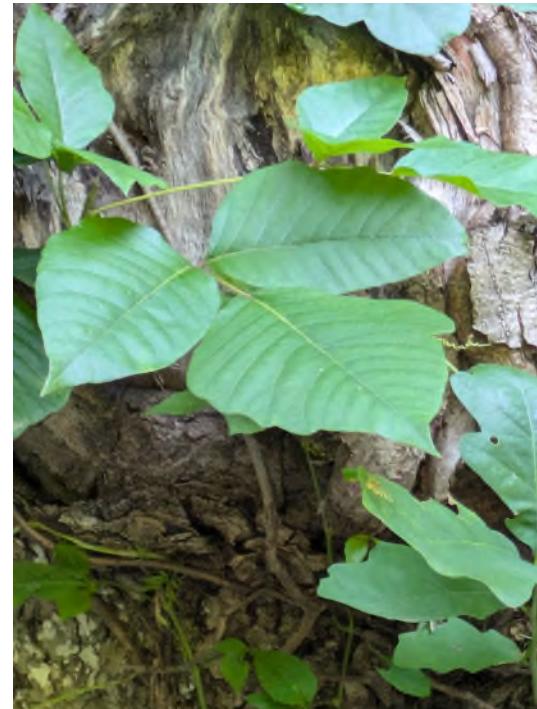
Site ID	Tree #	Street Name	House #	Loc	Pole #	Dia.	Species	# Stems	Defect Condition	Work Proposed
DC04	81	Lovers Lane	36		22-21	28	Oak		Weight over lines, more than 75% decline, multiple dead branches, water sprouts, trunk decay, more than half the roots under pavement	Remove

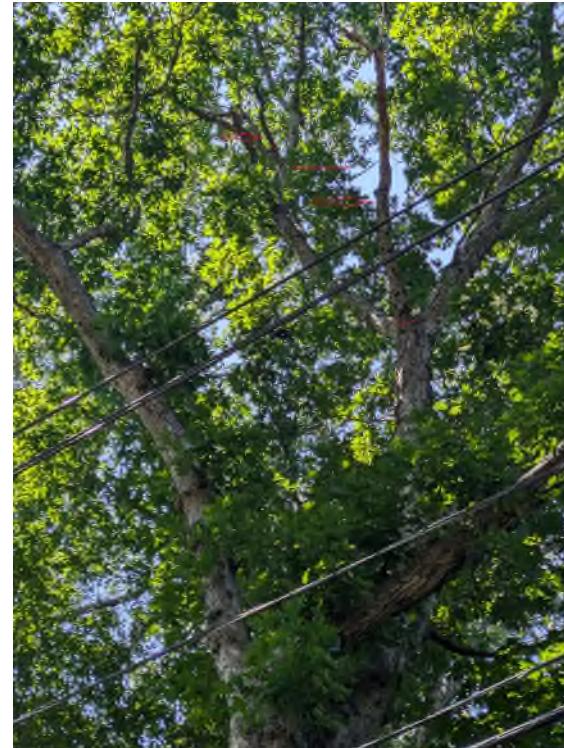
Site ID	Tree #	Street Name	House #	Loc	Pole #	Dia.	Species	# Stems	Defect Condition	Work Proposed
DC05	82	Lovers Lane	35		22-21	36	Oak		Weight over lines, multiple cavities w/decay. Remove 6" and 4" limb directly over lines. Both are dead	Trim

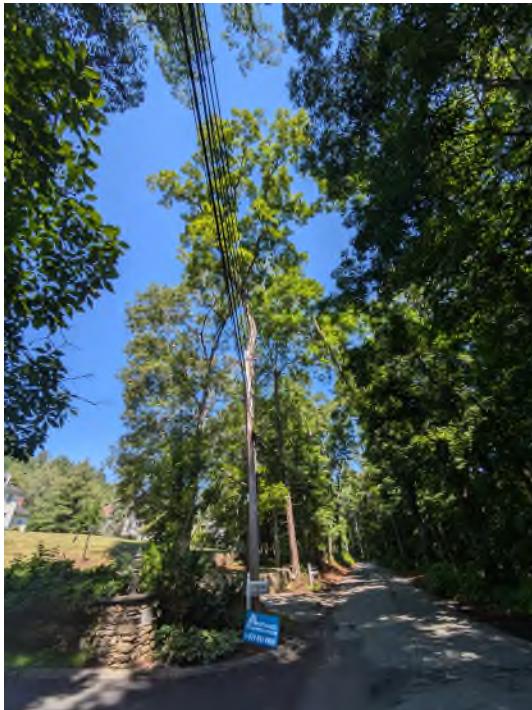
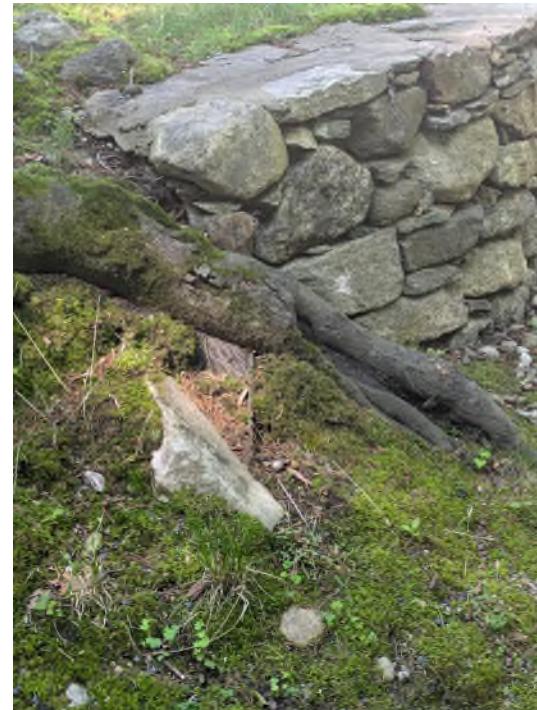
Site ID	Tree #	Street Name	House #	Loc	Pole #	Dia.	Species	# Stems	Defect Condition	Work Proposed
DC07	84	Lovers Lane	29		17/50-17	20	Hickory		Lean into pole, weight over pole, more than 50% decline, root damage w/decay	Remove

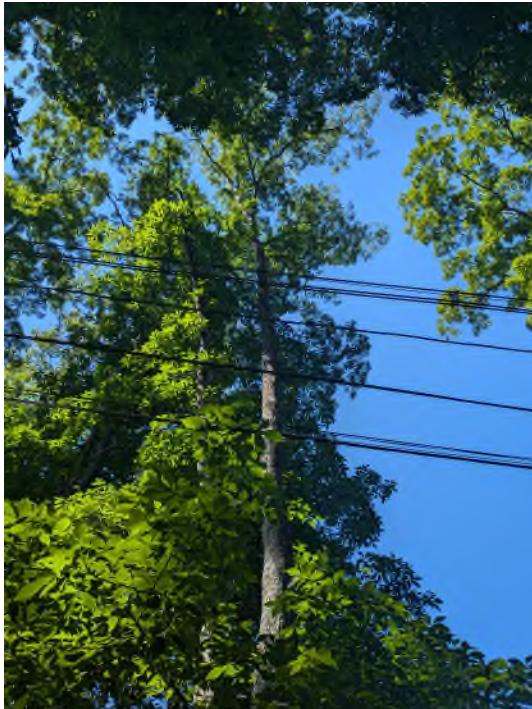
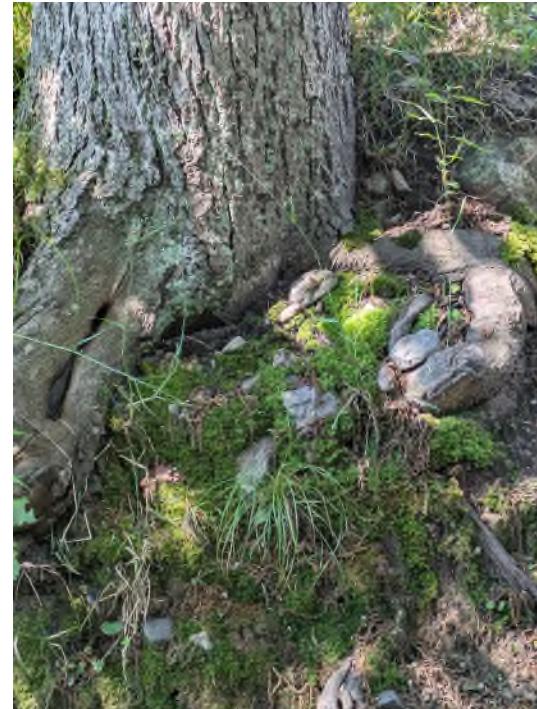
Site ID	Tree #	Street Name	House #	Loc	Pole #	Dia.	Species	# Stems	Defect Condition	Work Proposed
DC08	85	Lovers Lane	Lot		17-16/50	15	Hickory		Lean, weight over lines, more than 50% decline, root damage w/decay	Remove

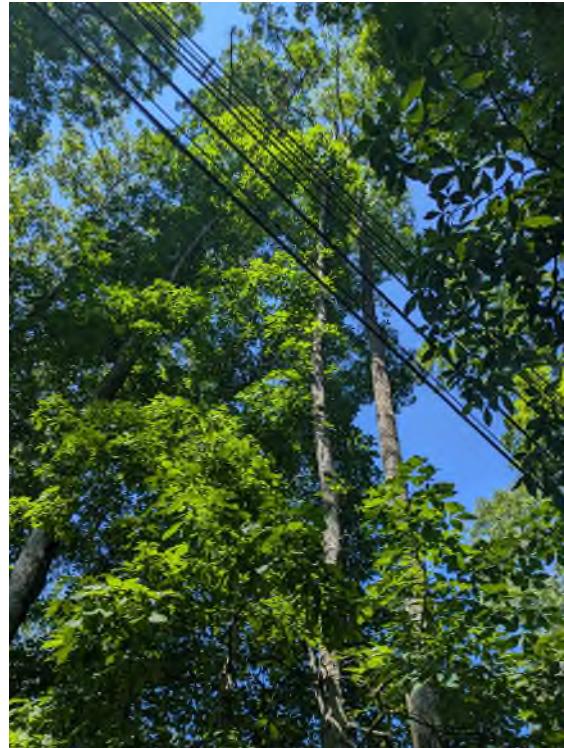
Site ID	Tree #	Street Name	House #	Loc	Pole #	Dia.	Species	# Stems	Defect Condition	Work Proposed
DC08	86	Lovers Lane	Lot		17-16/50	8	Hickory		90% decline, top dead, decay at base	Remove

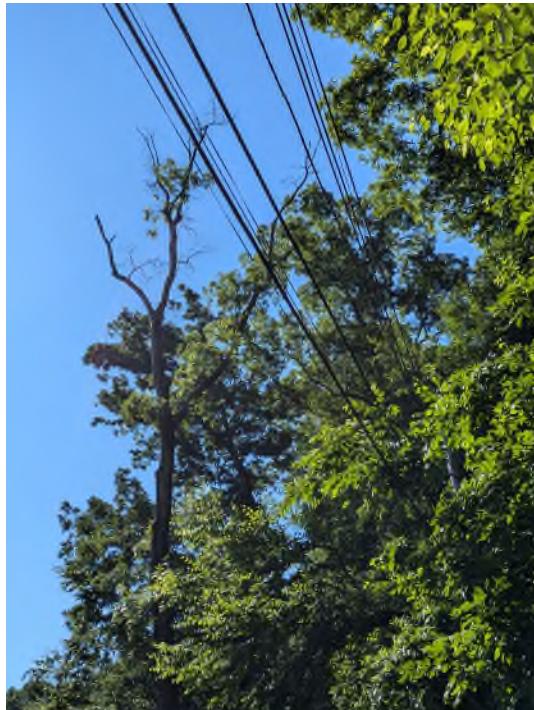
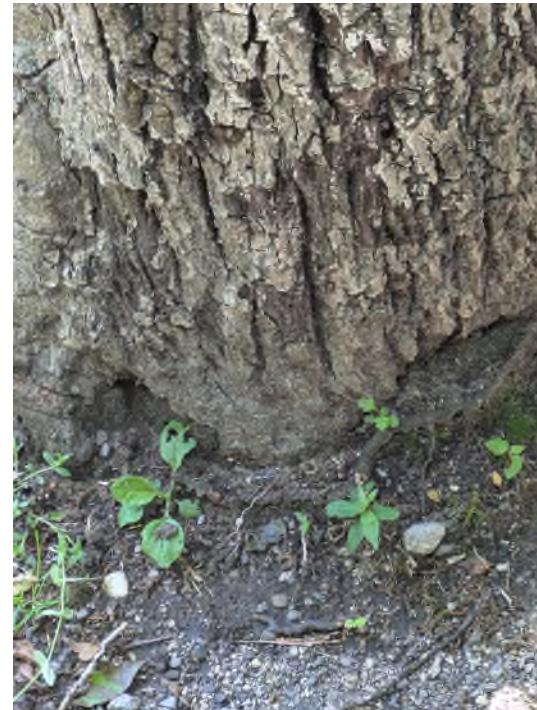
Site ID	Tree #	Street Name	House #	Loc	Pole #	Dia.	Species	# Stems	Defect Condition	Work Proposed
DC09	88	Lovers Lane	22A		16-15/50	22	Hickory		More than 90% decline, decay at base	Remove
