**TOWN OF SOUTHBOROUGH**  
**Planning Board**  
**Application for a**  
**Scenic Road Stonewall or Tree Removal**

Name of Applicant(s): National Grid (Hazard Tree Program)

## PUBLIC HEARING NOTICE TREE REMOVAL HEARING

Town of Southborough  
NE Hazard Tree Mitigation Program  
Hazard Tree Removal List

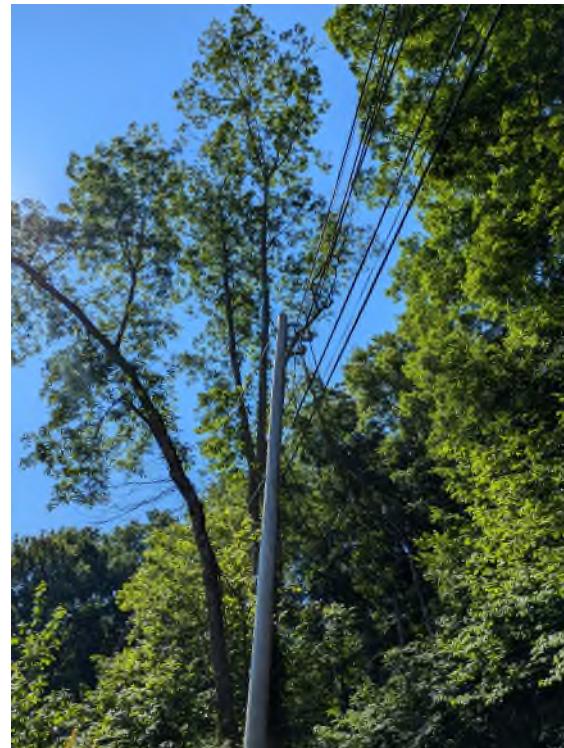
Site ID	Tree #	Street Name	House #	Loc	Pole #	Dia.	Species	# Stems	Defect Condition	Work Proposed
DC10	89	Lovers Lane	22		15/50-15	13	Hickory		Lean, weight over lines, more than 75% decline, heavy vines	Remove

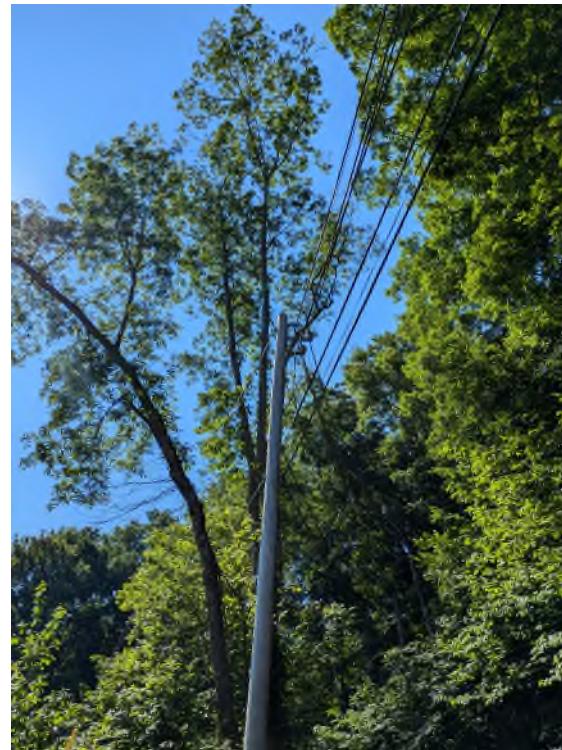
Site ID	Tree #	Street Name	House #	Loc	Pole #	Dia.	Species	# Stems	Defect Condition	Work Proposed
DC10	90	Lovers Lane	22		15/50-15	15	Hickory		Remove 8" limb over lines, 50% decline	Trim

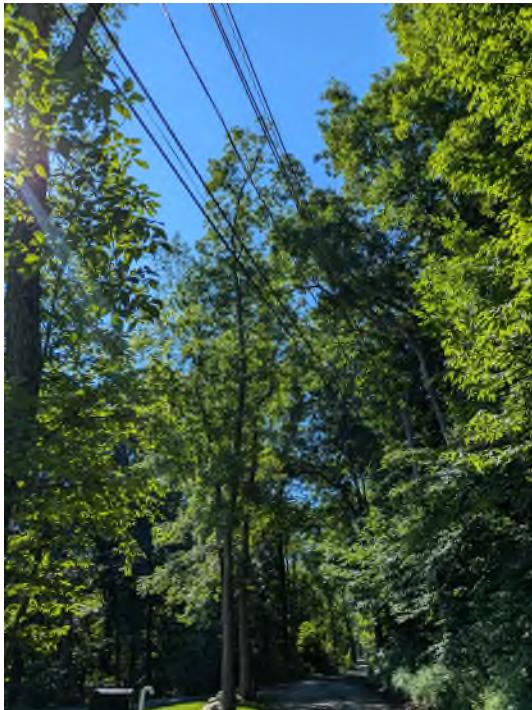
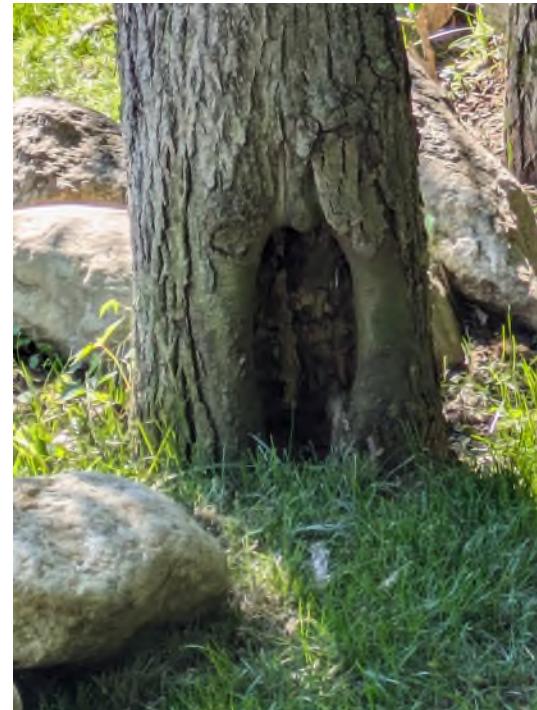
Site ID	Tree #	Street Name	House #	Loc	Pole #	Dia.	Species	# Stems	Defect Condition	Work Proposed
DC10	91	Lovers Lane	22		15/50-15	14	Hickory		Lean, weight over lines, more than 50% decline, cavity at base w/decay	Remove

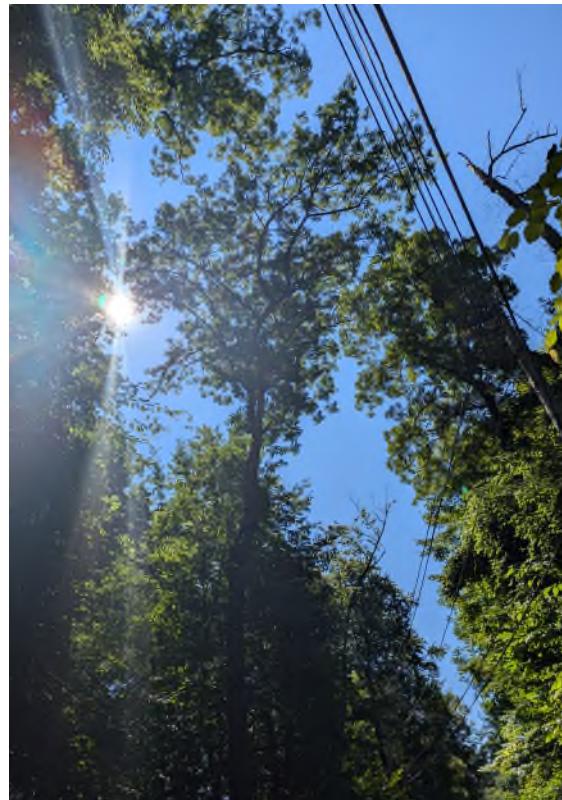
Site ID	Tree #	Street Name	House #	Loc	Pole #	Dia.	Species	# Stems	Defect Condition	Work Proposed
DC15	93	Lovers Lane	Lot		12-11/50	22	Ash		Lean, weight over lines, more than 50% decline	Remove

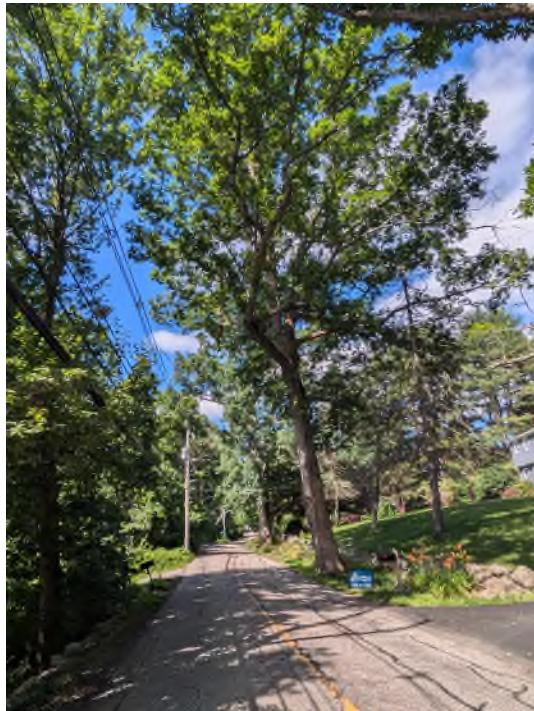
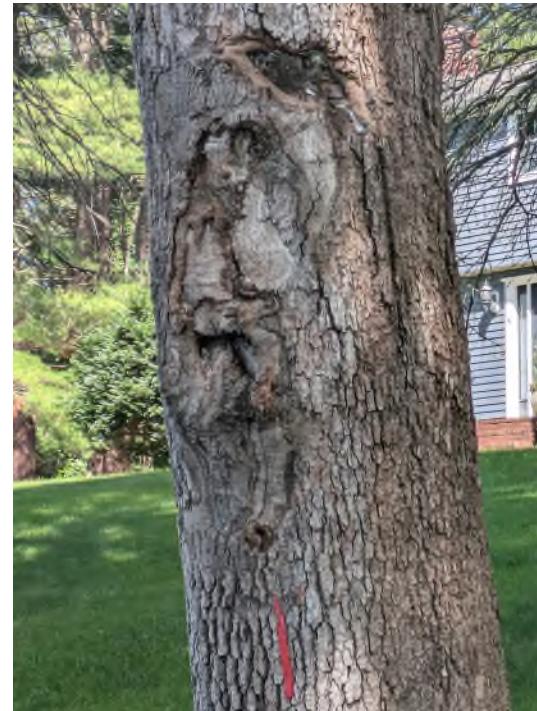
Site ID	Tree #	Street Name	House #	Loc	Pole #	Dia.	Species	# Stems	Defect Condition	Work Proposed
DC18	96	Flagg Rd	5	AF	3-4	32	Oak		Lean, weight over lines, multiple mechanical damage w/decay present, more than 30% decline	Remove

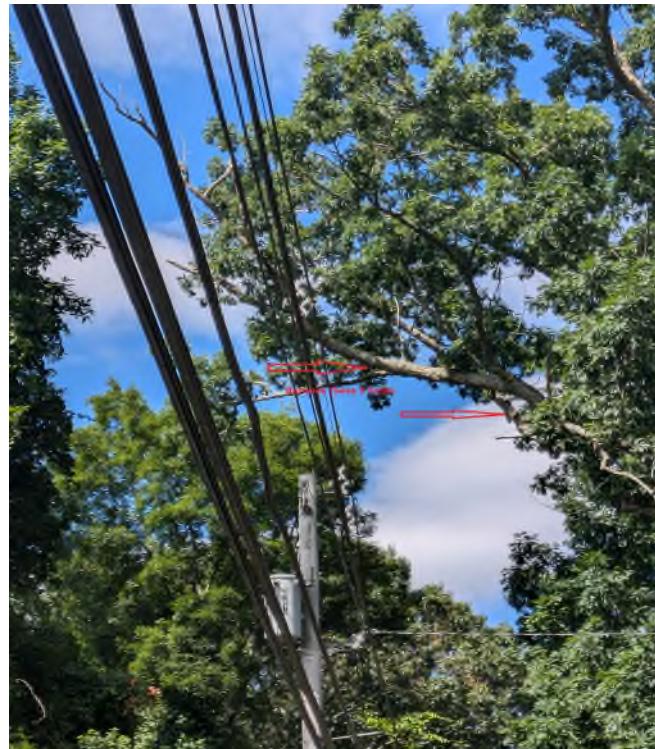
Site ID	Tree #	Street Name	House #	Loc	Pole #	Dia.	Species	# Stems	Defect Condition	Work Proposed
DC18	97	Flagg Rd	5	AF	4-6	38	Oak		Remove 8" limb about 35' up back to union with main limb, remove 12" limb about 30' up back to main trunk. Both directly over line and about 50% decline	Trim

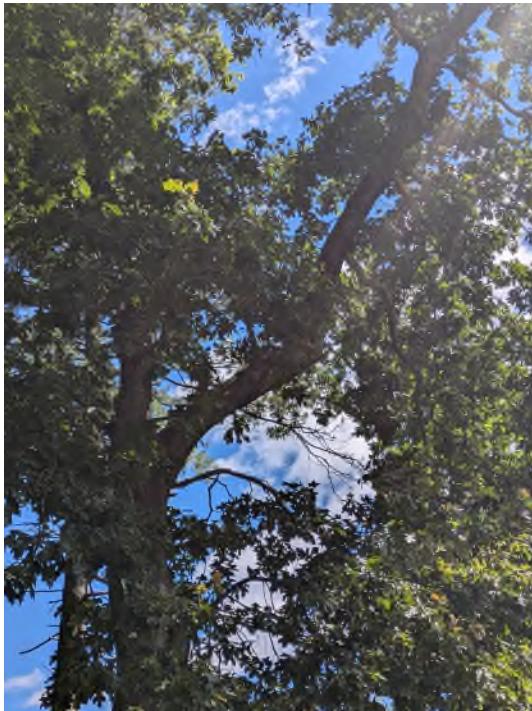
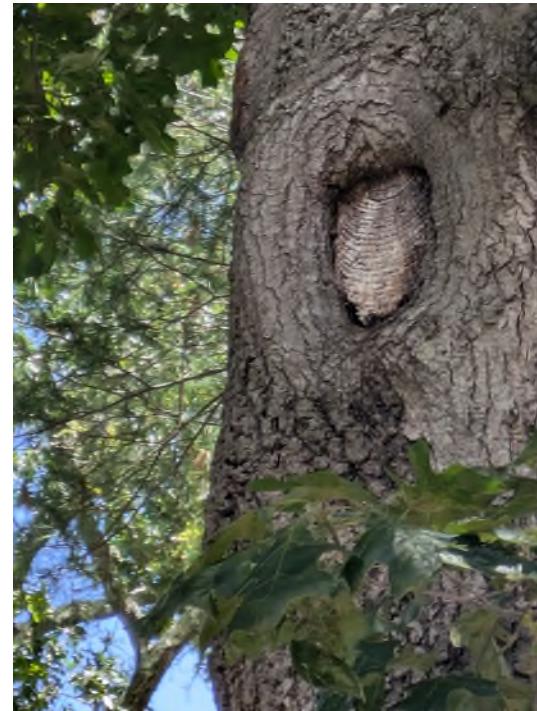
Site ID	Tree #	Street Name	House #	Loc	Pole #	Dia.	Species	# Stems	Defect Condition	Work Proposed
DC24	103	Flagg Rd	Lot	AF	18-19	35	Oak		Lean, weight over lines, more than 75% decline, previous failure, cavity w/decay	Remove

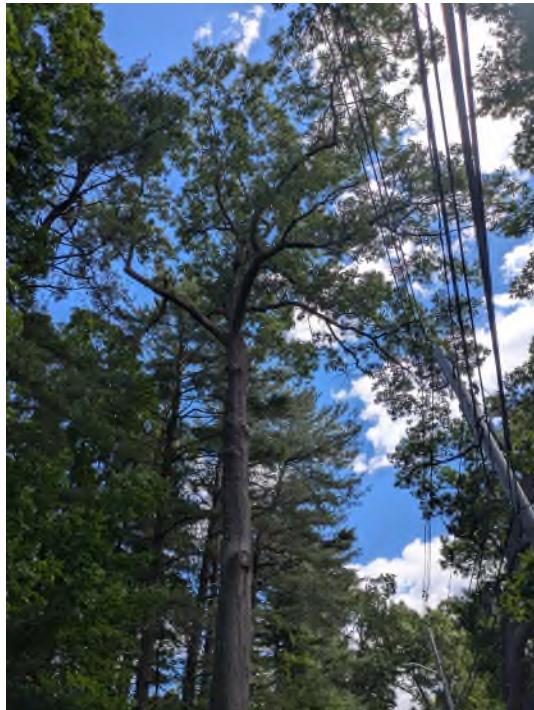
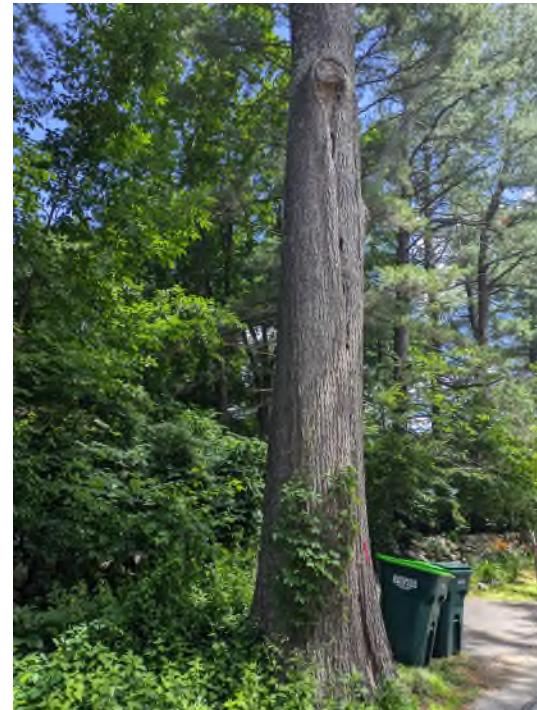
Site ID	Tree #	Street Name	House #	Loc	Pole #	Dia.	Species	# Stems	Defect Condition	Work Proposed
DC25	105	Flagg Rd	31	AF	19-20	36	Oak		Weight over lines, more than 50% decline, cavity from ground to 20'up. Signs of insect and internal decay	Remove

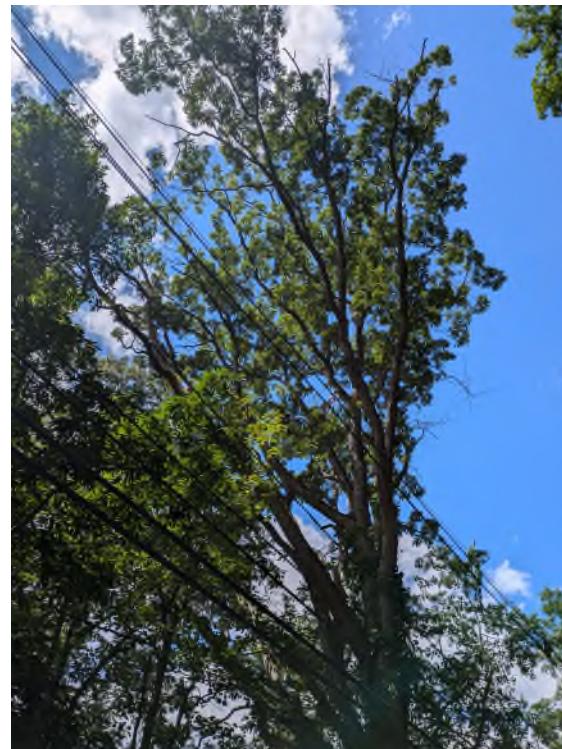
Site ID	Tree #	Street Name	House #	Loc	Pole #	Dia.	Species	# Stems	Defect Condition	Work Proposed
DC26	106	Flagg Rd	Lot		20-21	38	Oak		Weight over lines, more than 75% decline	Remove

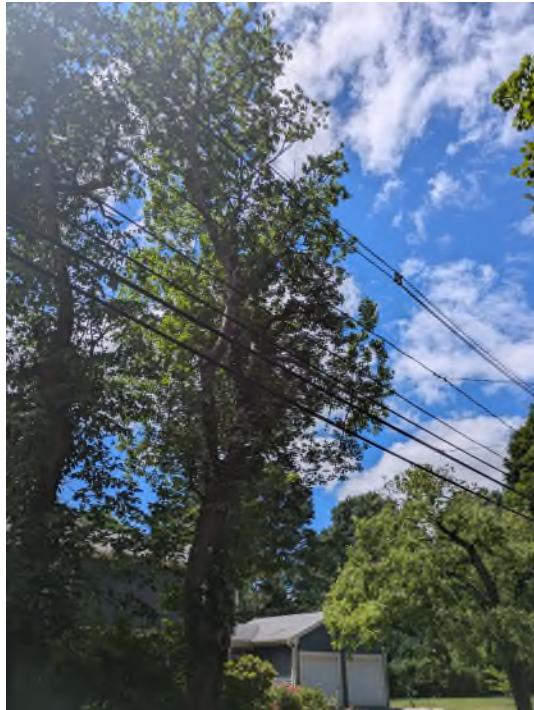
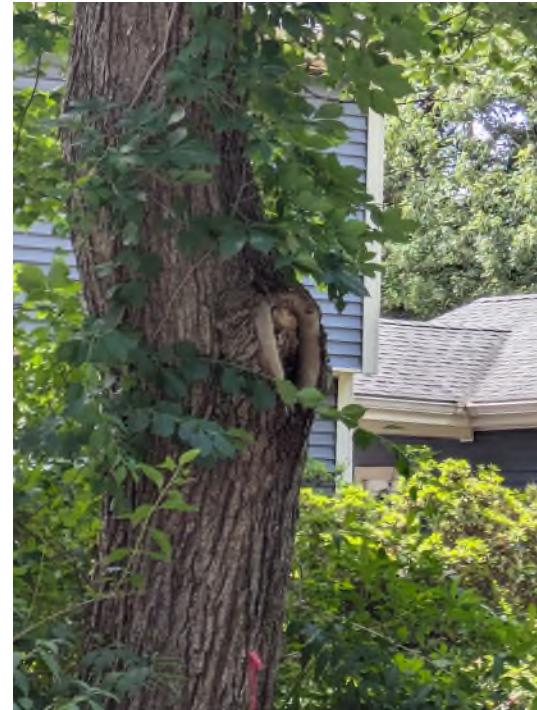
Site ID	Tree #	Street Name	House #	Loc	Pole #	Dia.	Species	# Stems	Defect Condition	Work Proposed
DC33	107	Flagg Rd	38		28-29	24	Maple		Weight over line, more than 75% decline, cavity 8' up w/decay	Remove

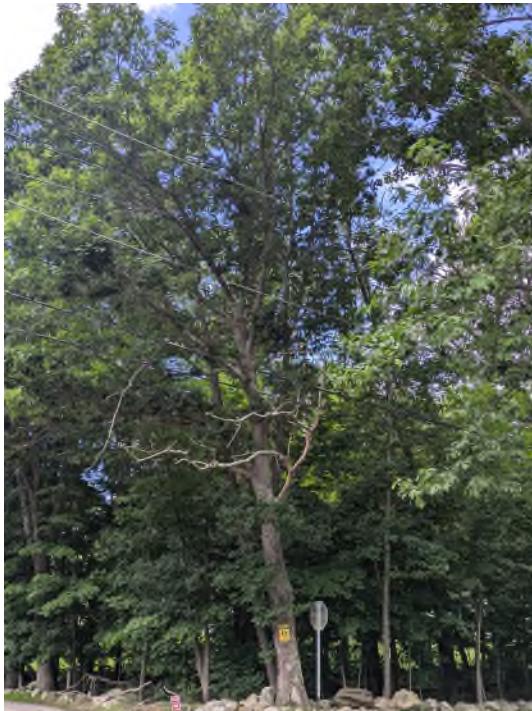
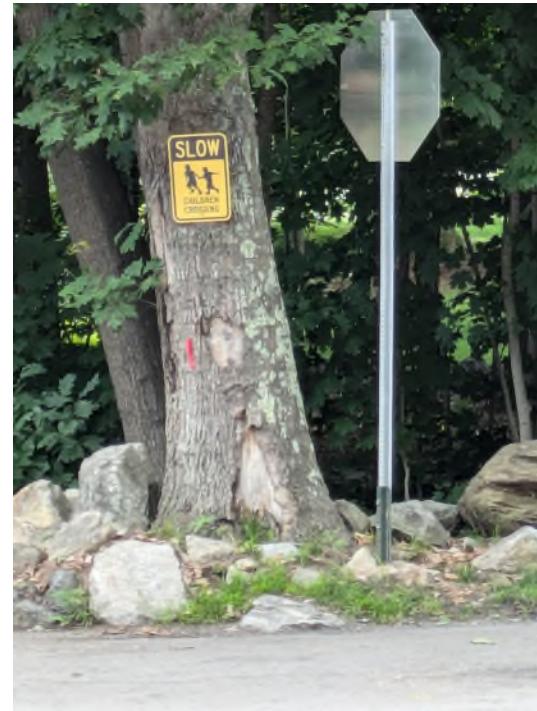
Site ID	Tree #	Street Name	House #	Loc	Pole #	Dia.	Species	# Stems	Defect Condition	Work Proposed
DC34	108	Flagg Rd	Lot		30-31	25	Oak		Lean, weight to line, cavity at base w/decay and insect damage, multiple dead branches	Remove

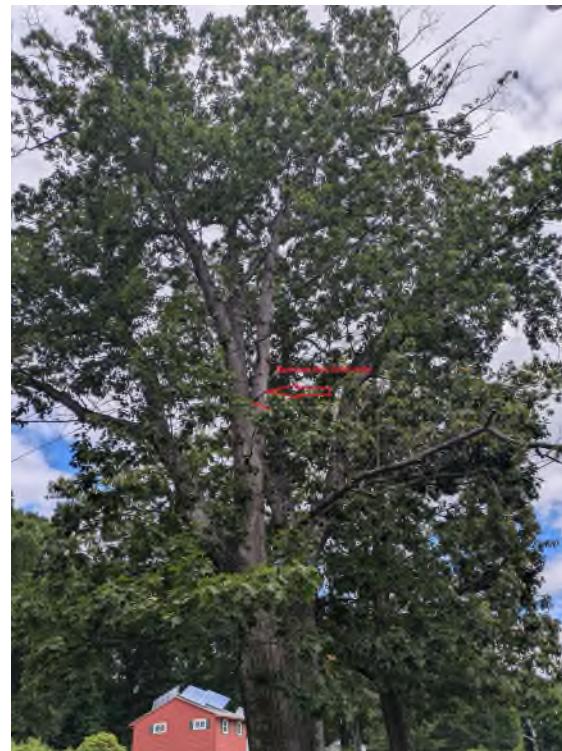
Site ID	Tree #	Street Name	House #	Loc	Pole #	Dia.	Species	# Stems	Defect Condition	Work Proposed
DC39	109	Flagg Rd	73	AF	40-41	42	Oak		Remove 10" limb back to main trunk. Limb more than 75% decline	Trim

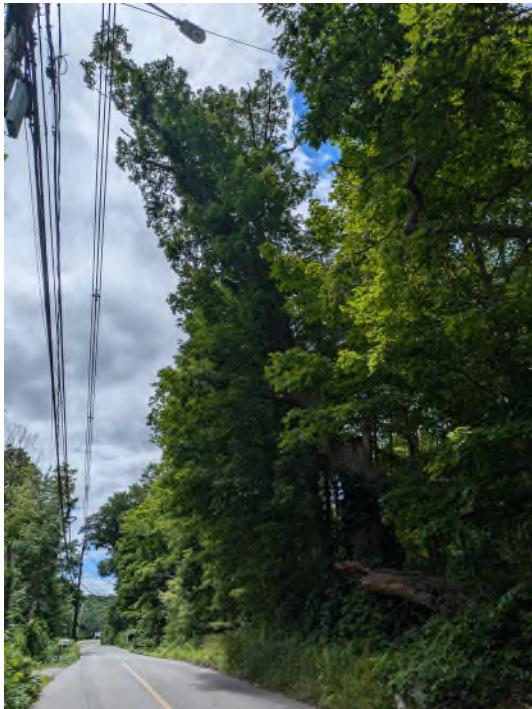
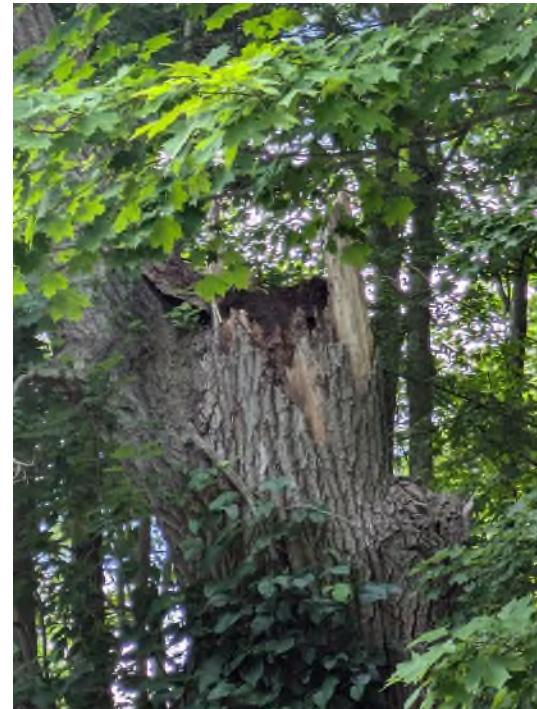
Site ID	Tree #	Street Name	House #	Loc	Pole #	Dia.	Species	# Stems	Defect Condition	Work Proposed
DC40	110	Flagg Rd	77	AF	42-43	42	Oak		Weight over lines, more than 75% decline, one lead broke off leaving large cavity w/extensive decay	Remove

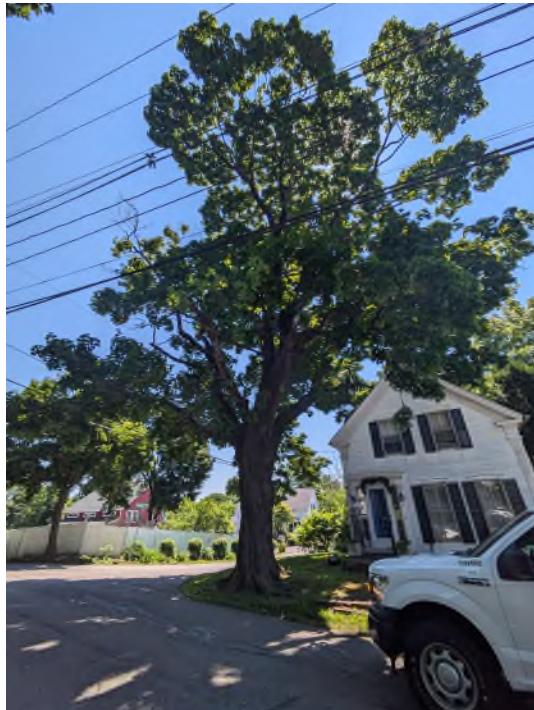
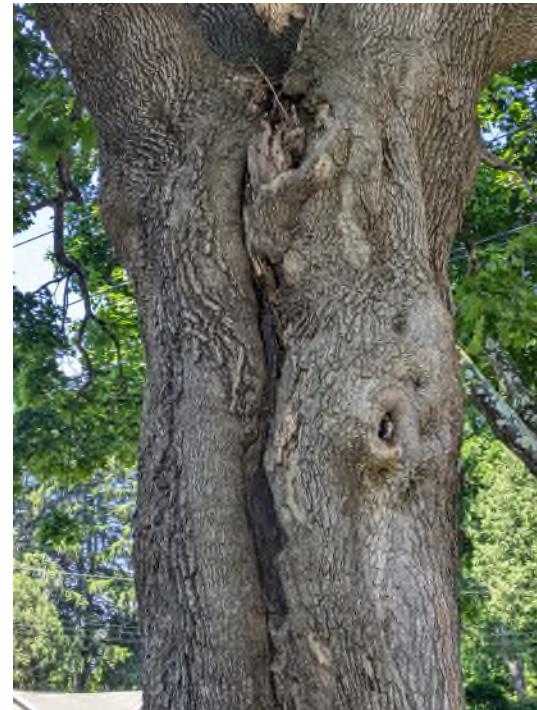
Site ID	Tree #	Street Name	House #	Loc	Pole #	Dia.	Species	# Stems	Defect Condition	Work Proposed
RK07	111	Ward Rd	5	AF	5-4	42	Maple		Extensive trunk decay	Remove

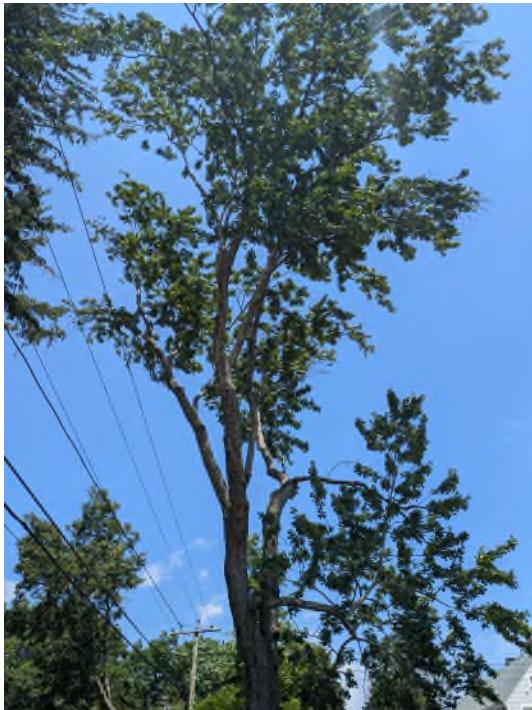
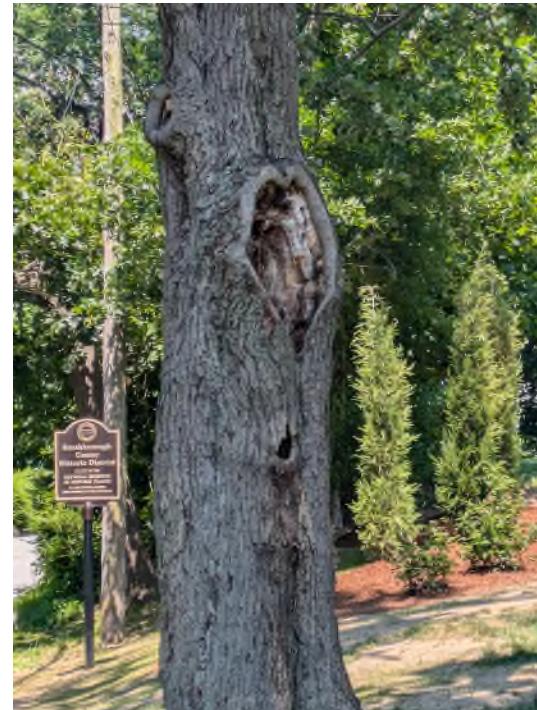
Site ID	Tree #	Street Name	House #	Loc	Pole #	Dia.	Species	# Stems	Defect Condition	Work Proposed
	113	Lattisquam a Rd	22		9-10	25	Maple		Cavities w/decay	Remove
