Southborough Rural Cemetery

Retaining Wall Evaluation

February 2021

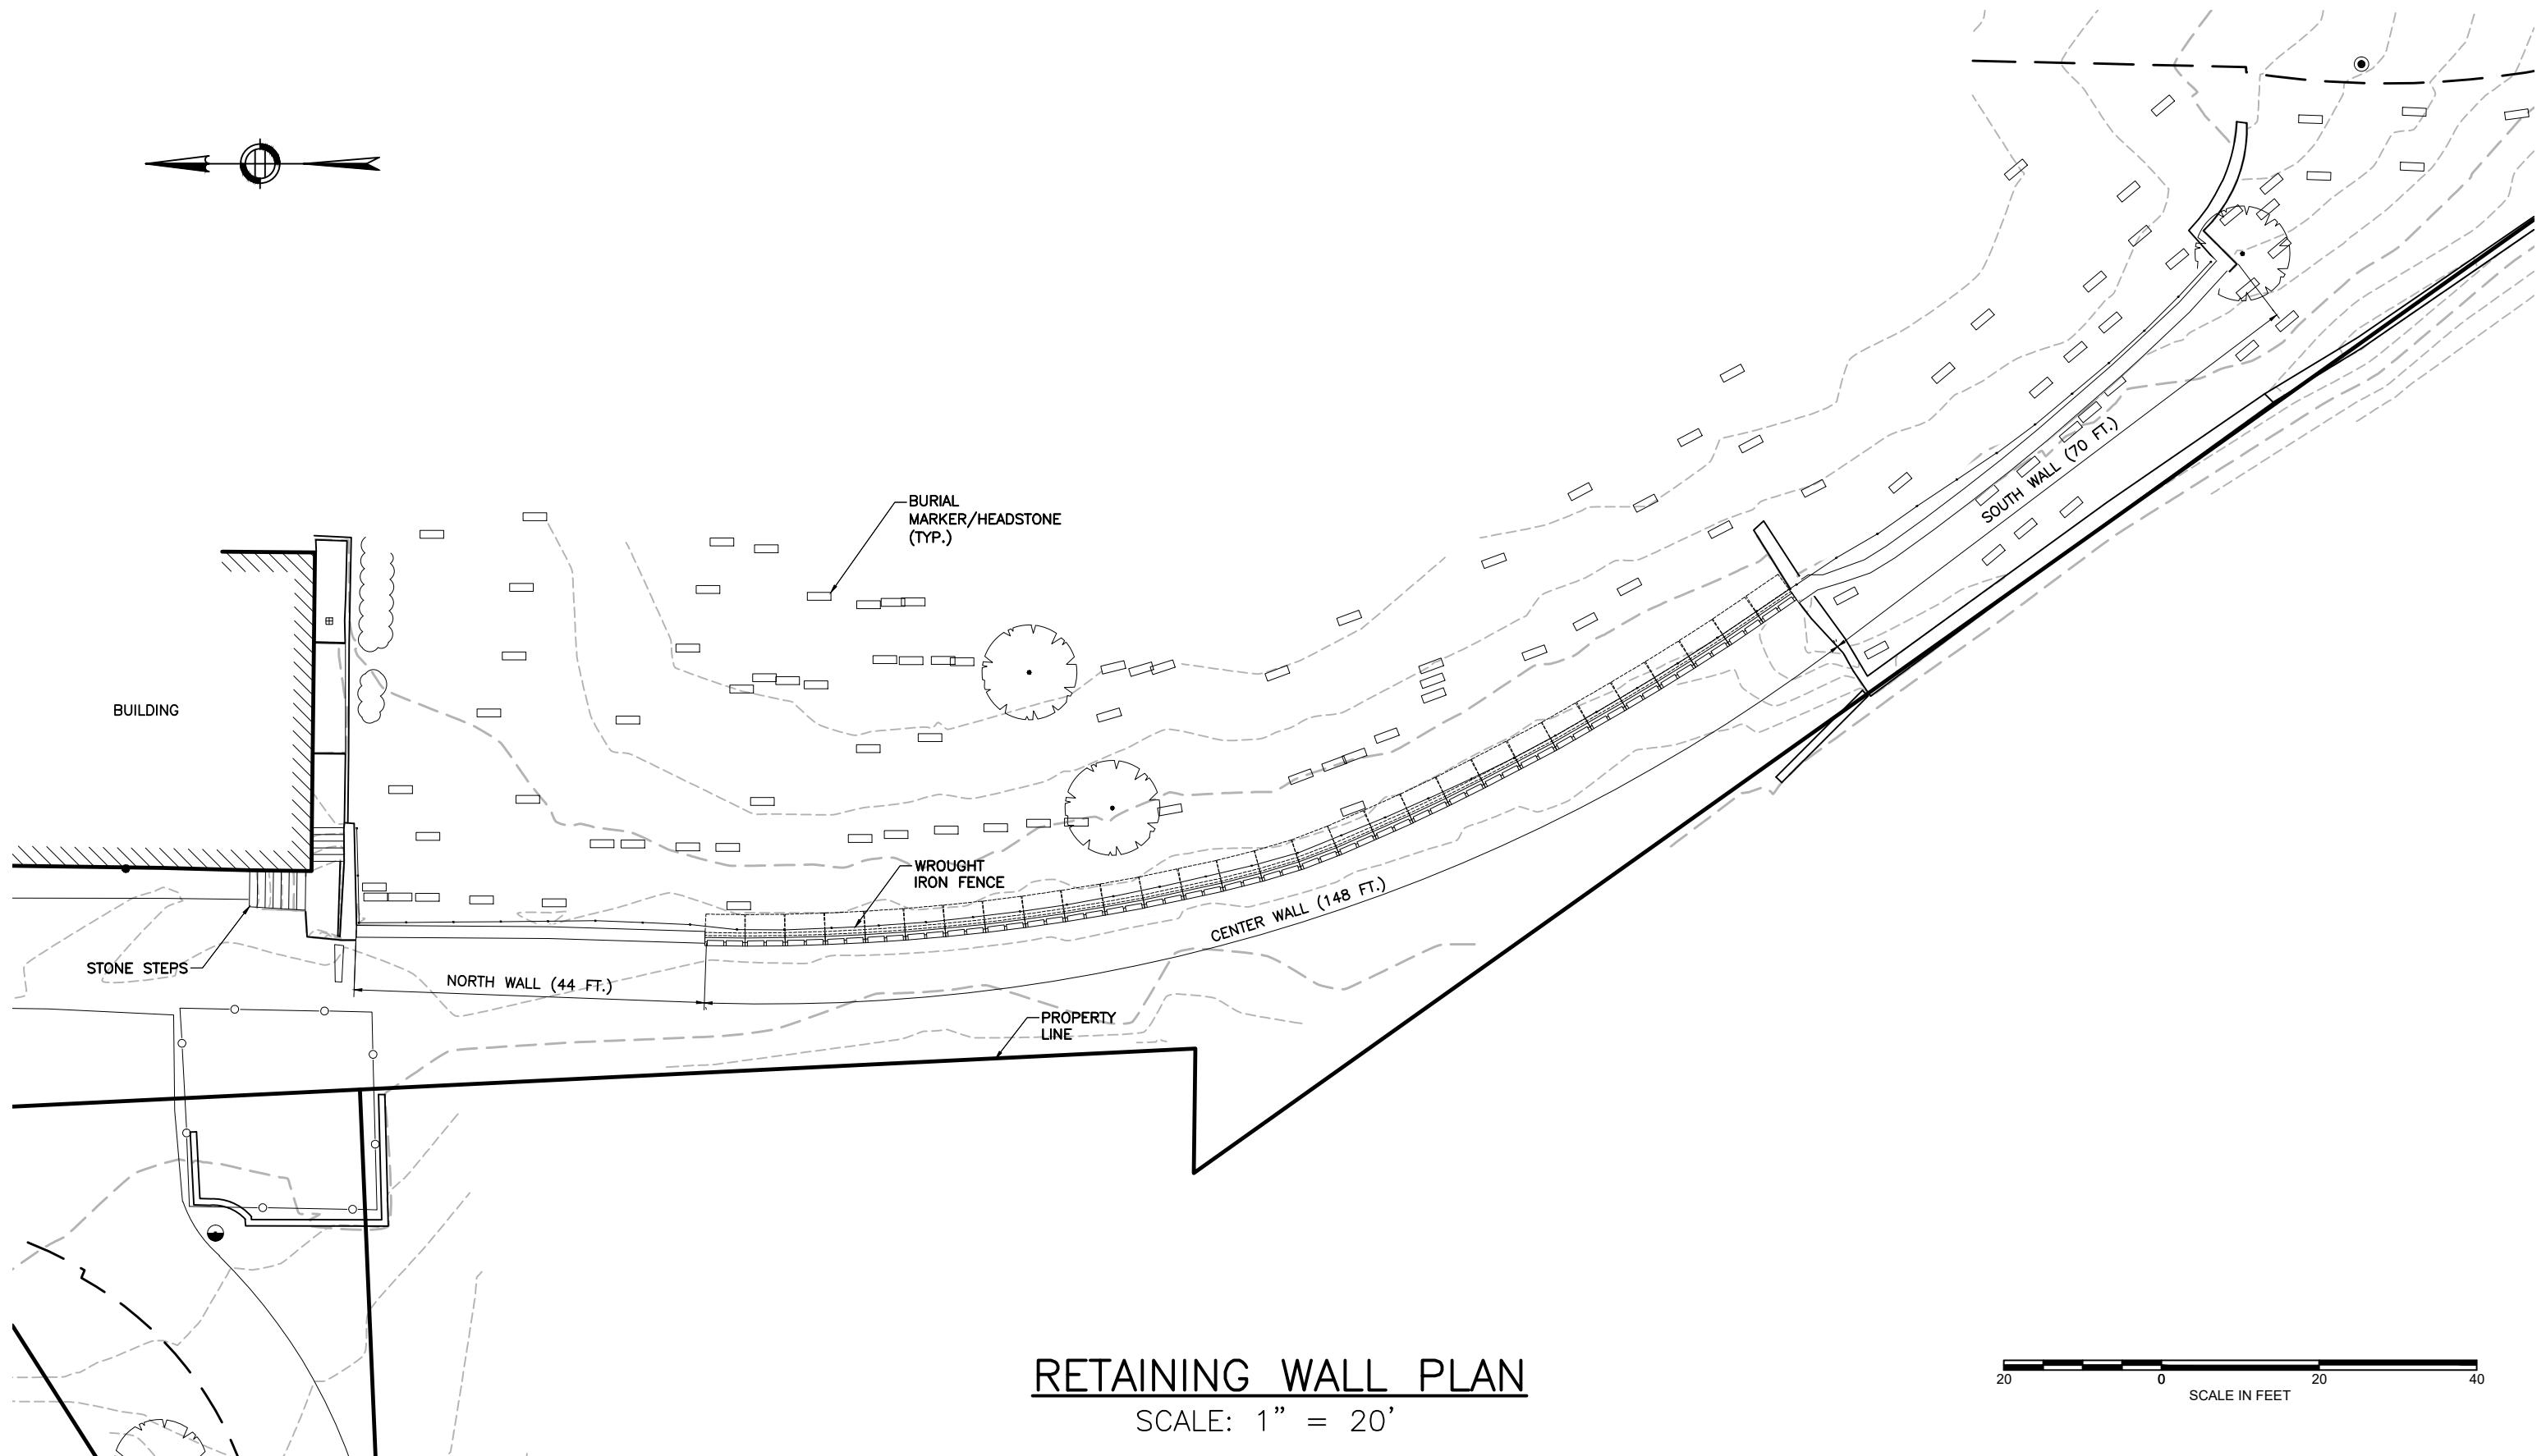
RETAINING WALL PLAN
SCALE: 1" = 20'

A plan of the existing retaining wall is attached as Appendix A.

The wall is approximately 262 ft. long with a maximum retained height of approximately 8 ft 6 in. It comprises three distinct sections. From south to north the wall consists of approximately 70 ft. of stone masonry, 148 ft. of precast concrete, and a second section of stone masonry approximately 44 ft. long. There is also a short return at the north end and a flight of steps in similar stone masonry construction.
